PHOTO 1 M1019 SOMERSET STREET: GENERAL VIEW (LOOKING NORTH)

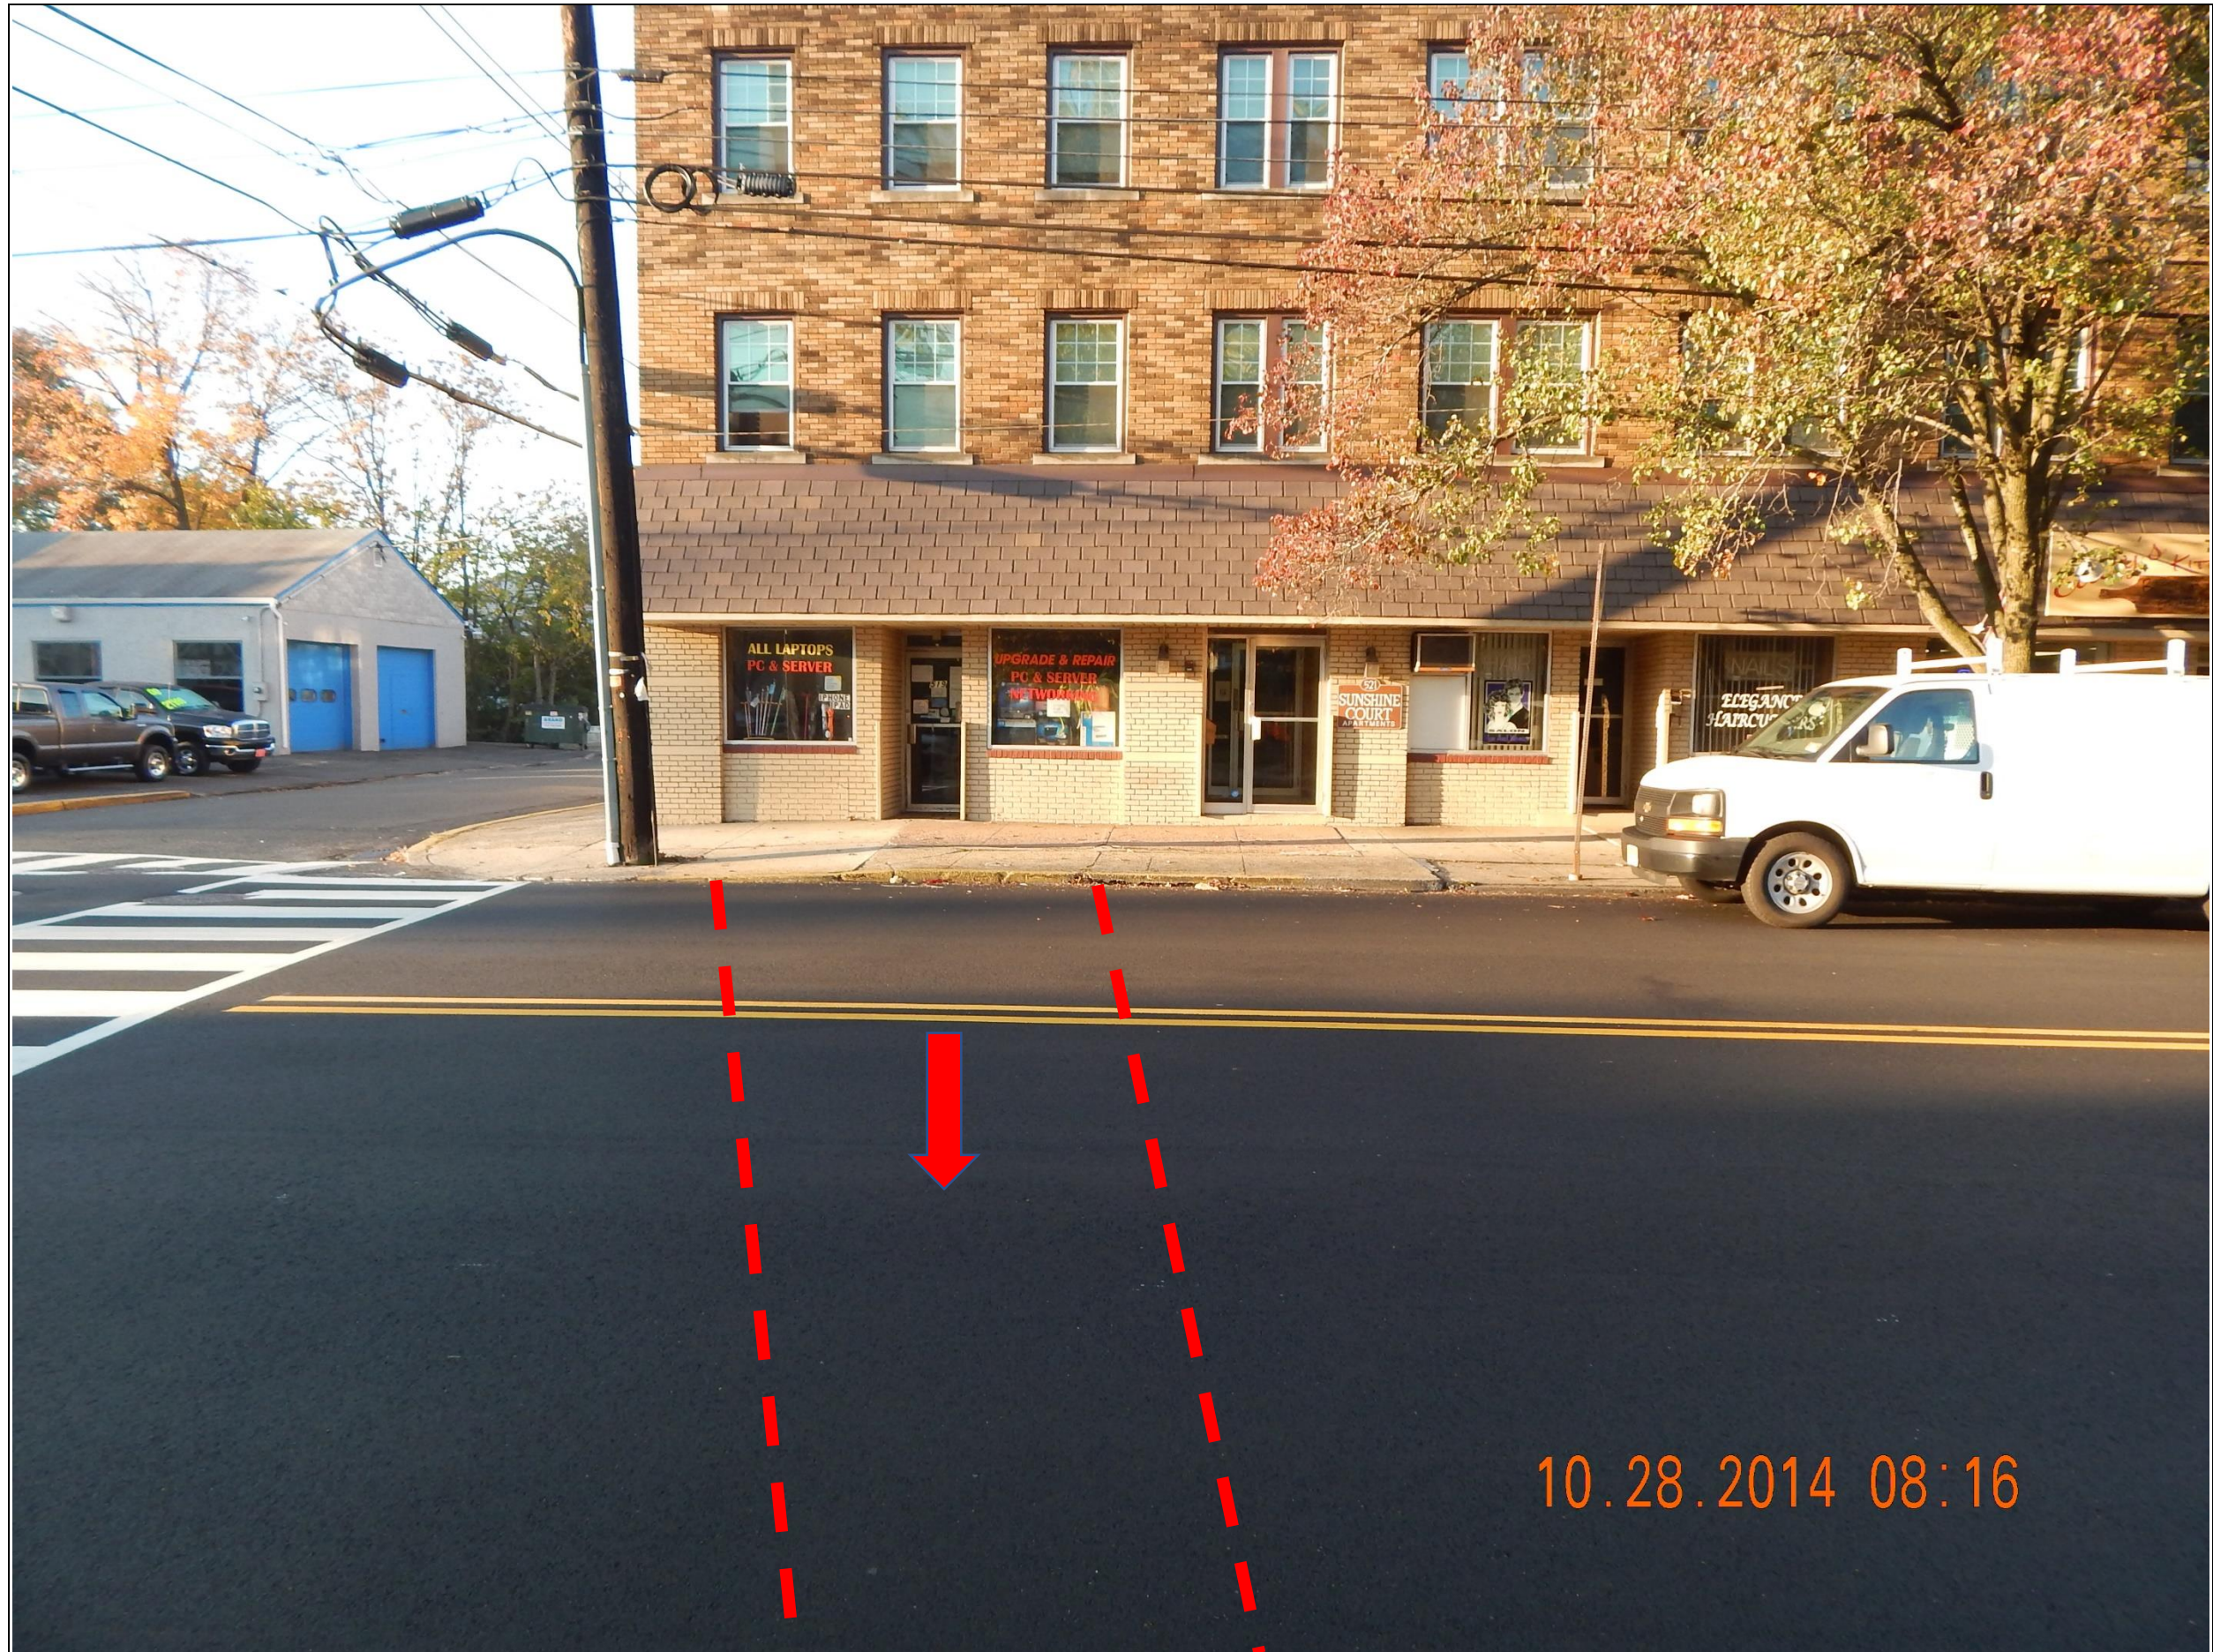
PHOTO 2 M1019 SOMERSET STREET: GENERAL VIEW (LOOKING WEST)

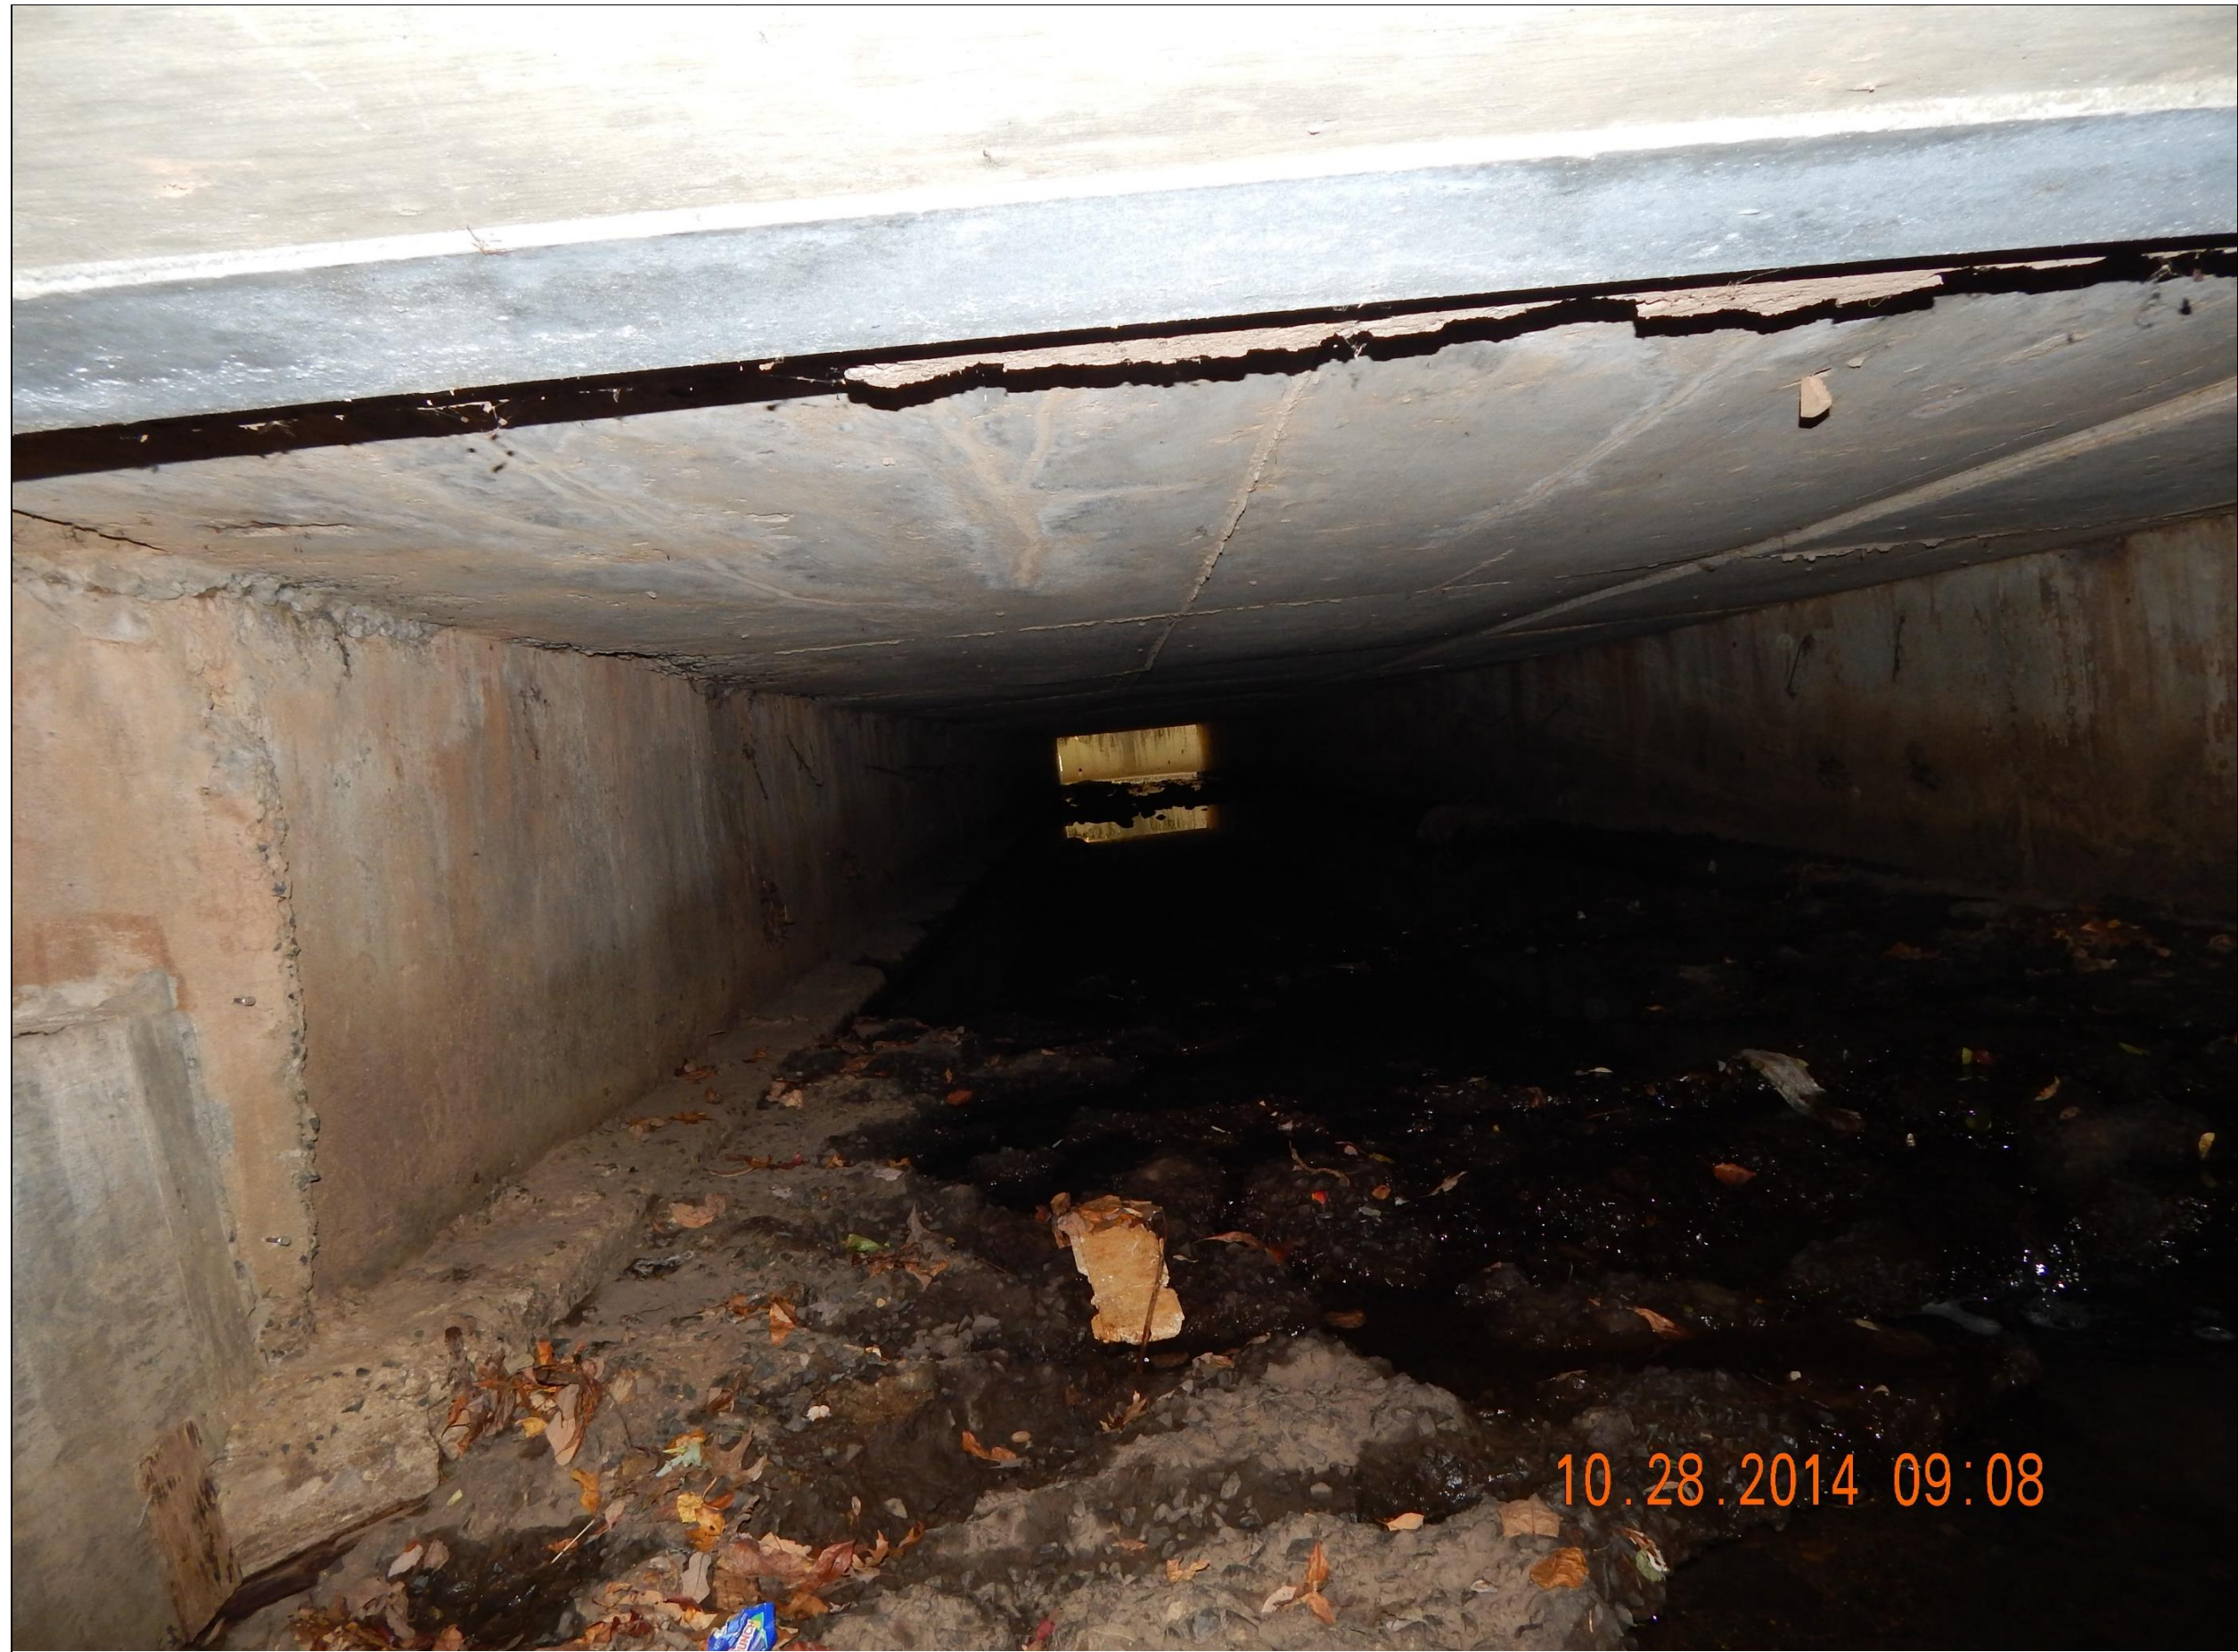
PHOTO 3 M1019 SOMERSET STREET: LOOKING EAST AT ADJACENT UPSTREAM STRUCTURE

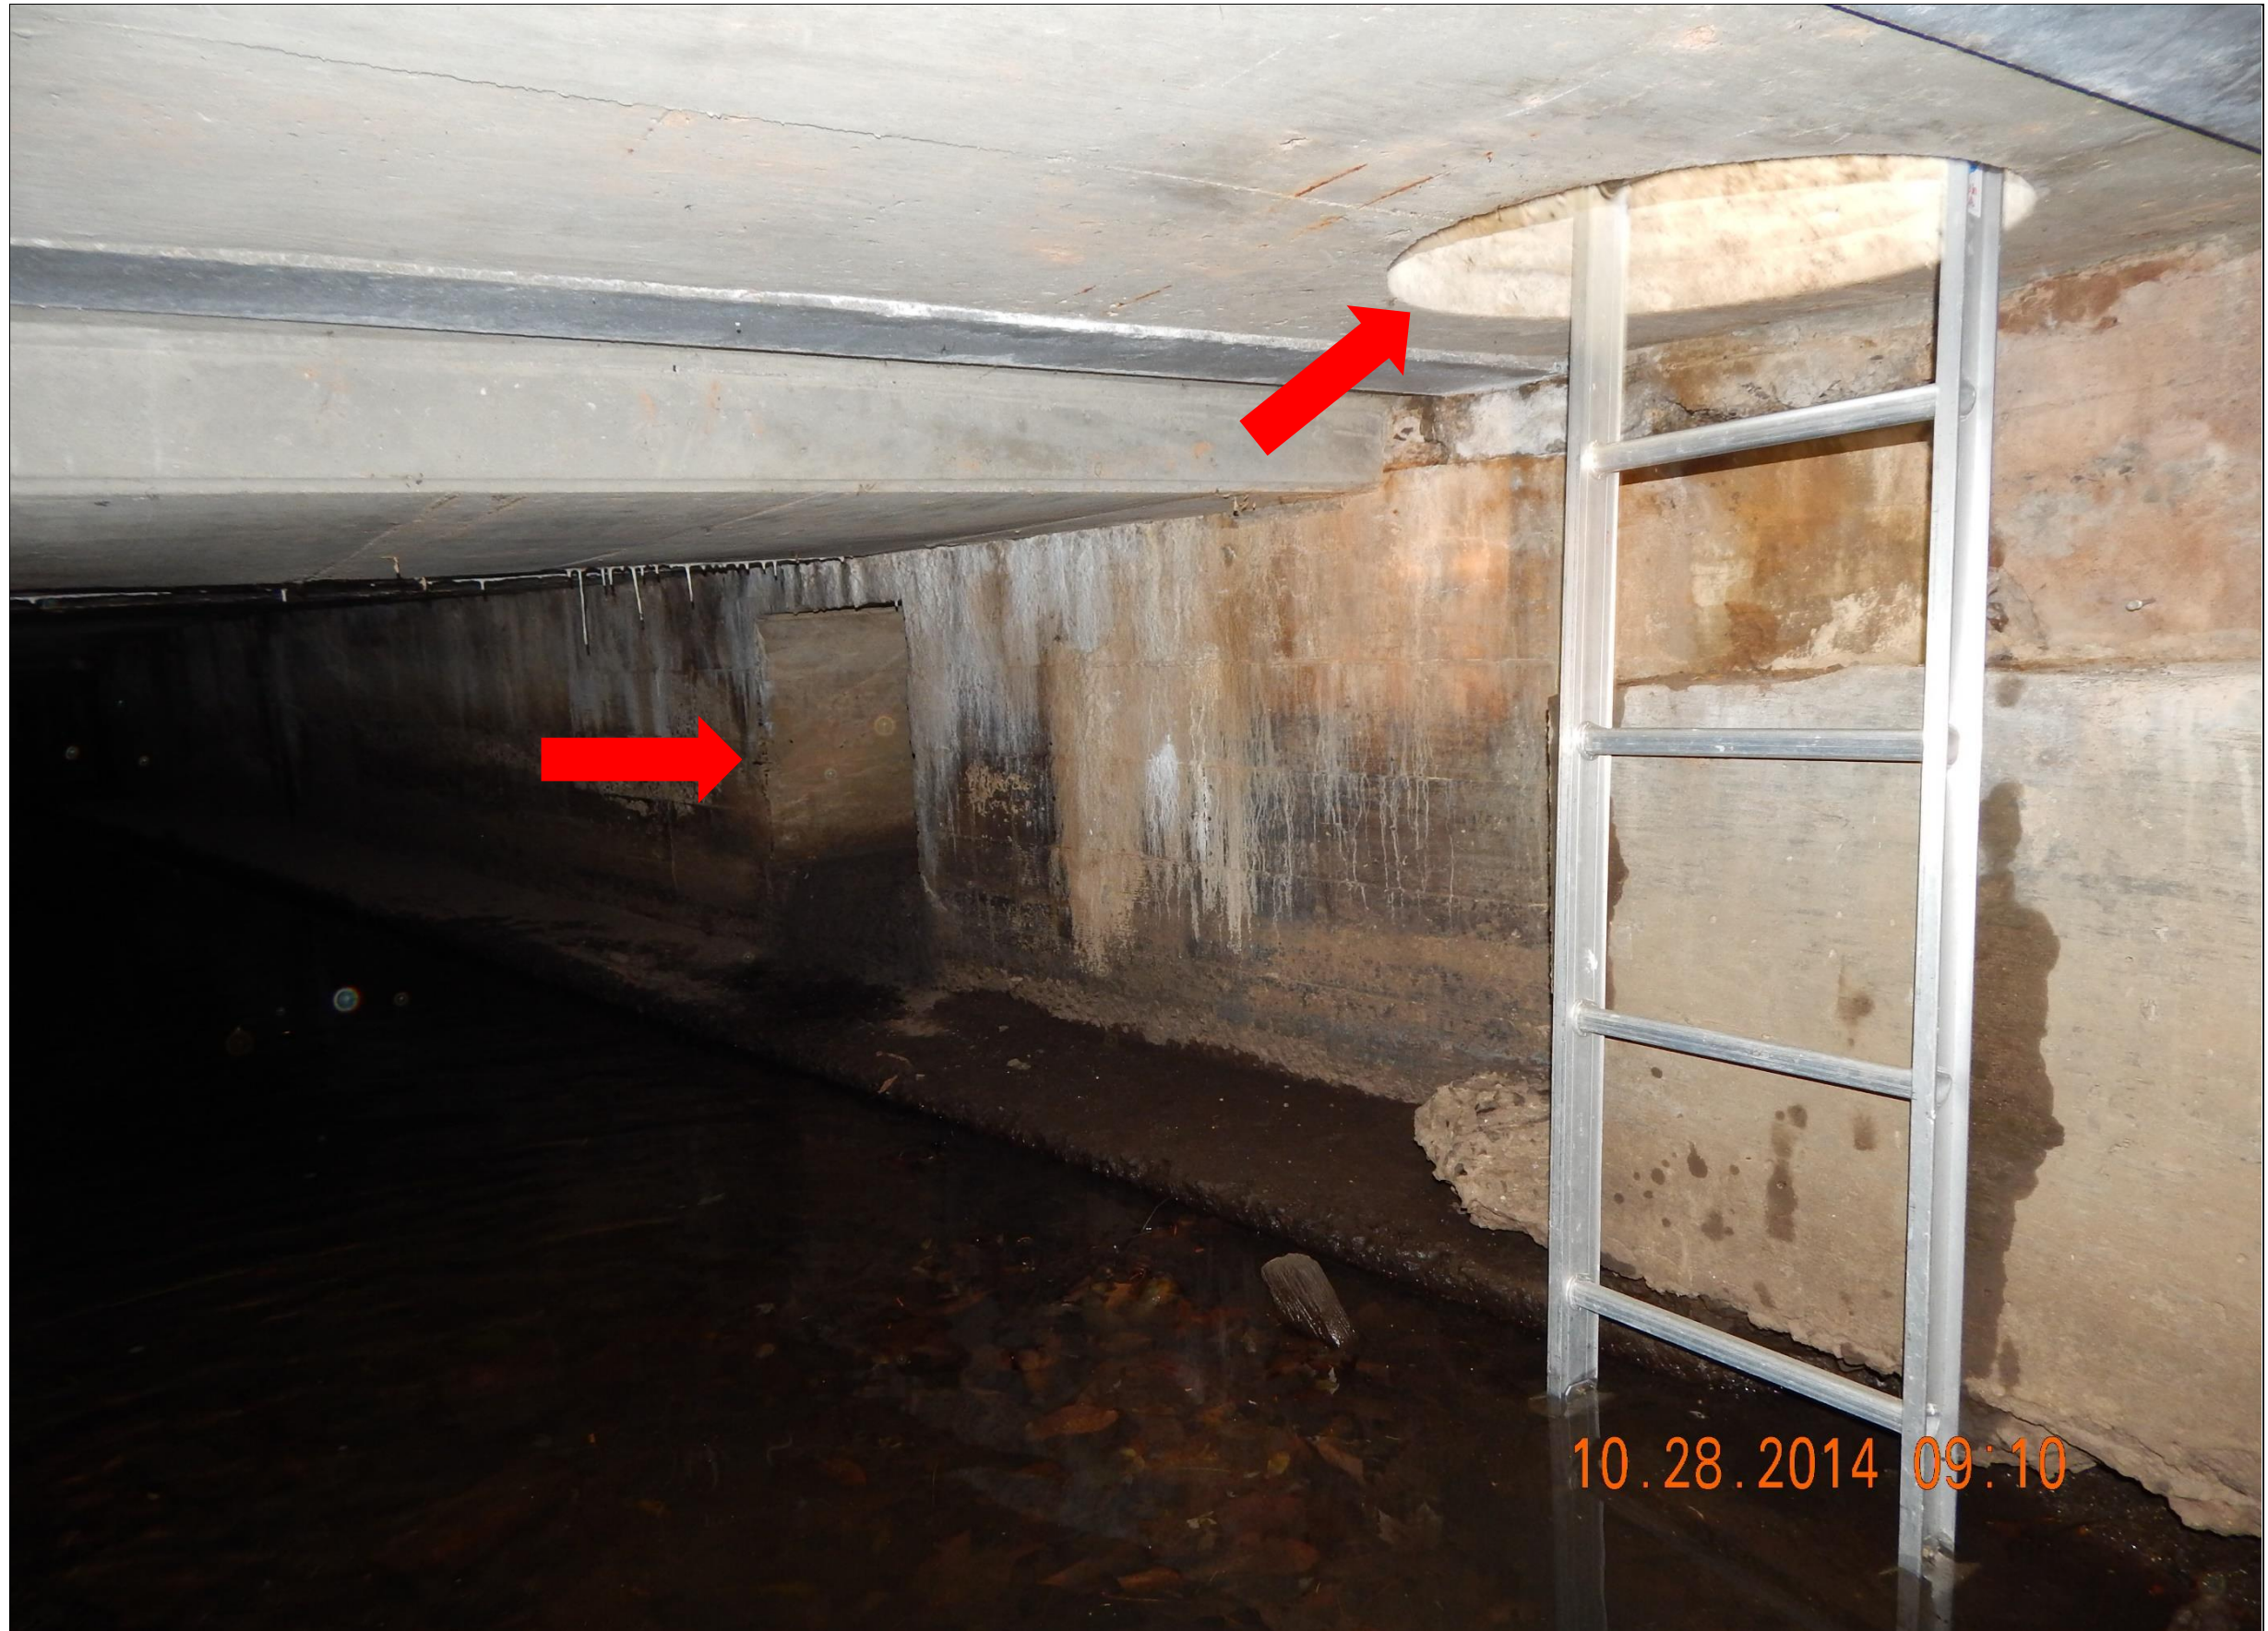
PHOTO 4 M1019 SOMERSET STREET: LOOKING WEST AT ACCESS MANHOLE AND DRAINAGE INLET

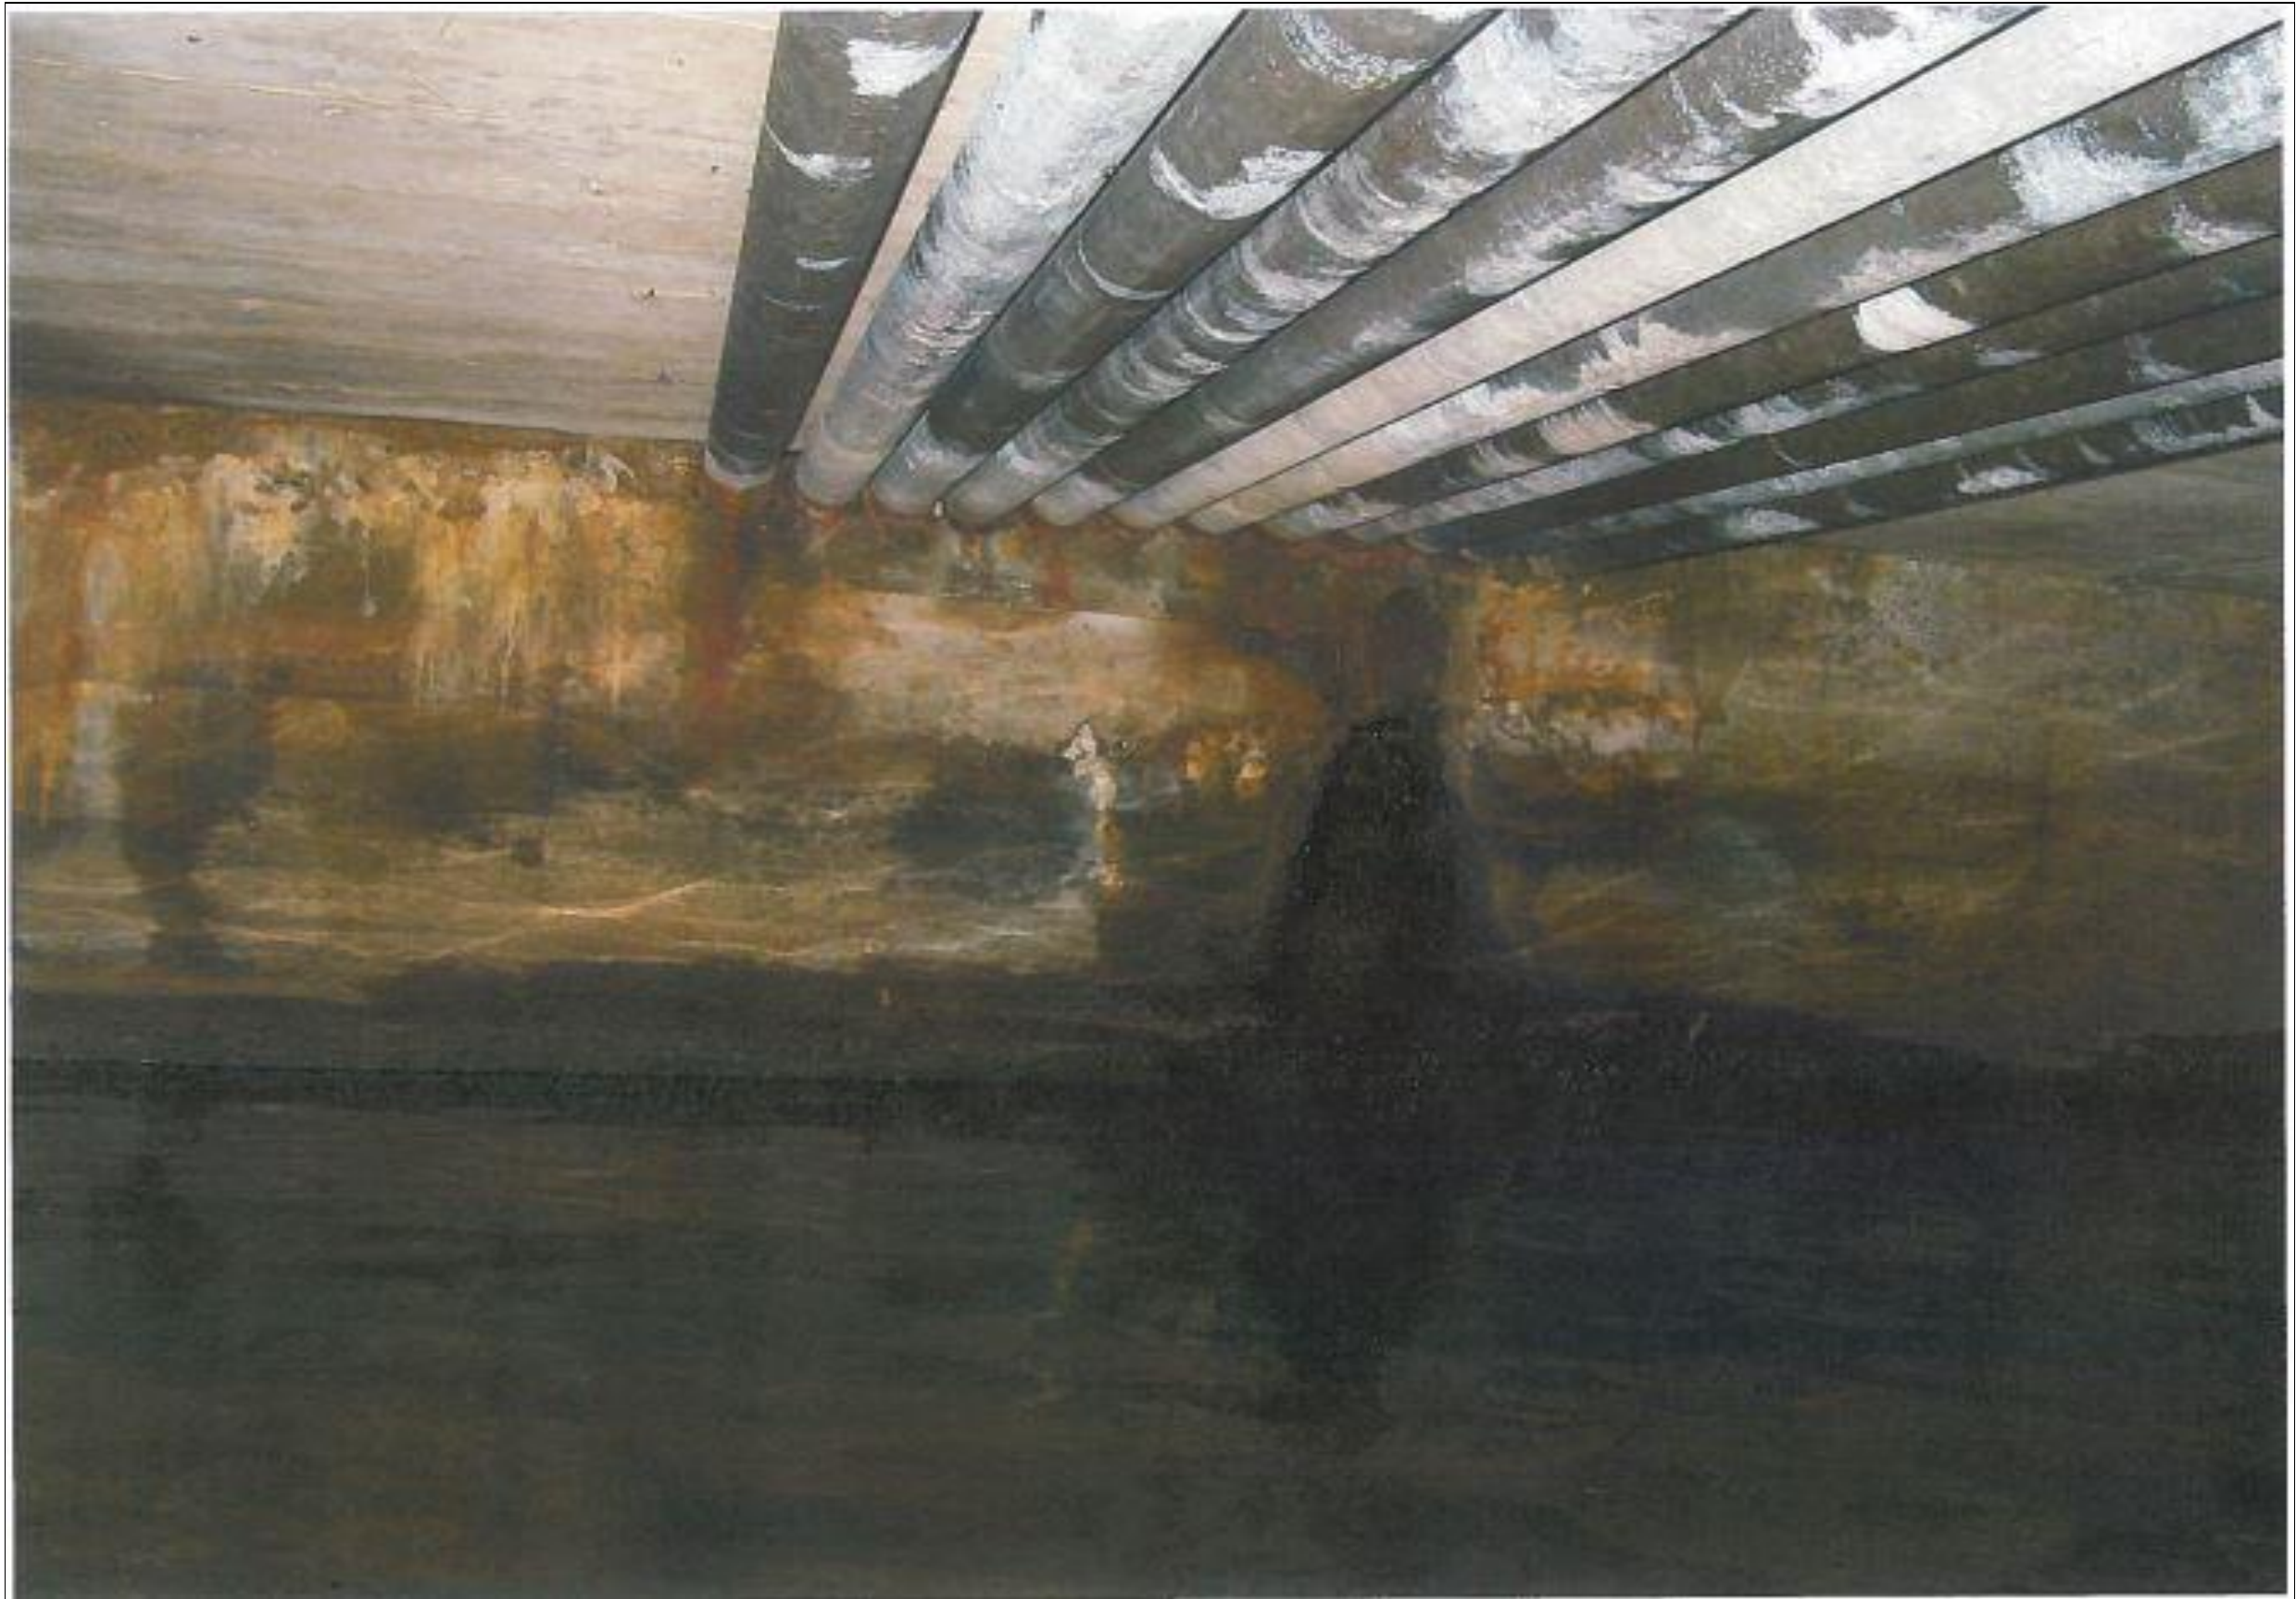
**PHOTO 5 M1019 SOMERSET STREET: LOOKING NORTH AT TELEPHONE CONDUITS**

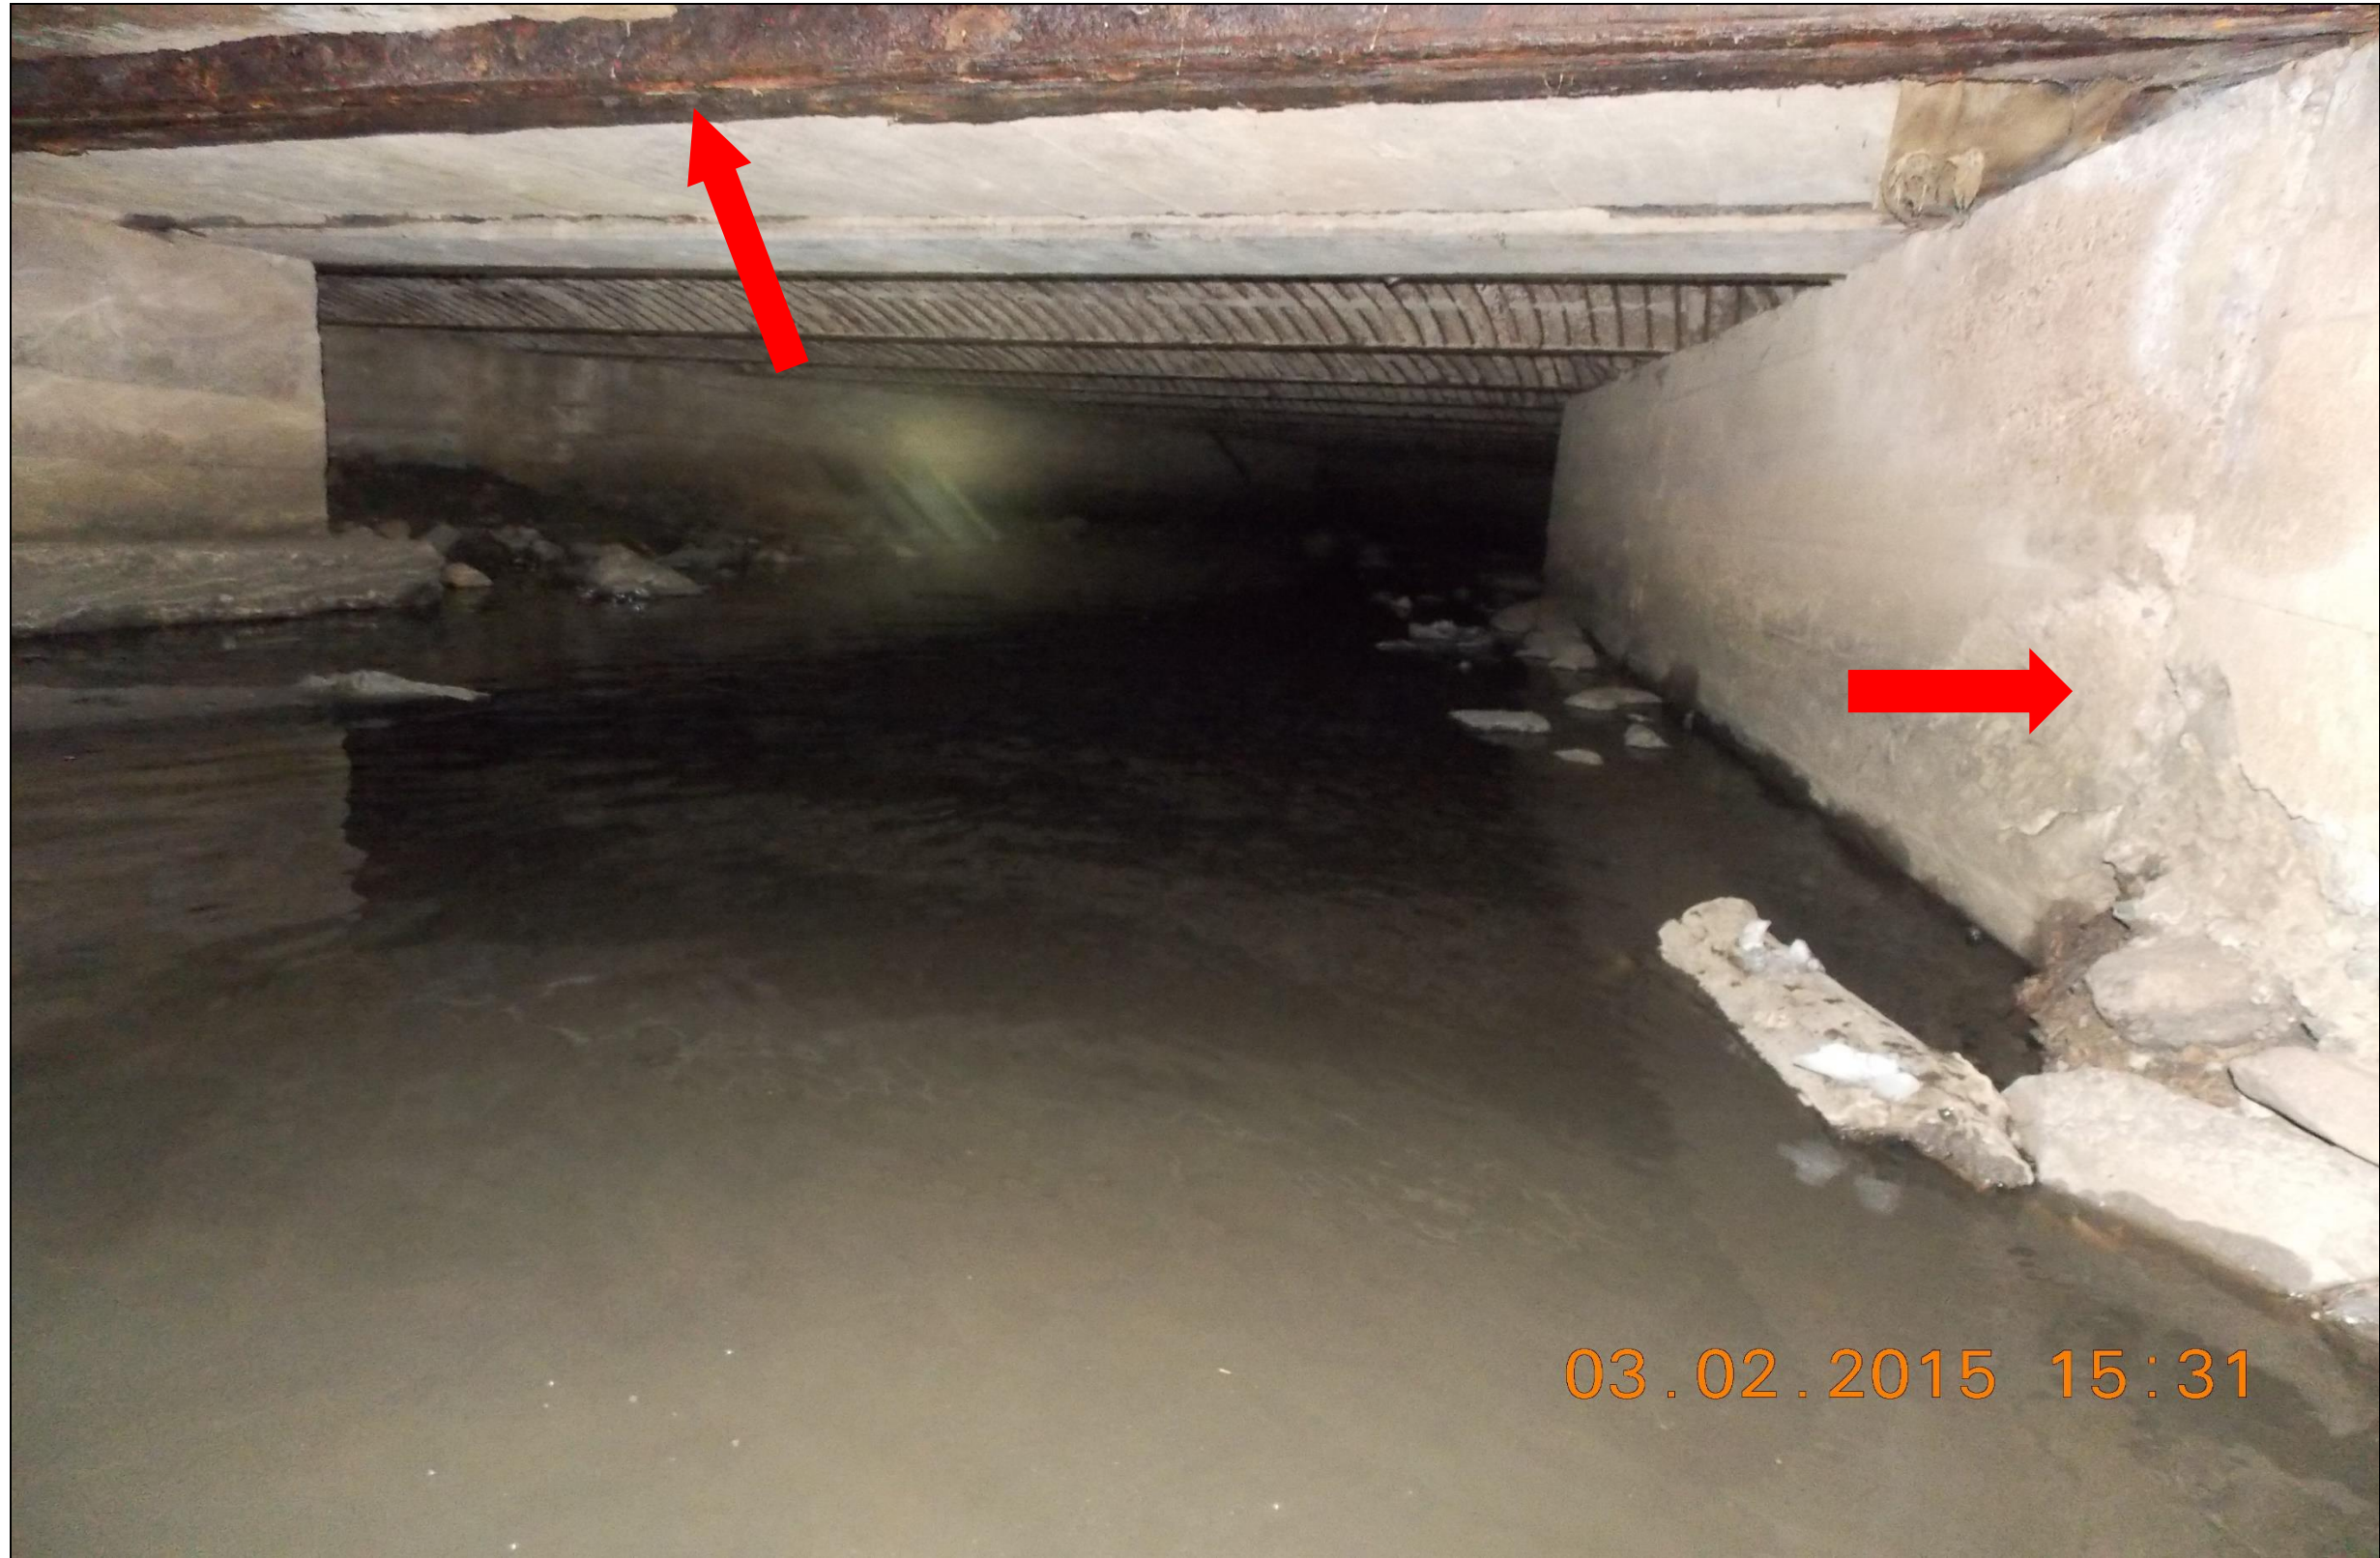
**PHOTO 6 M1019 SOMERSET STREET: LOOKING WEST AT ADJACENT DOWNSTREAM STRUCTURE.  
IT ALSO EXHIBITED SEVERELY CORRODED STRINGER AND SPALLED ABUTMENT**

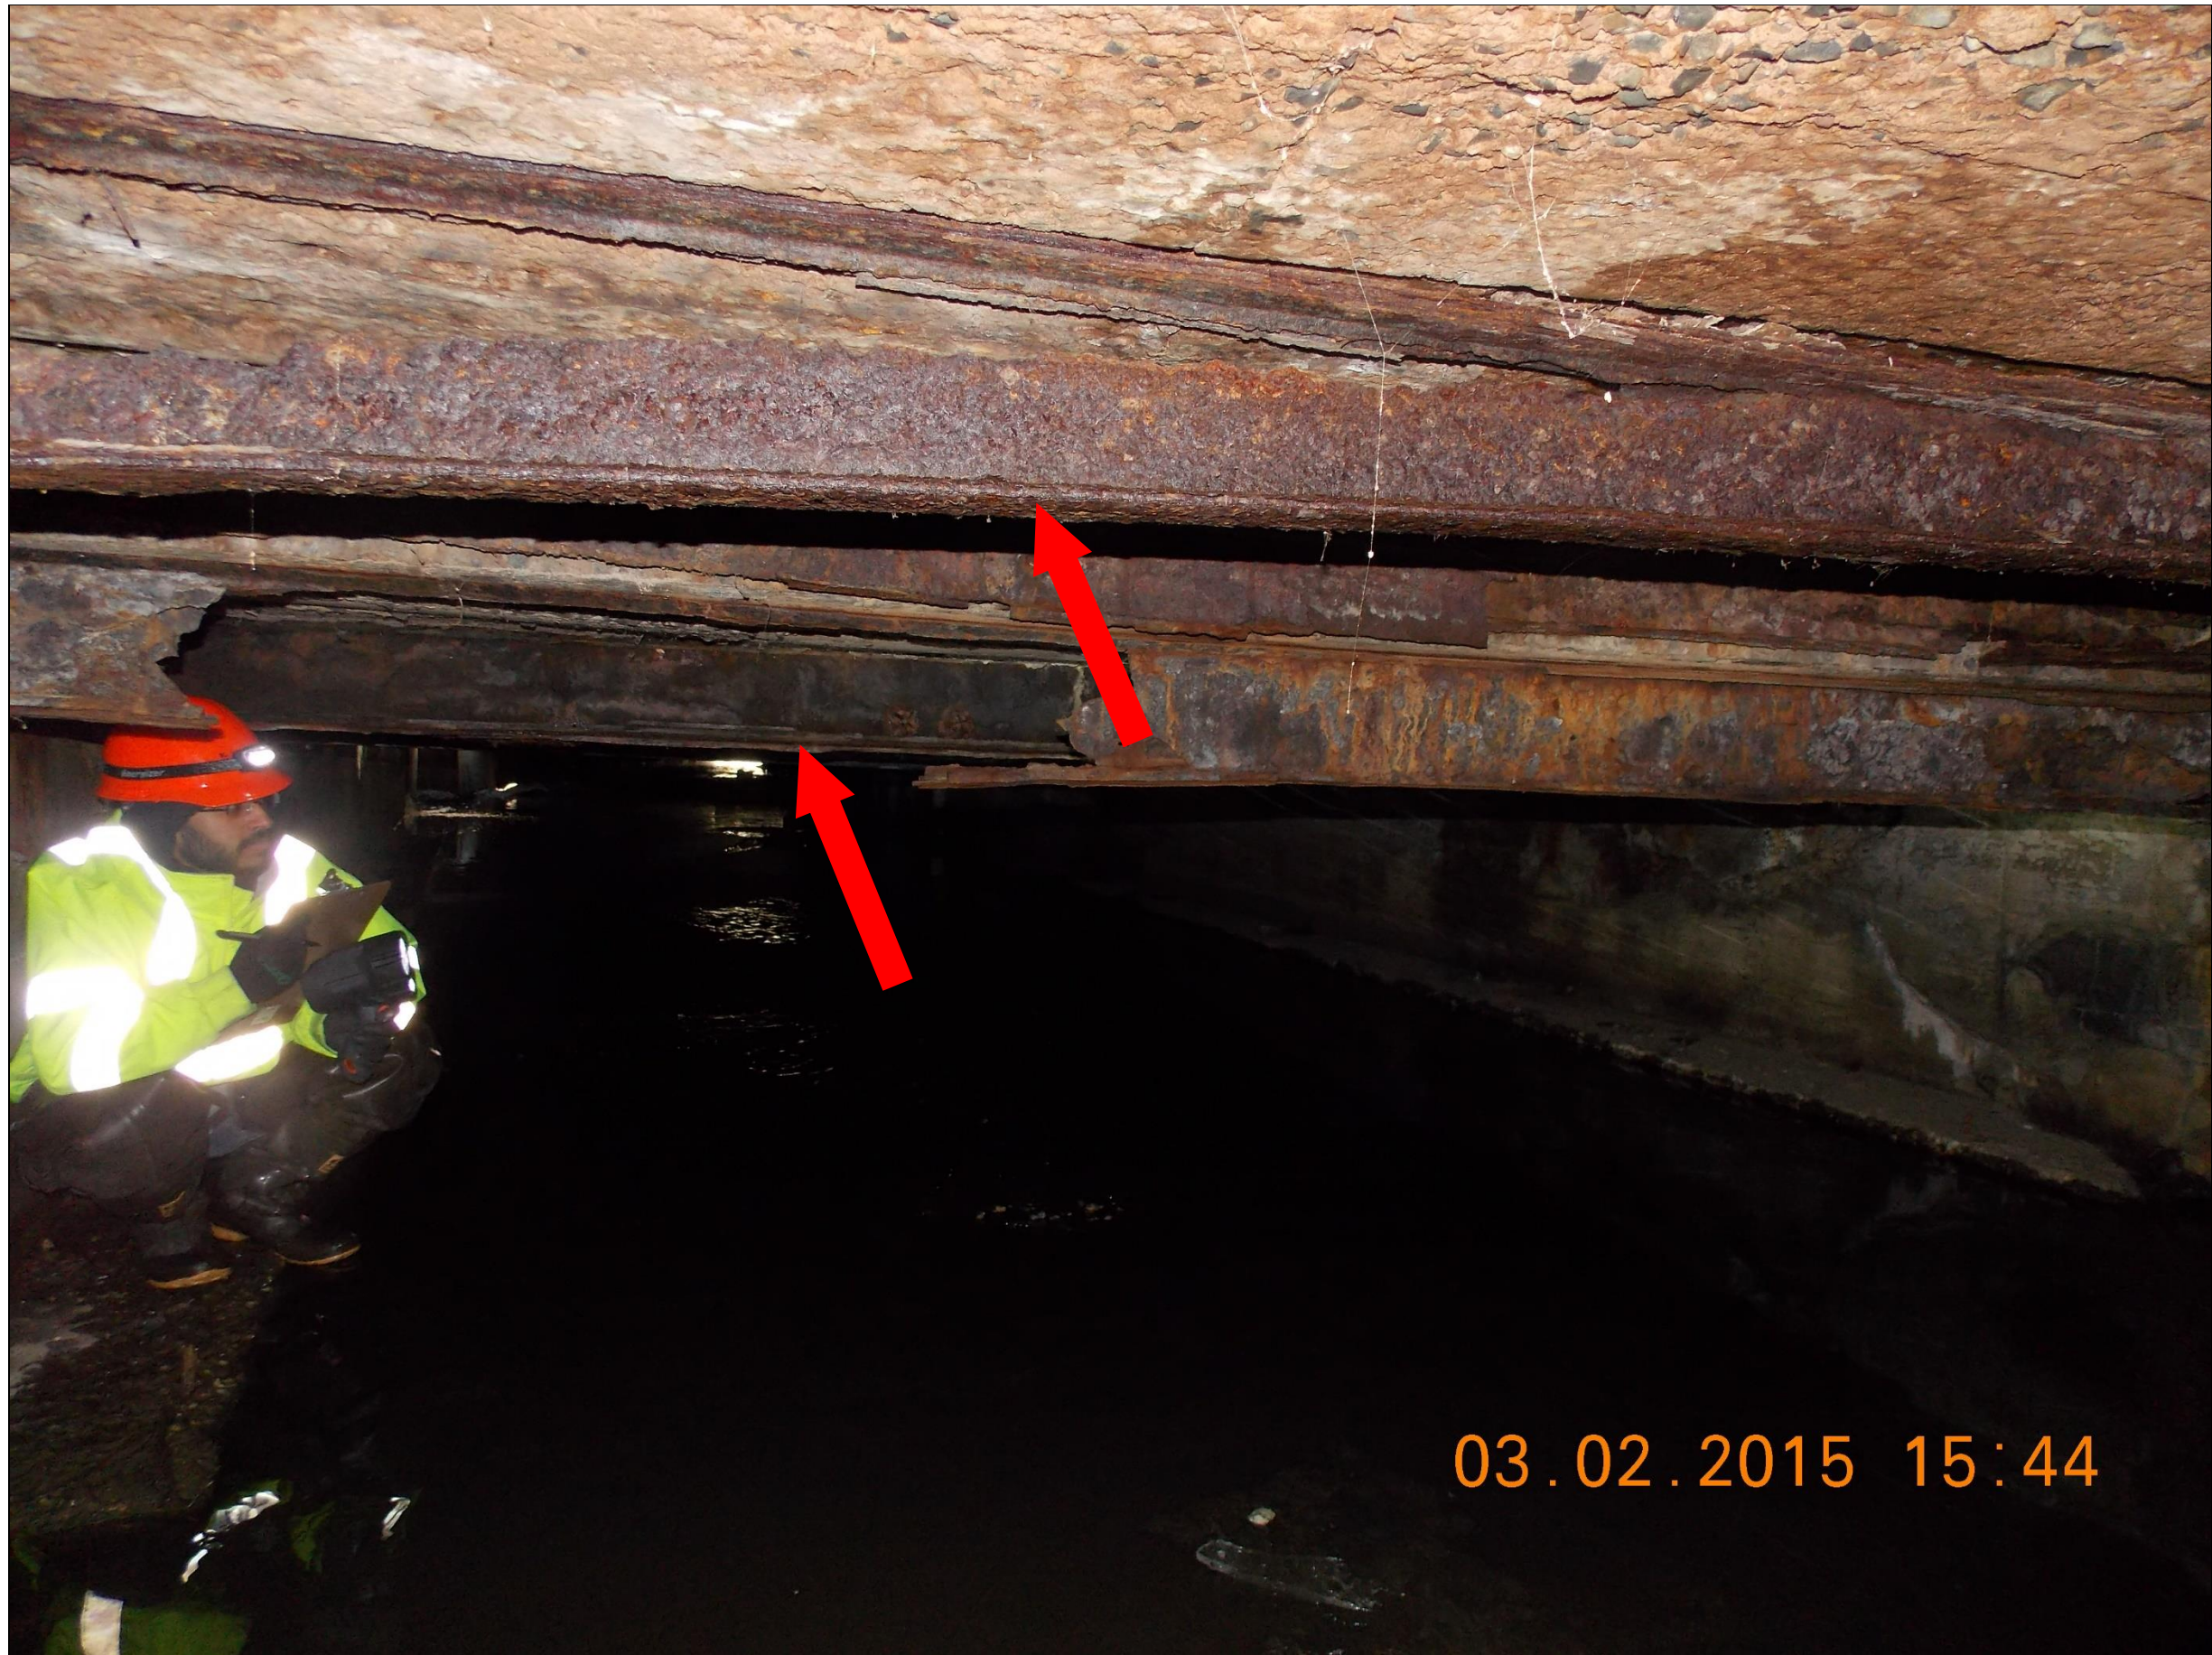
PHOTO 7 M1019 SOMERSET STREET: LOOKING EAST AT LOW CLEARANCE STRUCTURE AND SEVERELY CORRODED STRINGERS
