**Somerset County Bridge D1302**  
**Pottersville Road (CR 512) over Peapack Brook**  
**Borough of Peapack and Gladstone**  
**Existing Conditions**

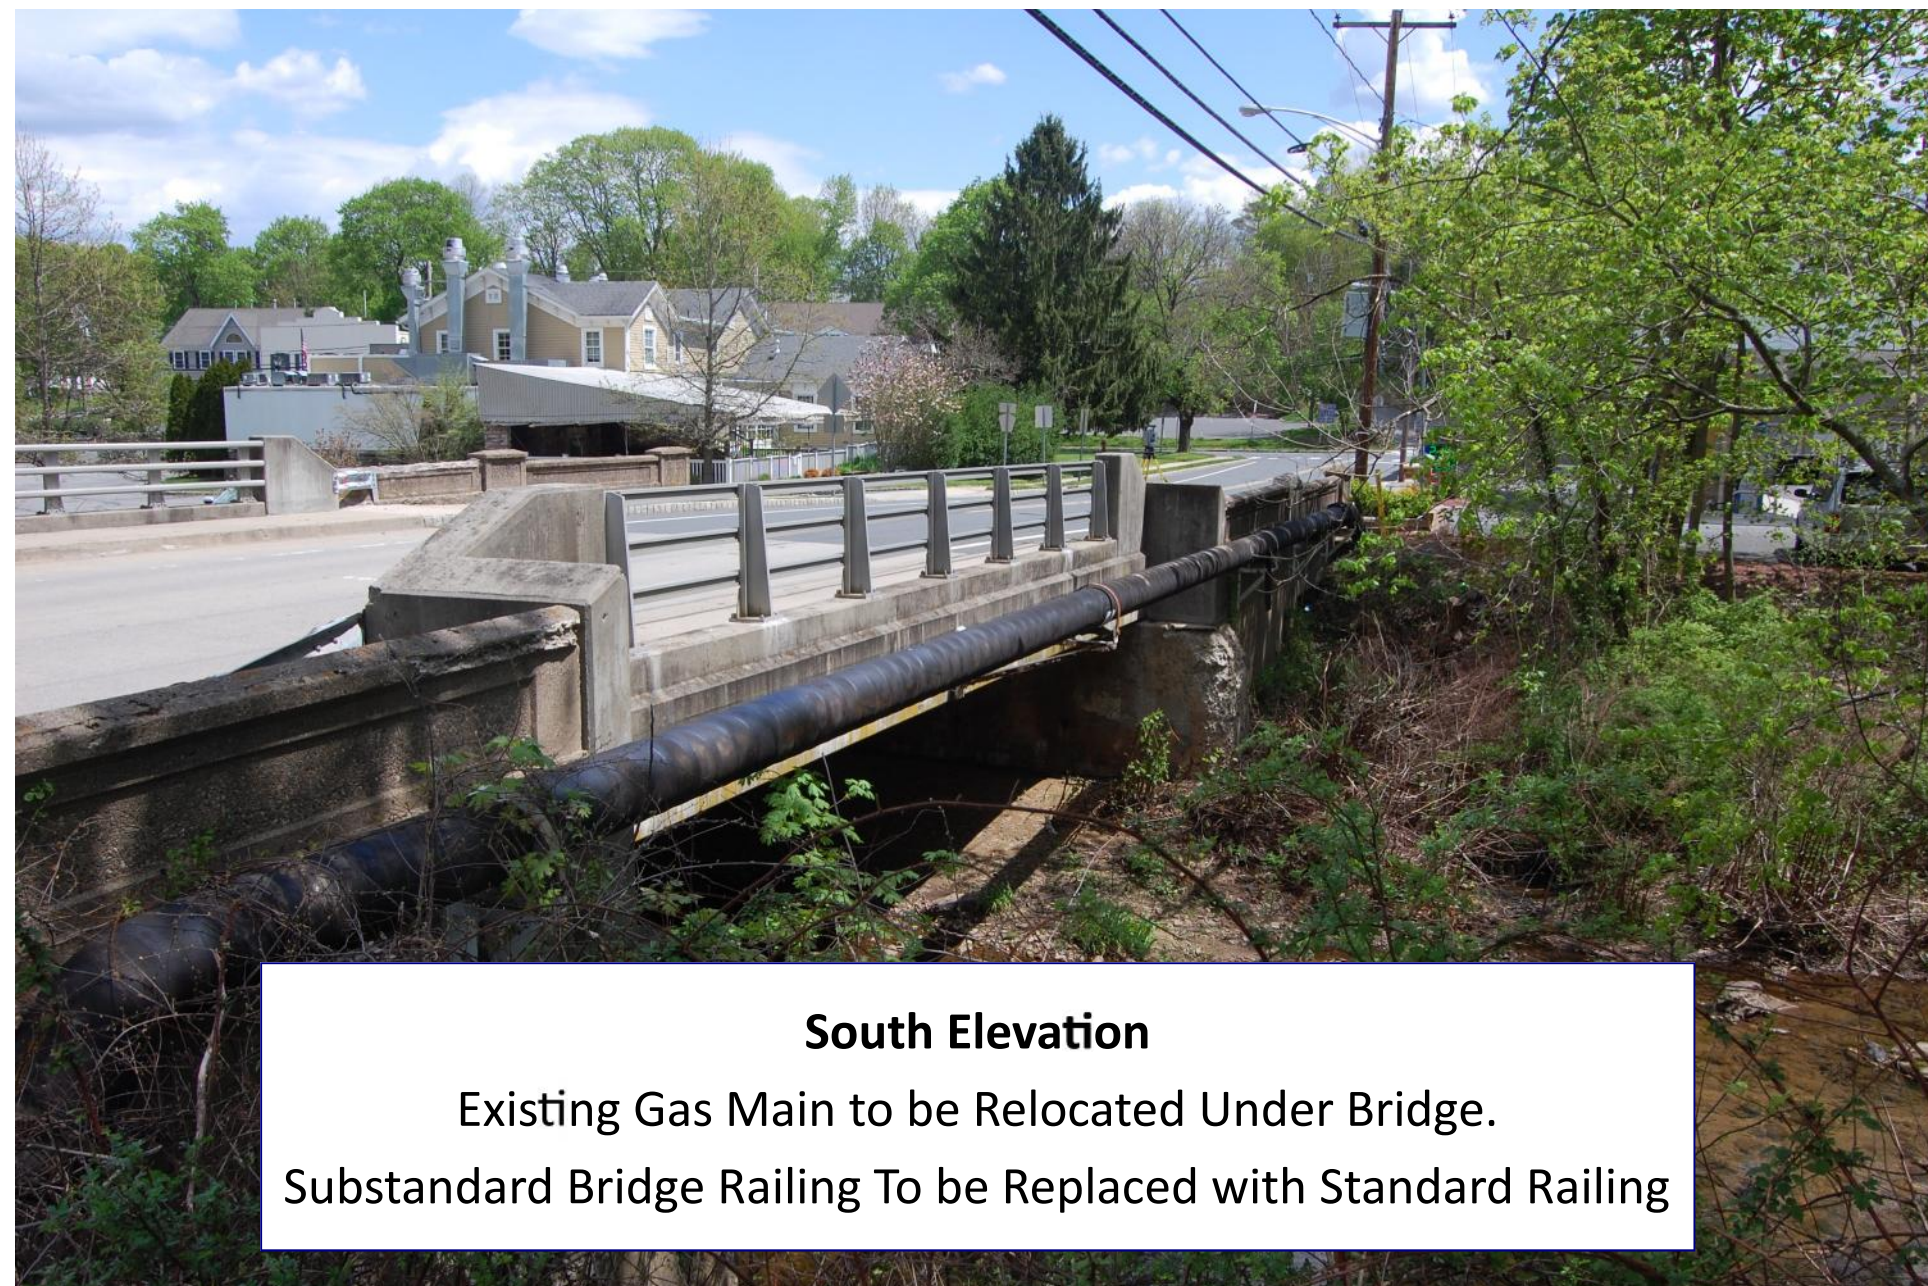
**South Elevation**  
Existing Gas Main to be Relocated Under Bridge.  
Substandard Bridge Railing To be Replaced with Standard Railing

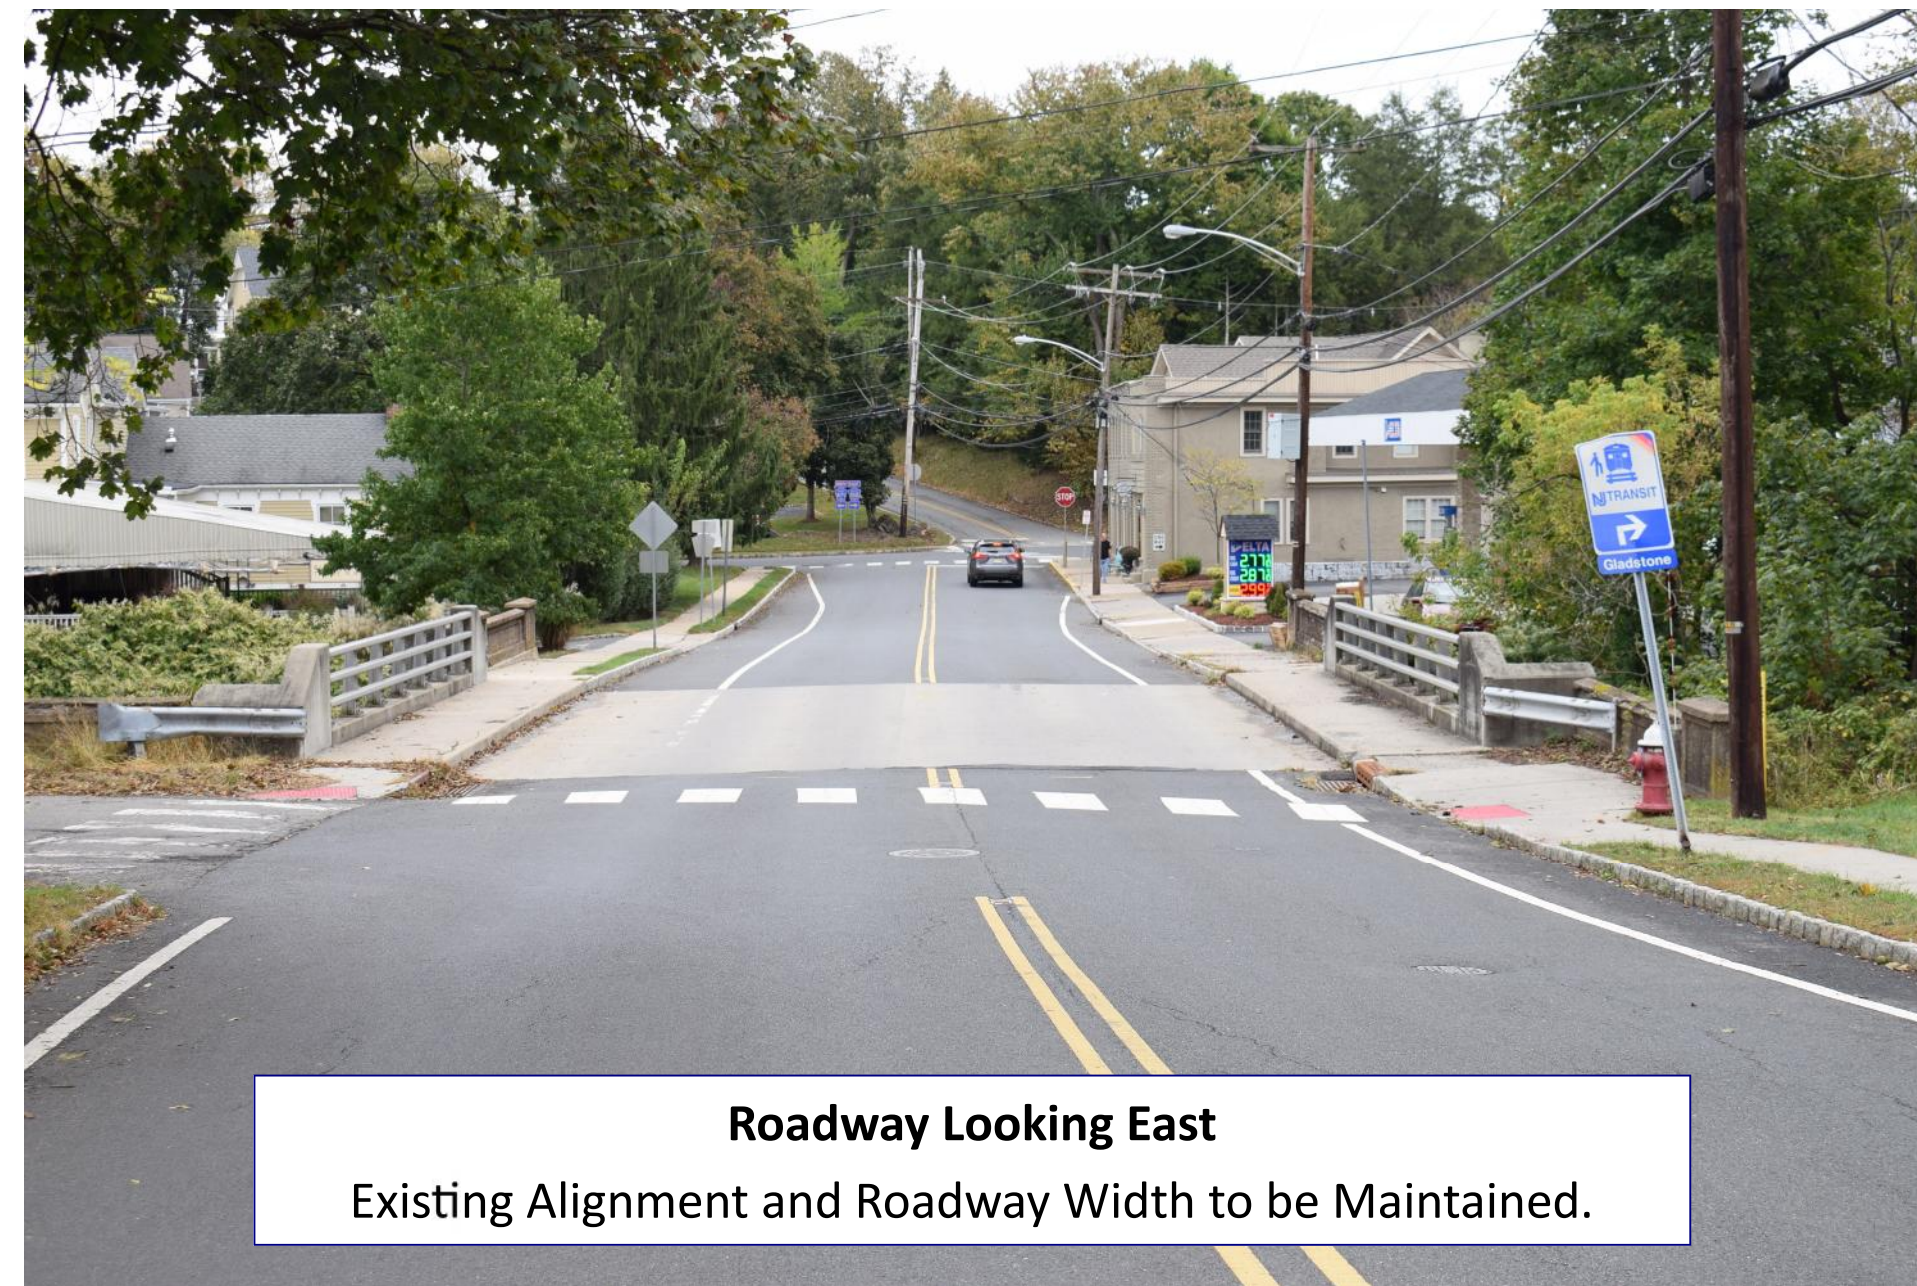
**Roadway Looking East**  
Existing Alignment and Roadway Width to be Maintained.

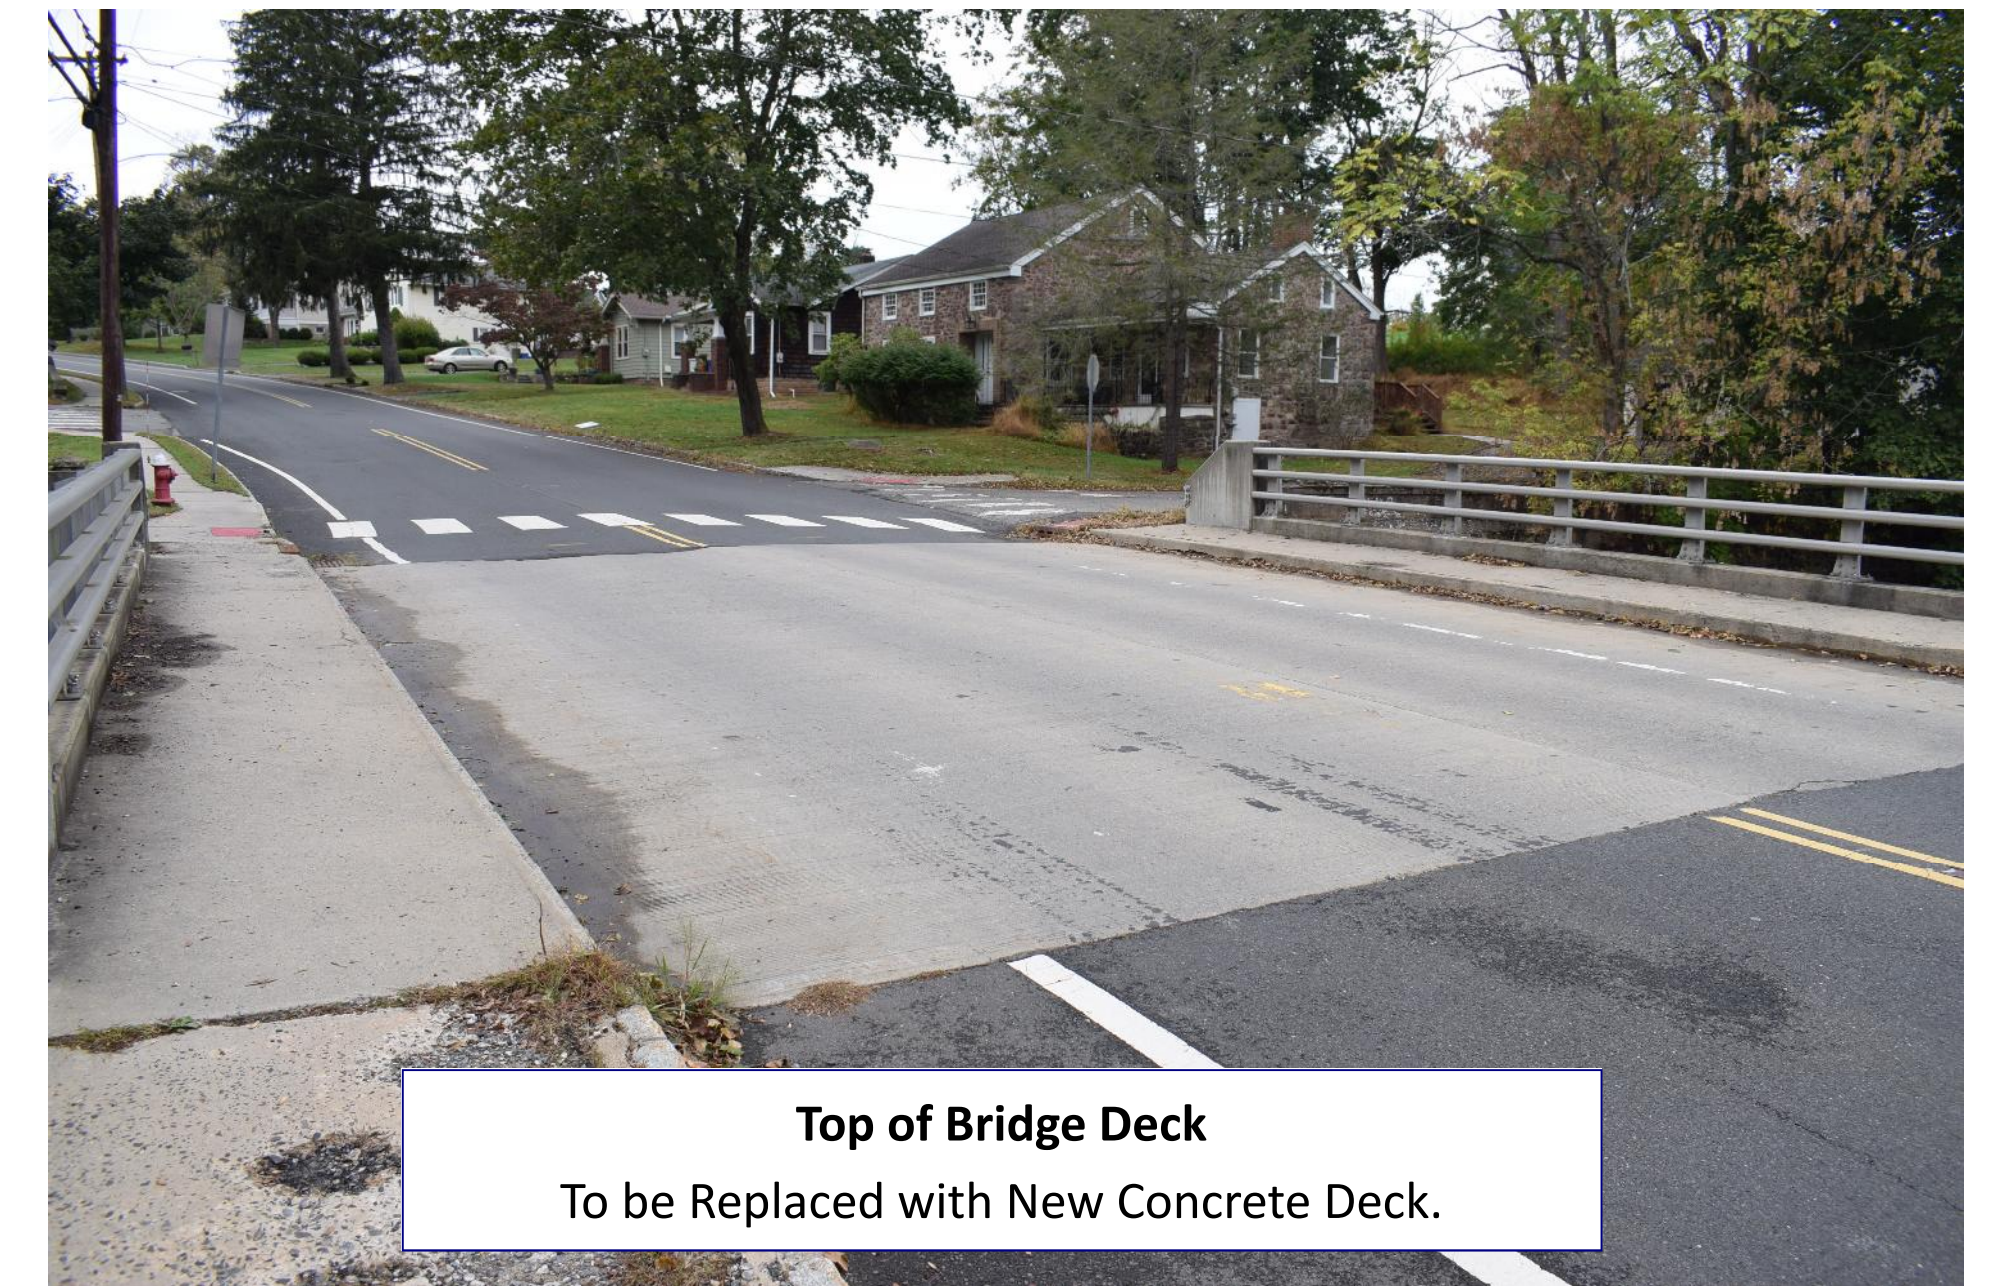
**Top of Bridge Deck**  
To be Replaced with New Concrete Deck.

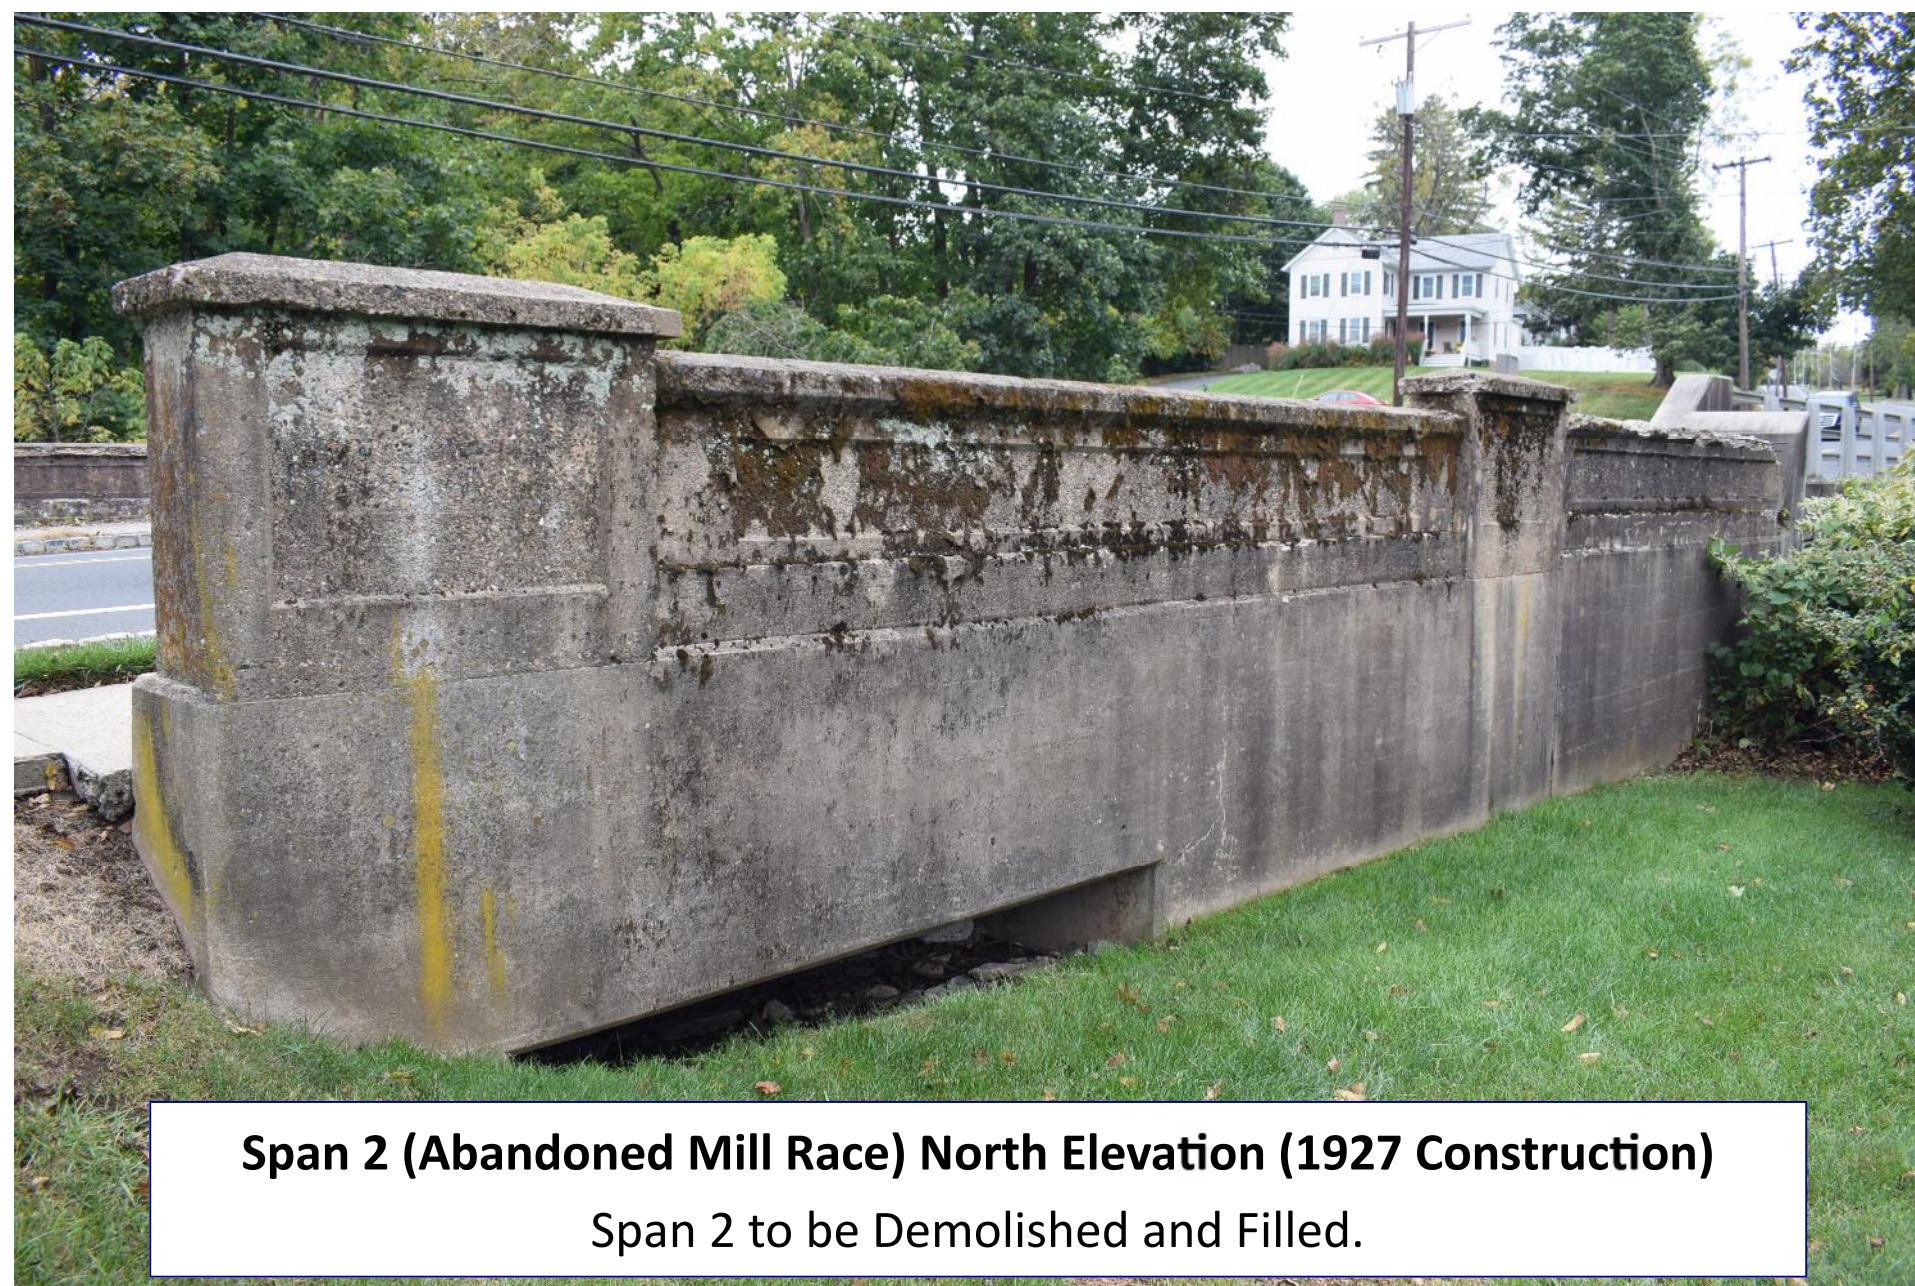
**Span 2 (Abandoned Mill Race) North Elevation (1927 Construction)**  
Span 2 to be Demolished and Filled.

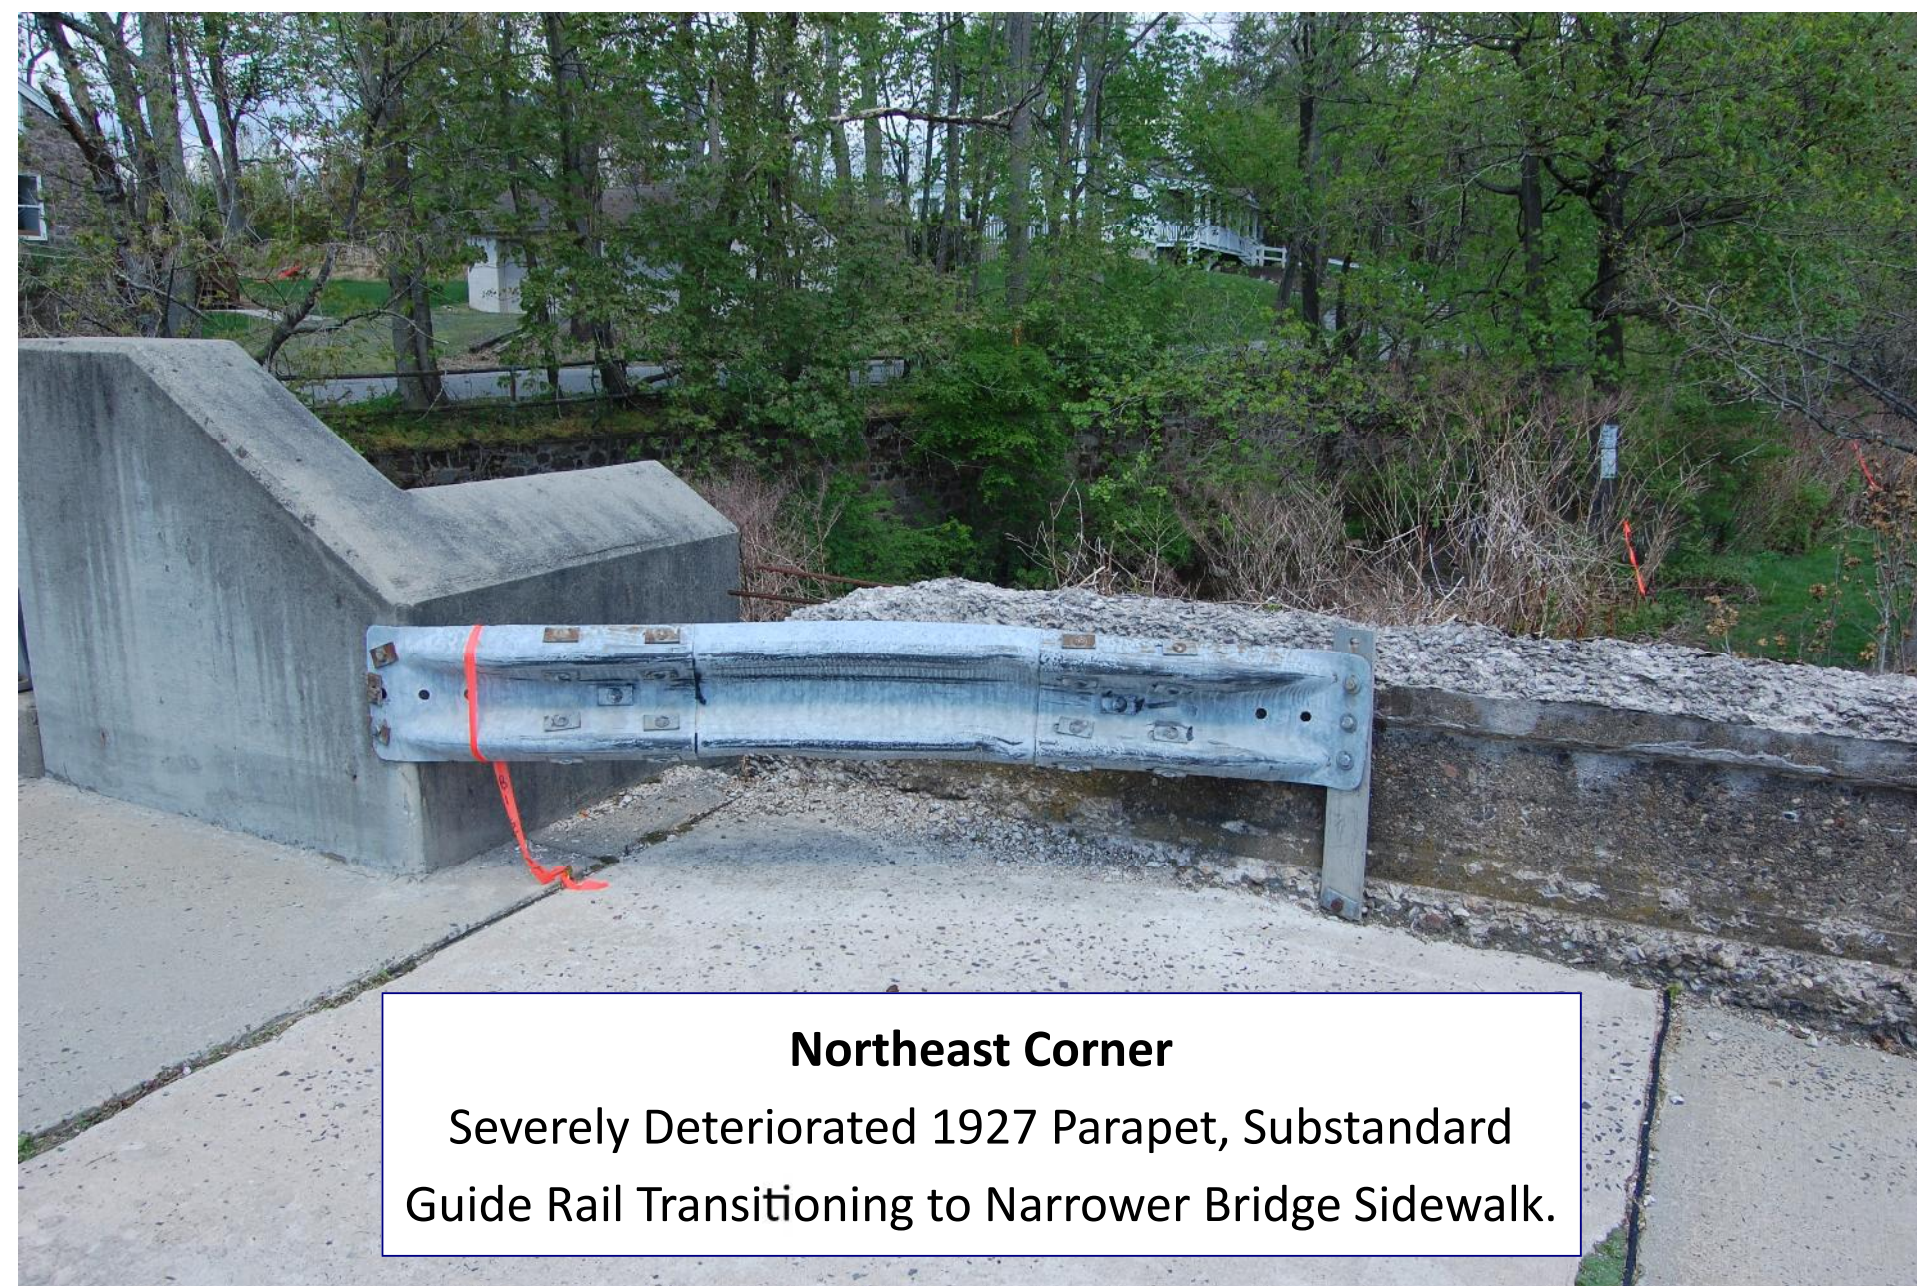
**Northeast Corner**  
Severely Deteriorated 1927 Parapet, Substandard Guide Rail Transitioning to Narrower Bridge Sidewalk.

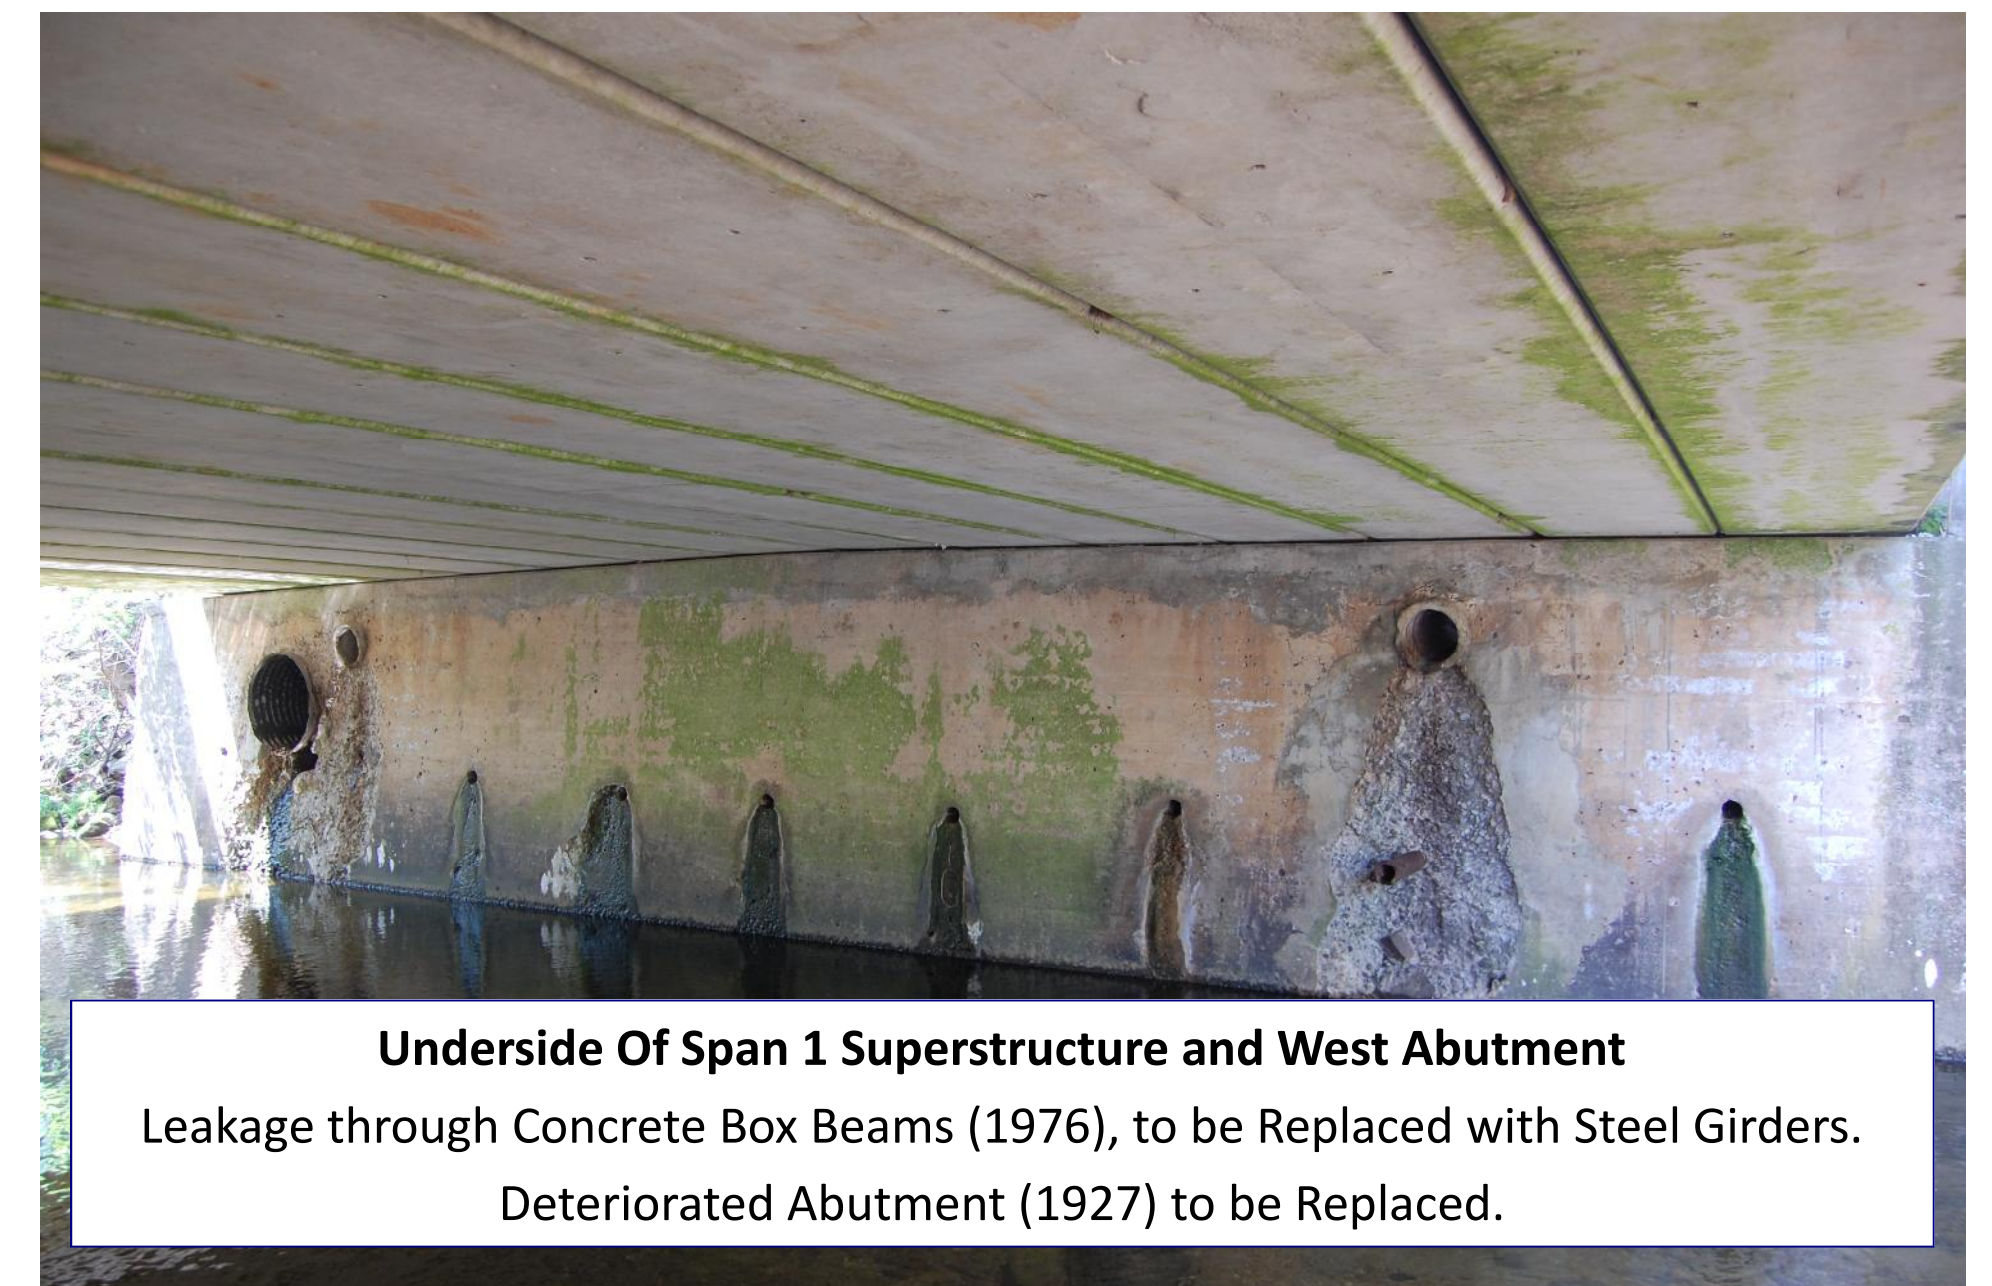
**Underside Of Span 1 Superstructure and West Abutment**  
Leakage through Concrete Box Beams (1976), to be Replaced with Steel Girders.  
Deteriorated Abutment (1927) to be Replaced.

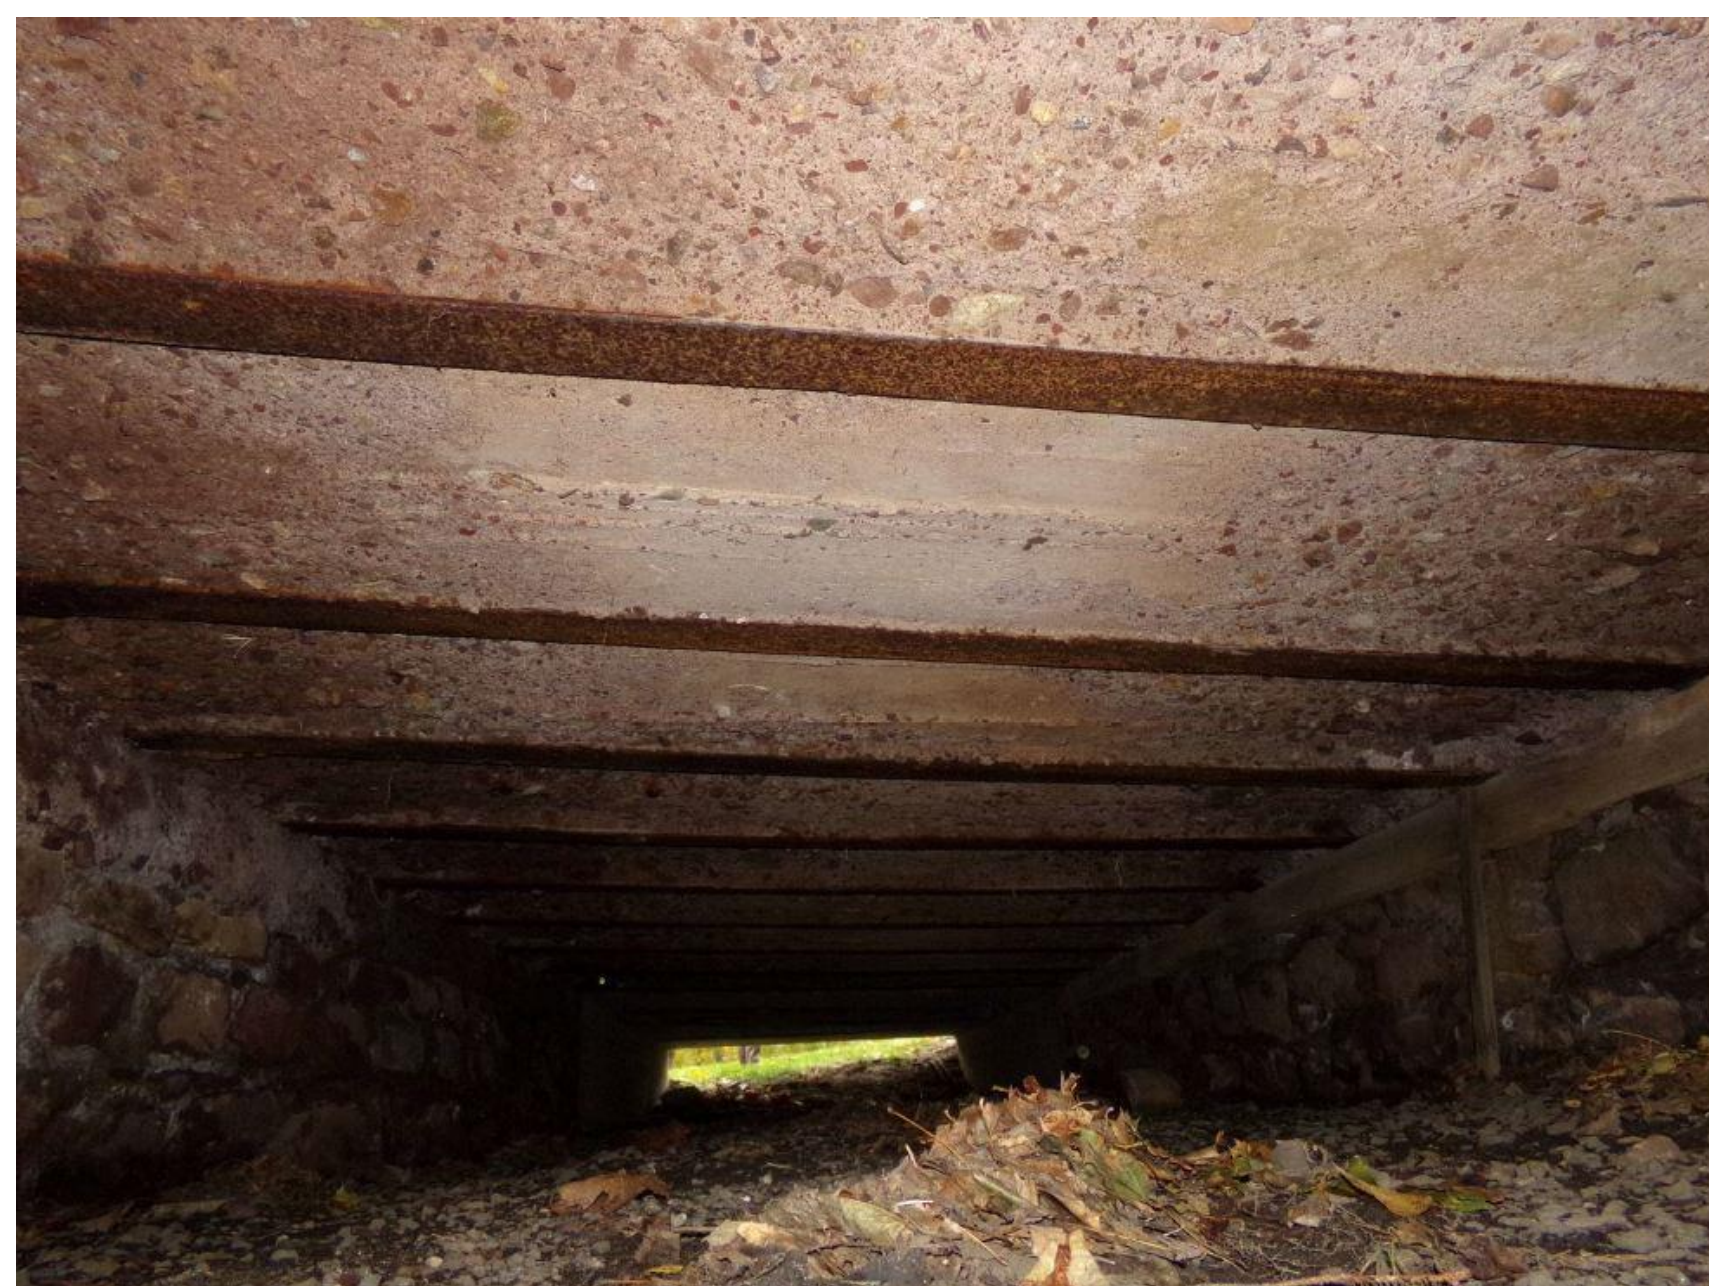
**<== Span 2 (Abandoned Mill Race)**  
Superstructure in Poor Condition due to Heavy Rusting of Steel Beams. Span 2 to be Demolished and Filled. Pre-1927 Construction.

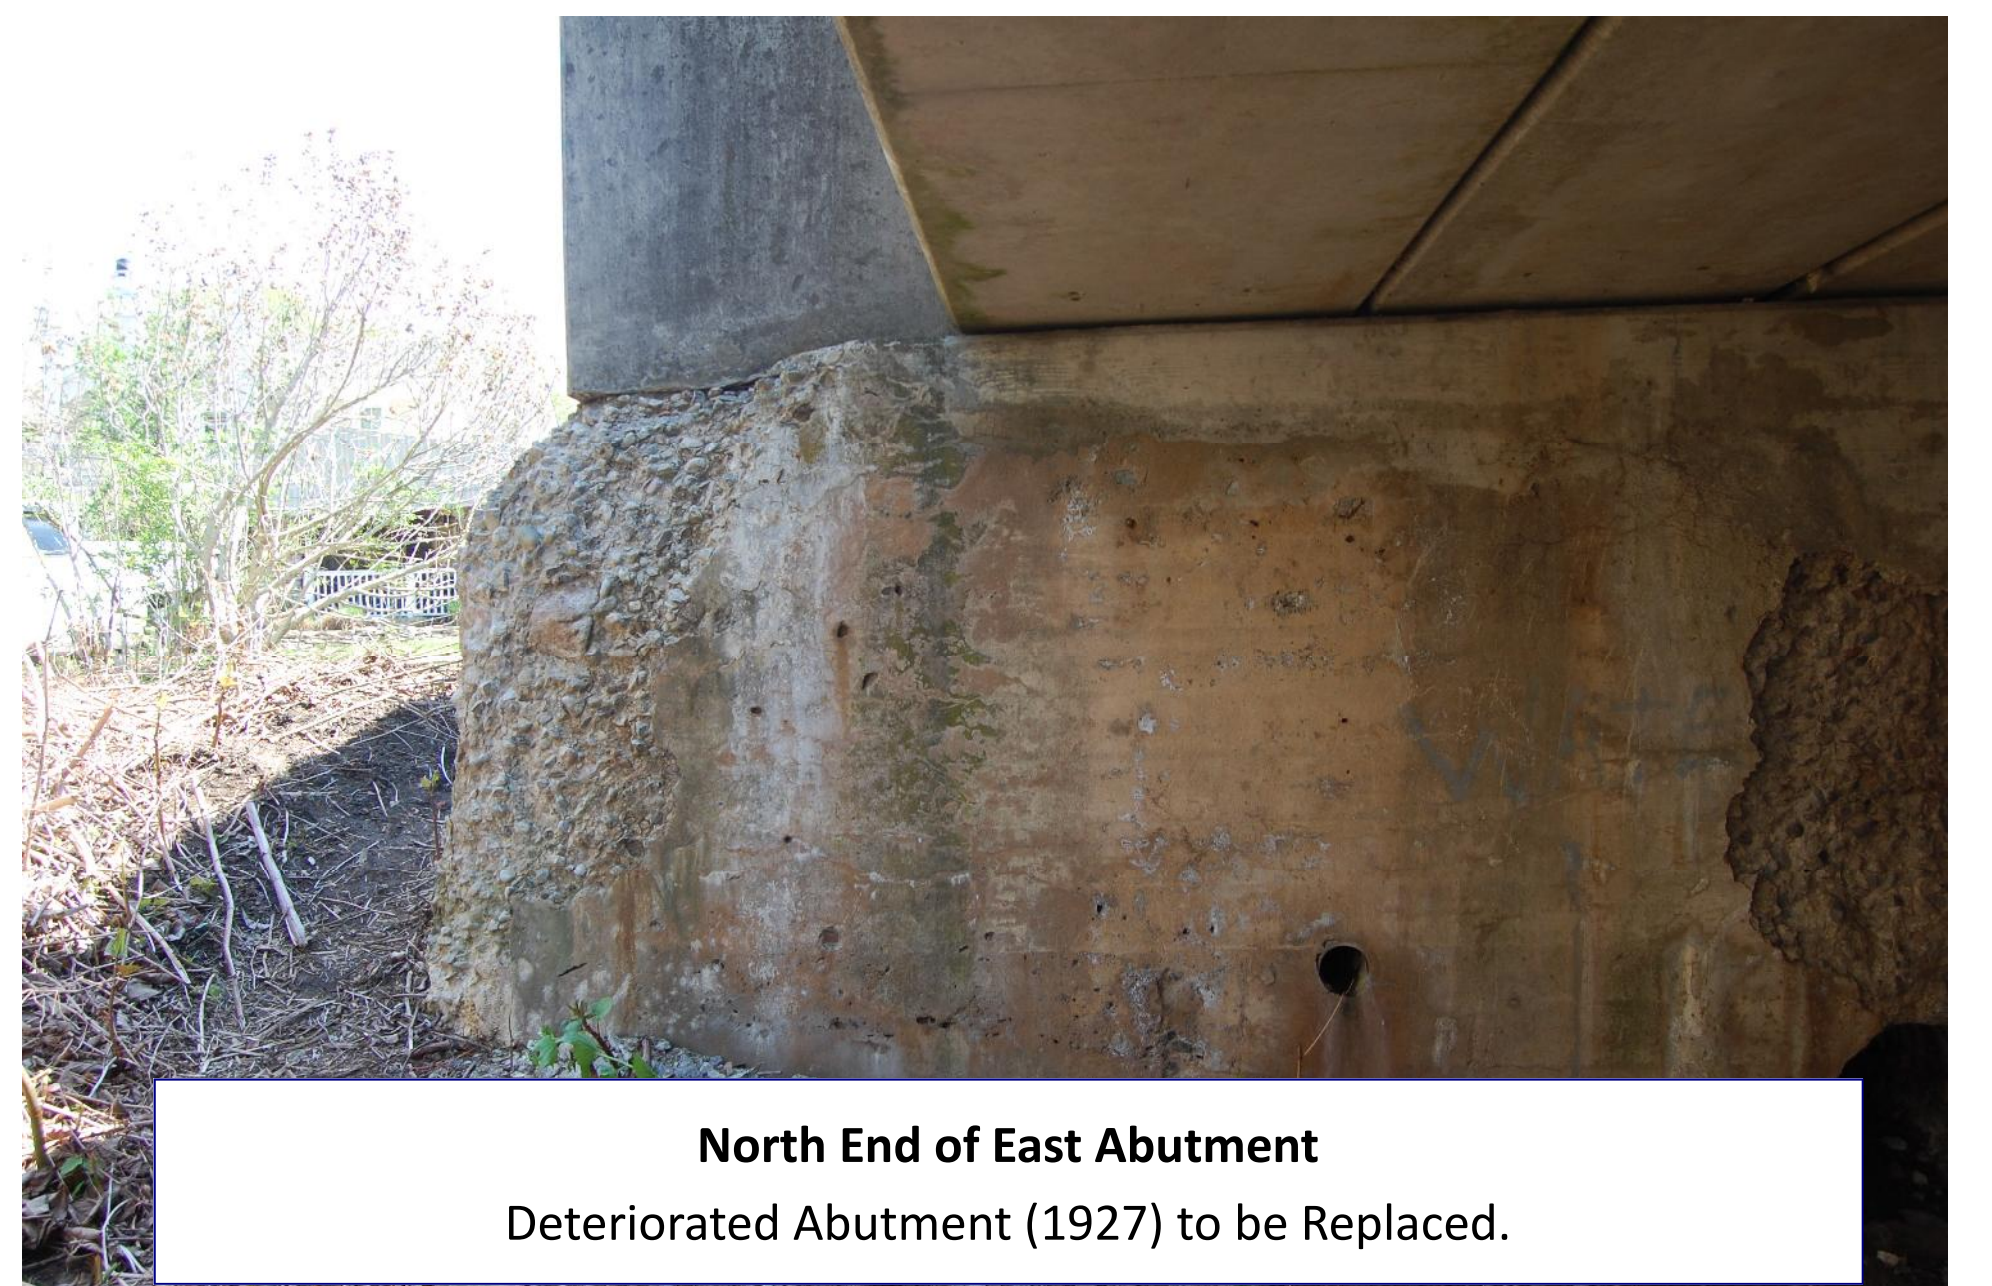
**North End of East Abutment**  
Deteriorated Abutment (1927) to be Replaced.
