Somerset County Roadway Safety Study
Subregional Project

ROAD SAFETY AUDIT REPORT

FRANKLIN BOULEVARD IN FRANKLIN TOWNSHIP

November 2021

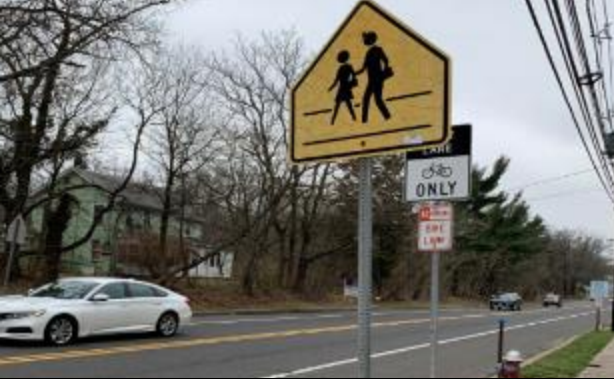
<p>Discontinuous sidewalk near Matilda Avenue</p>	<p>Sparsely located bike lane signing and striping, bike lane mistaken as vehicular shoulder</p>

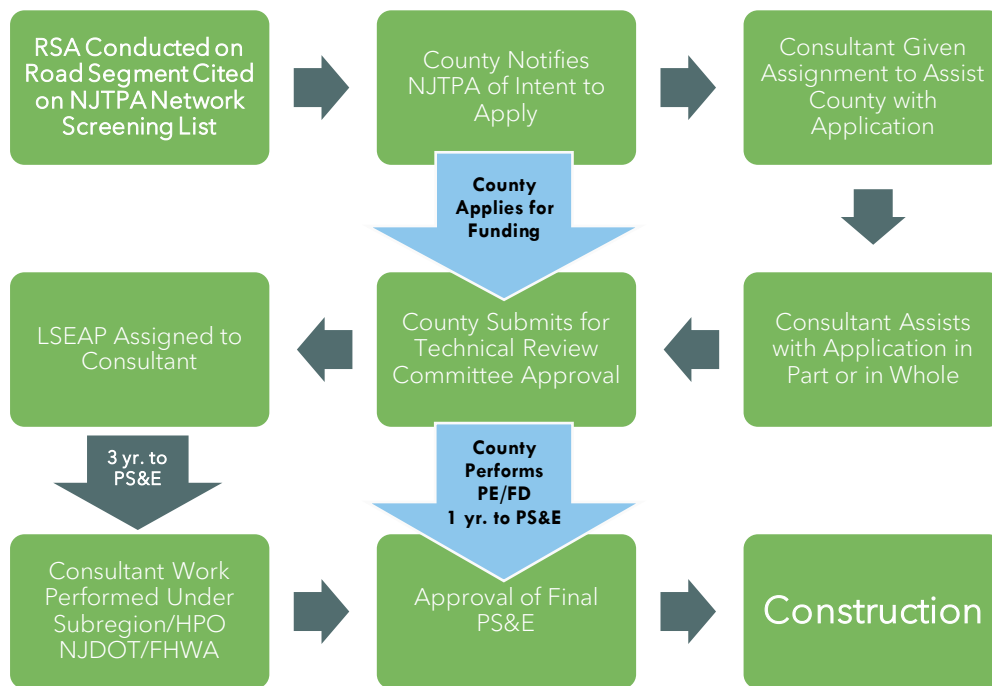
Figure 14 – Project Development Process for Local Safety Program after RSA Completion

The RSA can also be appended to Section 4 of the funding application¹⁶ submitted to NJTPA as a further substantiation and documentation of the understanding of the existing concerns and proposed safety measures. This application, which also requests information on scope, location ranking, HSM analyses, estimated costs, and environmental impacts, may be filled out by the County itself or with assistance from a consultant designated by NJTPA. Pending determination of eligibility by NJTPA’s Technical Review Committee, the County can choose to either perform the Preliminary Engineering and Final Design work in-house or obtain assistance for such work through NJTPA’s Local Safety Engineering Assistance Program. It should be noted that implementation of improvements through the LSP often takes around five to six years from corridor selection to construction. If faster implementation is desired, County, and municipal operating and capital budgets could be relied upon if internal funding is available.

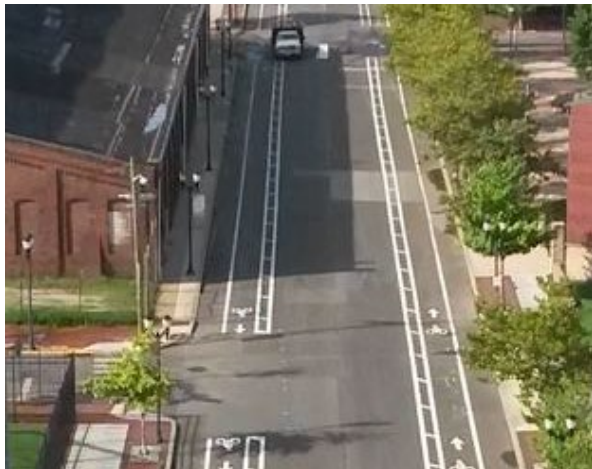
Figure 18 – Buffered Bicycle Lanes in the City of Camden²⁶

). During the RSA, it was also noted that, just past the northern limit of the study corridor at Belmar Street, the bike lanes in each direction dropped off for the roadway to accommodate a two-way left turn lane within the cartway width. To provide continuity of bicycle travel, it is recommended that a “BIKE MAY USE FULL LANE” sign be posted on Franklin Boulevard on segments where the bike lane ends (**Figure 19**).

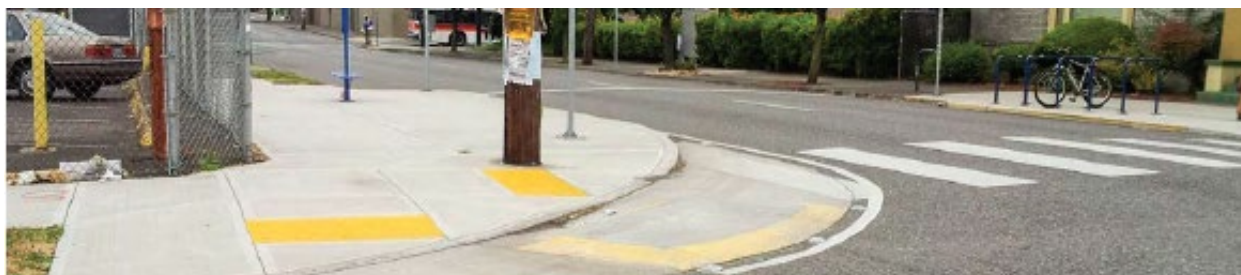
Figure 21 – Mountable Concrete Curbs in Portland Oregon²⁷

Conceptual design of improvements at Franklin Boulevard intersections with Route 27 and Hamilton Street are underway with NJDOT redesigning the Route 27 (Somerset Street) corridor for a road diet and the County redesigning Hamilton Street, incorporating various safety improvements. In addition to these improvement projects, due to the heavy truck turning movements at these intersections and numerous curb overruns (especially in the northwest corner of both intersections), it is recommended that concrete mountable curbs (Figure 21) be considered for the redesigns of both intersections to accommodate the large sweeping truck turning movements at these heavily traveled intersections, mitigating the instances of pedestrian space encroachment and encroachment into the opposing lane of travel. These curbs also allow the designer to tighten turning radii for general passenger car traffic, slowing turning speeds and mitigating the risk of pedestrian-vehicle conflicts and collisions. Should a road diet be achieved at the intersection with Route 27, the additional lateral space provided between the curb and southbound travel lane via the bike lane would mitigate the occurrence of pedestrian space and opposing traffic encroachments for the truck turning movements from Franklin Boulevard southbound onto Route 27 southbound.

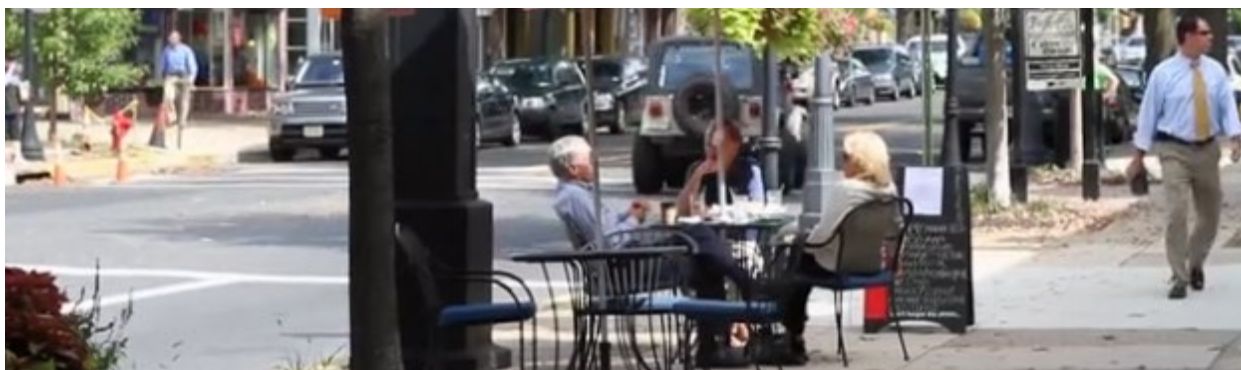
Figure 22 – Street Furniture in Downtown Haddonfield

New development projects within this Priority Growth Investment Area (see Phase III study) on the southern end of the corridor, such as 727 Franklin Boulevard between Fuller Street and Frank Street, should specify the design of similar buildings with parking provided behind storefront areas and storefront areas adjacent to the street and sidewalk, which helps drivers to slow vehicle speeds with visual queues of a downtown neighborhood feel. It was noticed, however, that many businesses at 727 Franklin Boulevard were empty and lacked street furniture outside the store front, which made the businesses feel less “engaging” with the street traffic. The Township should consider the addition of street furniture (**Figure 22**) in front of this and other new developments to help provide more of a downtown street feel on Franklin Boulevard. Additional striped crossing locations traversing Franklin Boulevard unlocked by a potential road diet would also help achieve this traffic calming effect.

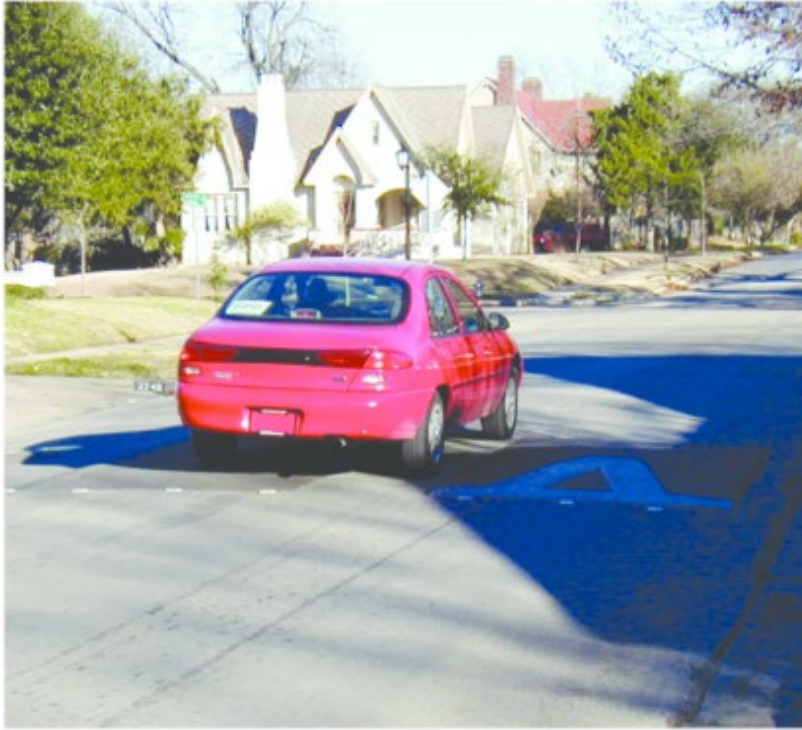
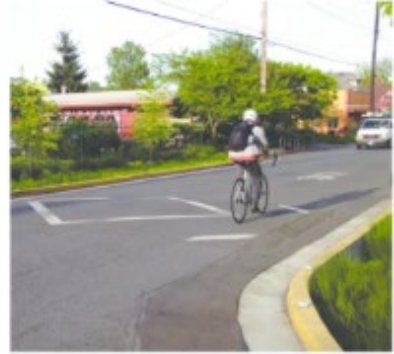
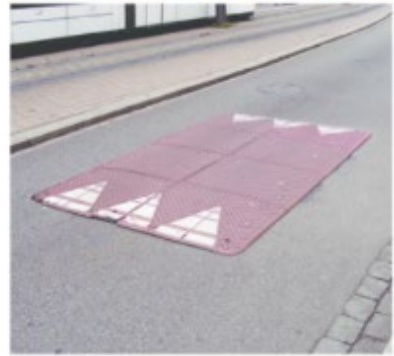
Figure 23 – Sample Speed Humps from NACTO²⁸

Cut-through traffic was observed to occur on Berry Street and Ellen Street, with vehicles bypassing peak hour congestion at the intersection with Hamilton Street to the southwest. Speed humps (**Figure 23**), combined with turning restrictions could help to discourage this cut-through traffic activity. Speed humps can be designed to slow an average vehicle’s wheelbase width yet can also allow for bicyclists and larger emergency vehicles, such as firetrucks, to move along the street unimpeded.
