Somerset County Roadway Safety Study
Subregional Project

ROAD SAFETY AUDIT REPORT

GREENBROOK ROAD IN NORTH PLAINFIELD BOROUGH

November 2021

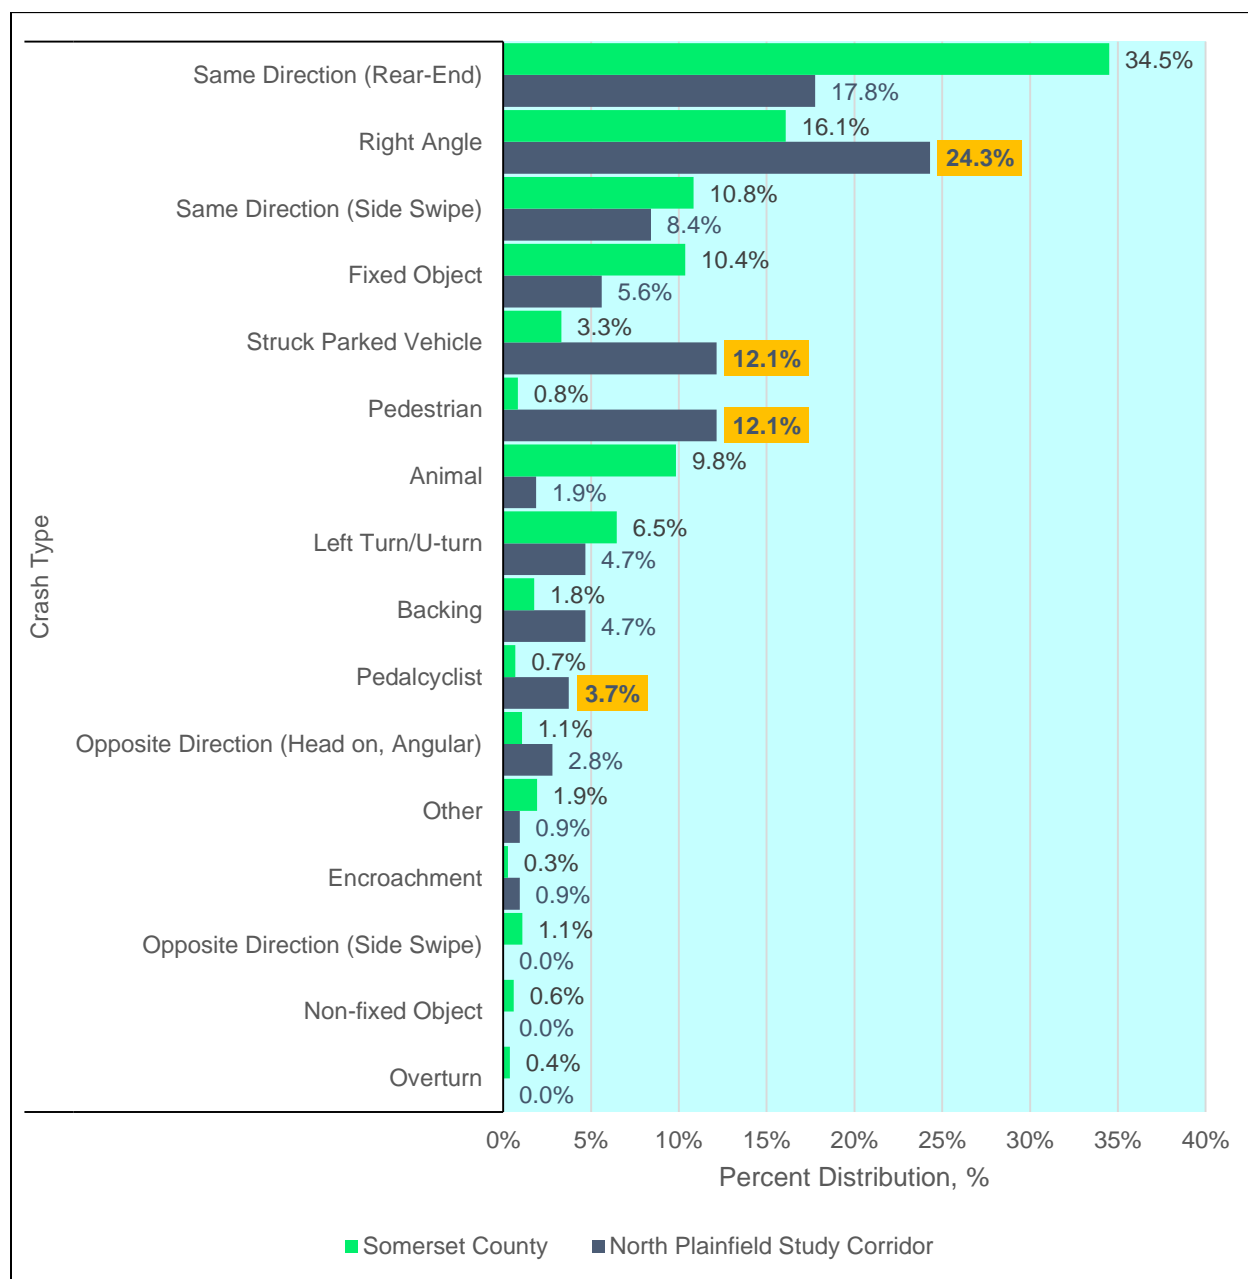
Figure 6 – Vehicular Crashes, Percent Distribution by Crash Type

Eighteen rear end and 26 right angle collisions make up more than 43% of the crash distribution along the study segment. When compared to County-wide averages, the study segment has less frequent rear end crashes than the County as a whole by 16.7%. However, right angle crashes are more frequent on the study segment than the County, by approximately 8.2%, as shown highlighted in yellow in **Figure 6**. Crashes involving parked vehicles account for 12.1% of crash occurrences, nearly four times the County average. The most significant information that can be discerned from **Figure 6** is the high frequency of pedestrian involved crashes highlighted in yellow. 0.8% of crashes that occur on County roads involve pedestrians, compared to a 12.1% frequency, more than the County-wide averages. A breakdown of frequency by crash type is provided on **Table 4**.

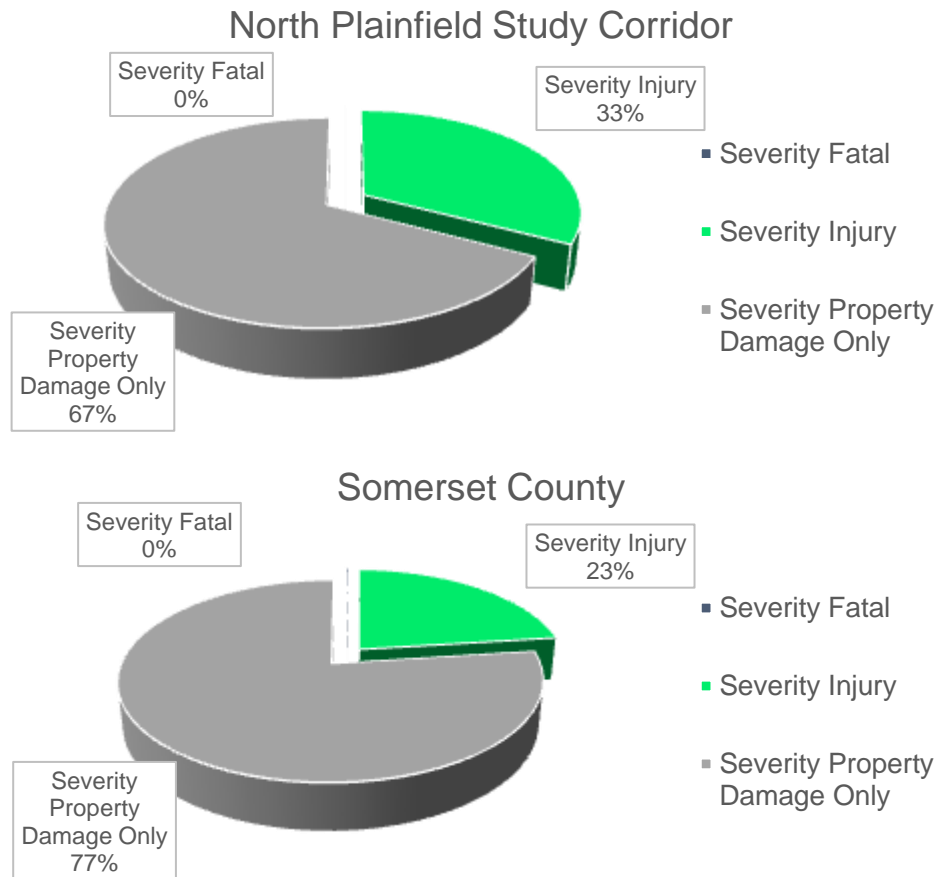
Figure 7 – Vehicular Crashes, Percent Distribution by Severity

Data shows a considerable increase in crashes resulting in injuries rather than property damage only when compared to the County, perhaps due to the relatively high share of pedestrian crashes at this location. The analysis period had no fatalities along the selected roadway study segment.

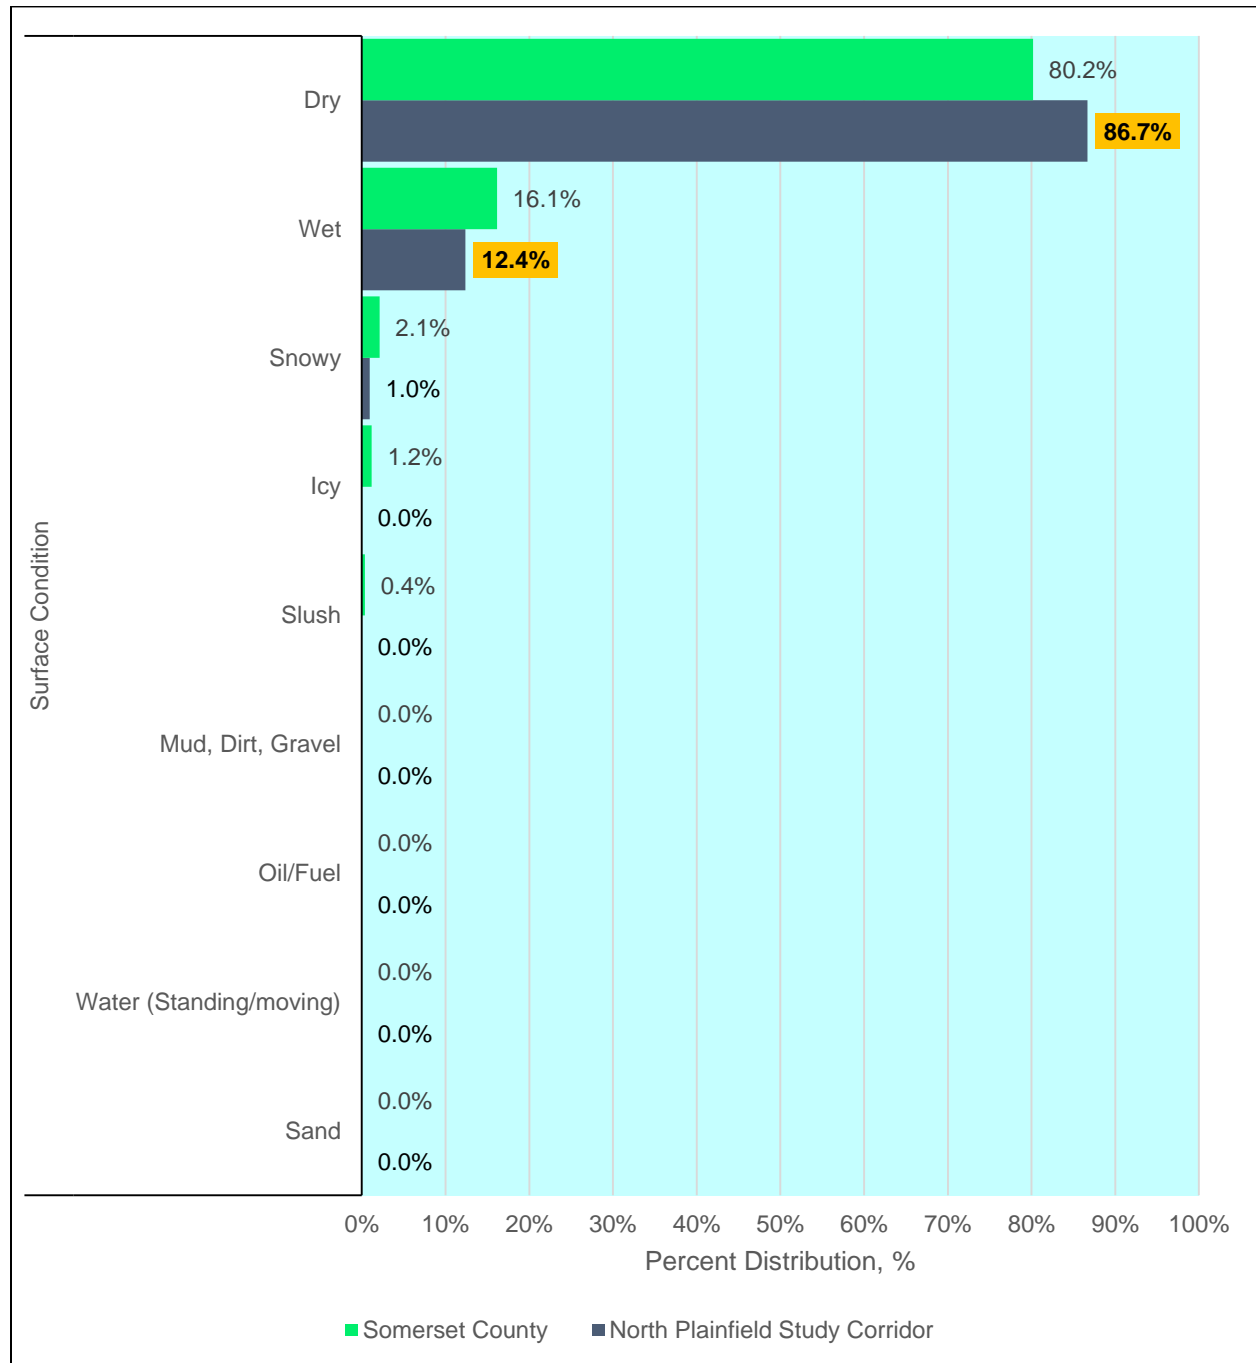
Figure 8 – Vehicular Crashes, Percent Distribution by Surface Condition

Crashes occurred more frequently during dry driving conditions on the study segment than the County-wide average. Wet road-related crashes are the second most overrepresented roadway surface condition during crashes, 12.4%, which is approximately 4% less frequent than the County-wide average at 16.1% (highlighted in yellow in **Figure 8**).

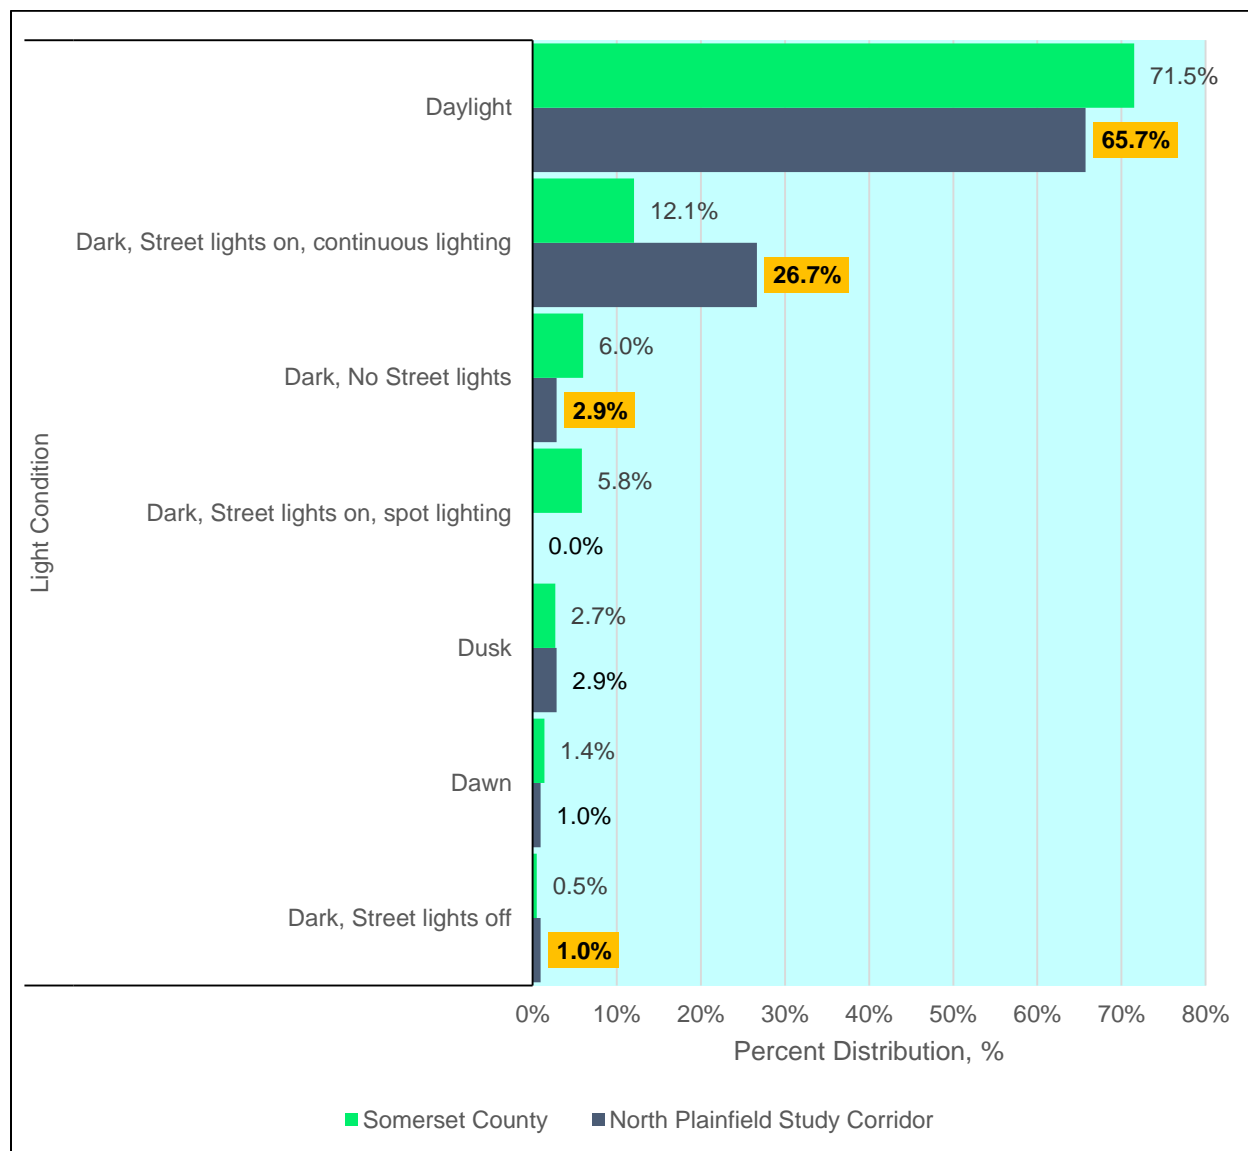
Figure 9 – Vehicular Crashes, Percent Distribution by Light Condition

Approximately 65.7% of the crashes on the study segment occurred during daylight conditions, which is slightly lower than the County-wide average of 71.5% (as shown highlighted in yellow in **Figure 9**). Crashes occurring during “Dark, Street lights on, continuous lighting” is noticeable higher than the County average, more than double the frequency. However, it should be noted that some of these County crashes were recorded as occurring in dark conditions with either no streetlights, or with streetlights off (as shown highlighted in yellow in **Figure 9**).

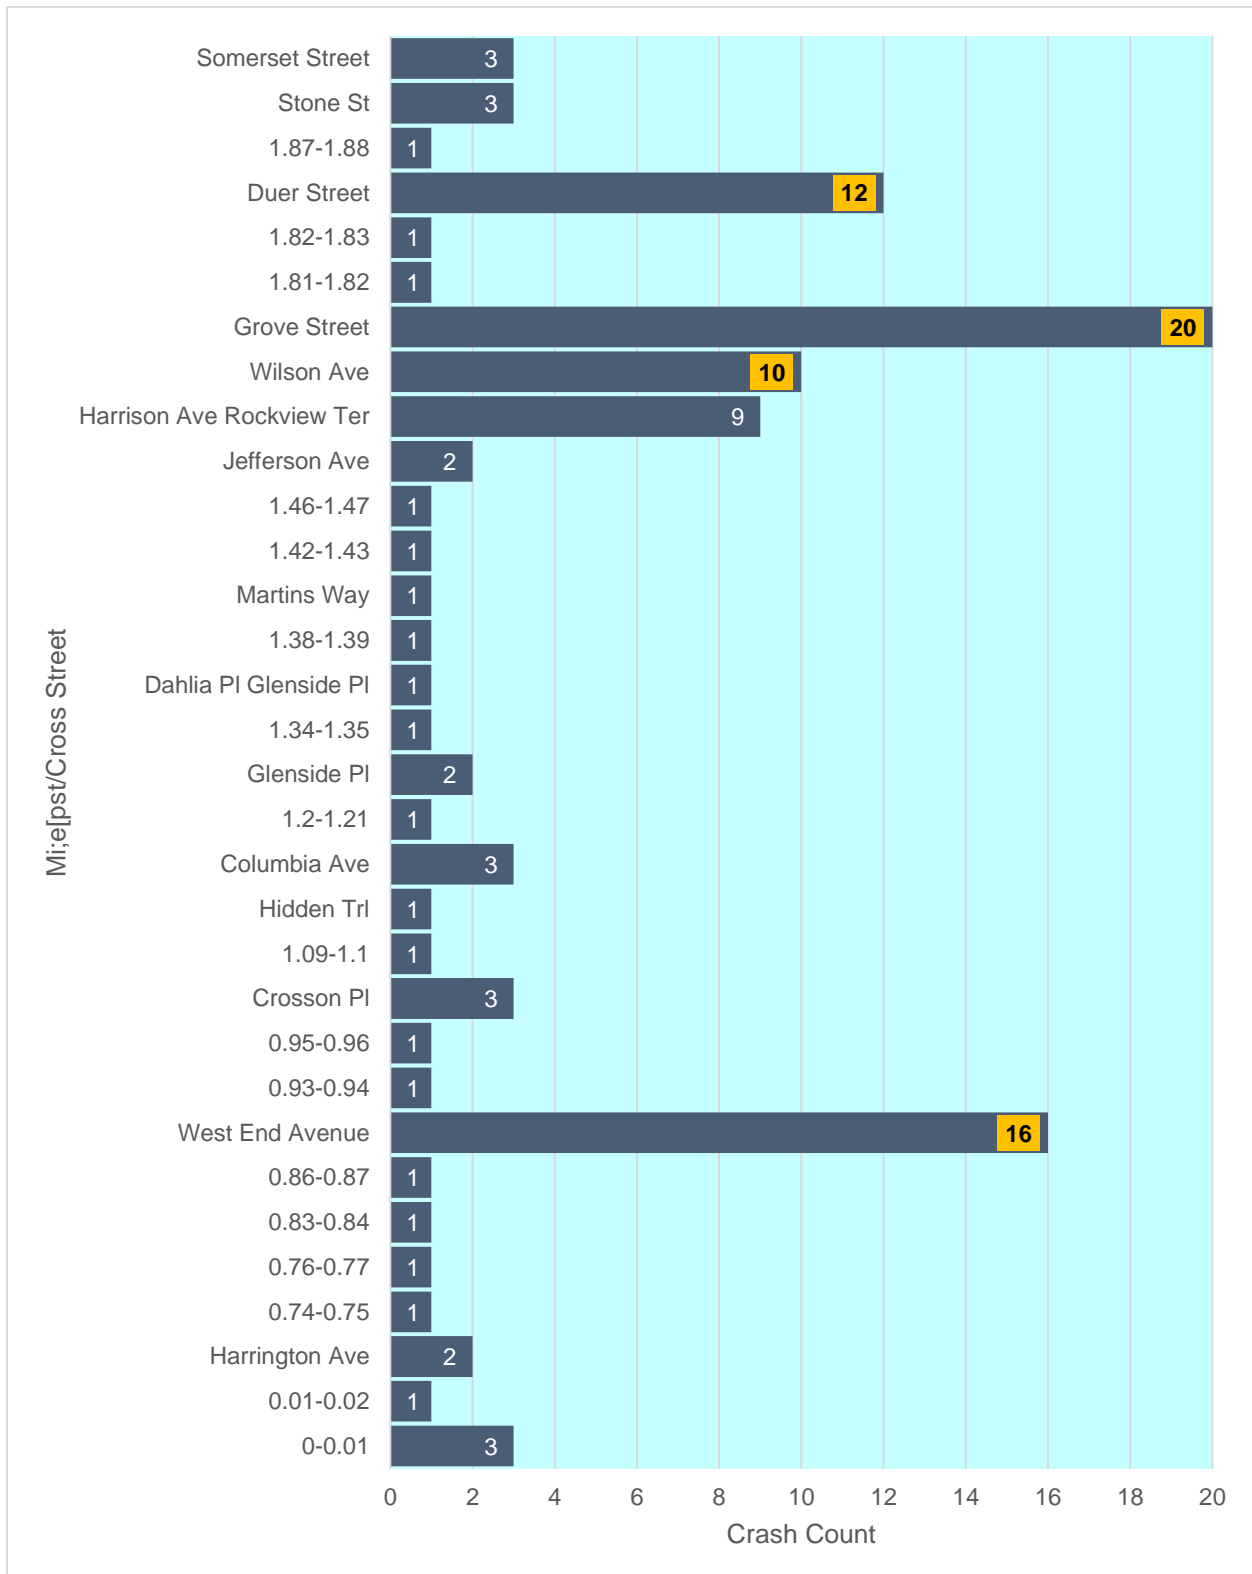
Figure 10 – Vehicular Crash Counts by Milepost

Crash visualization by the use of the histogram, grouped in 0.02-mile segments, **Figure 10** below indicates that the signalized intersections of Grove Street and West End Avenue experience the highest occurrence rate of crashes, shown highlighted in yellow in **Figure 10**. Duer Street and Wilson Avenue presents the highest crash totals at unsignalized intersections, with 11 crashes, shown highlighted in yellow in **Figure 10**. A three-dimensional representation of this crash histogram for the 2016 through 2020 timeframe, imposed onto a map of the study area, is shown on **Figure 11**.

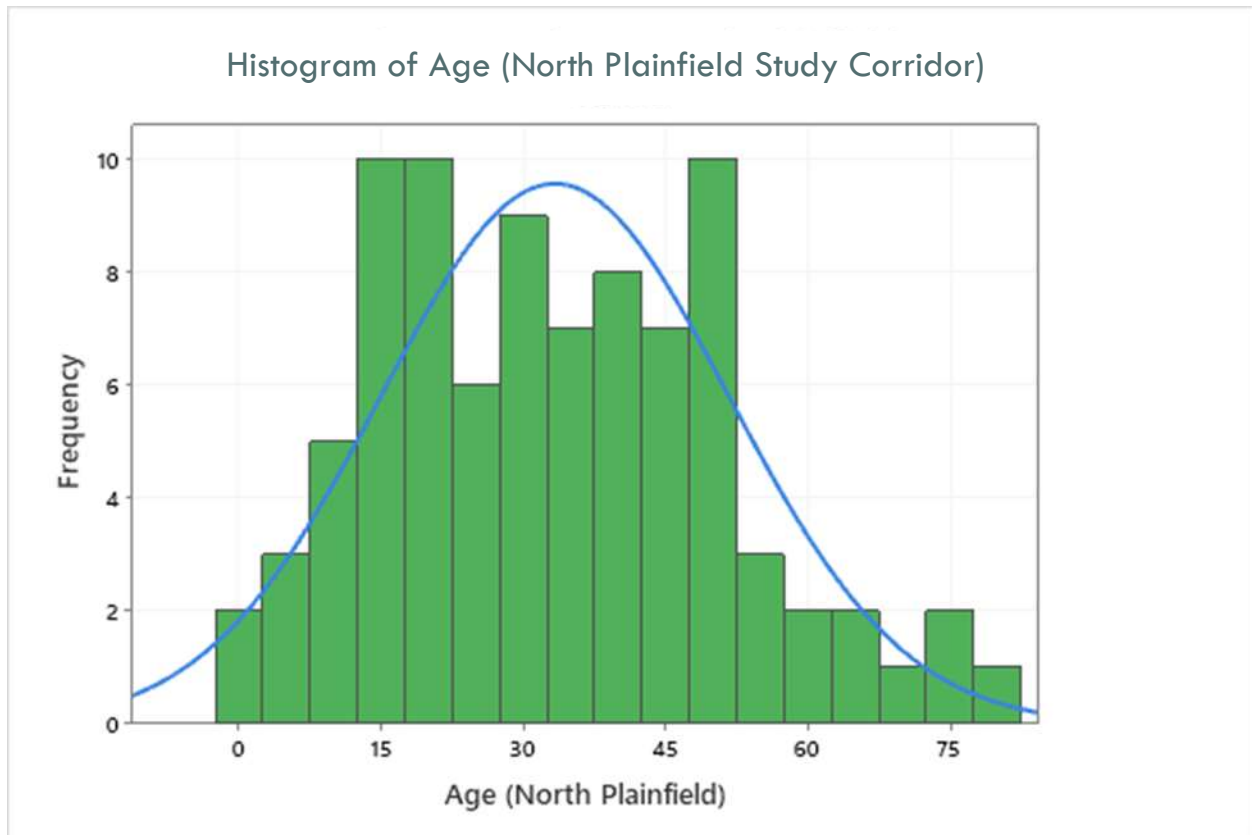
Figure 12 – Histogram of Age(s) Involved

Driver-, occupant-, and pedestrian-involved data was also accessible from the NJDOT crash tables. A normal distribution table was developed (**Figure 12**) utilizing the age data provided by NJDOT. Amongst the eighty-eight crashes reported, the average person(s) involved age was determined to be approximately 33 years old. Approximately 68% of person(s) involved were between the ages of 14 and 51 years old. **Table 5** outlines the percent distribution of the age(s) of those involved in the vehicular crashes, grouped by ten years of age. Data from the table indicates that crashes with driver groups of 26-55 years old occur with a higher frequency on the study segment than the County average for the same age groups. Ages 16-25 and 46-55 account for the highest frequency of those involved at 21.4 percent each. Notably, the under 16 age group average was higher than the County, 8.6 percent versus 7.9 percent.

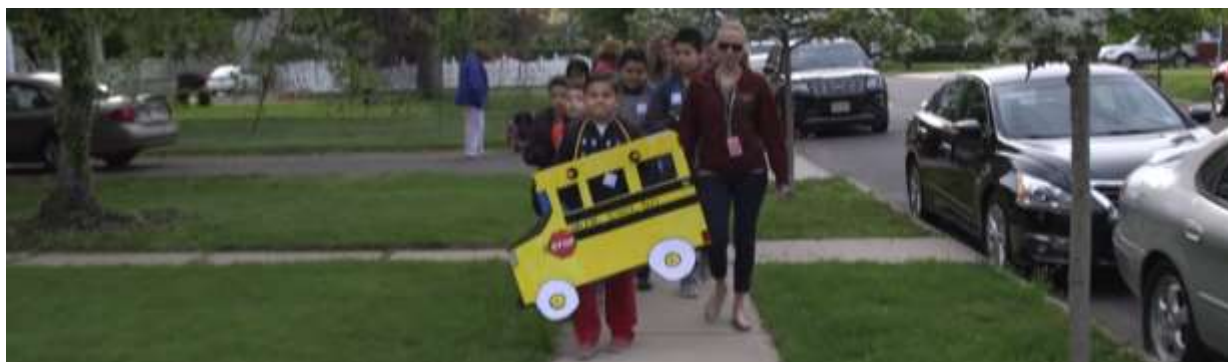
Figure 14 – Walking Bus Demonstration Project in Bound Brook¹⁹

In concert with the Borough Police Department, the Borough's School District and RideWise TMA could plan a one-day event to conduct a Walking Bus activity along select neighborhood streets, and a selected length of Greenbrook Road with students and parents (**Figure 14**). The goals of this demonstration project are to reduce vehicular travel to school and improve the safety of students walking or biking to school. The North Plainfield School District is encouraged to coordinate with RideWise (the County's TMA) to set up this demonstration project to improve the walkability of the Greenbrook Road corridor.

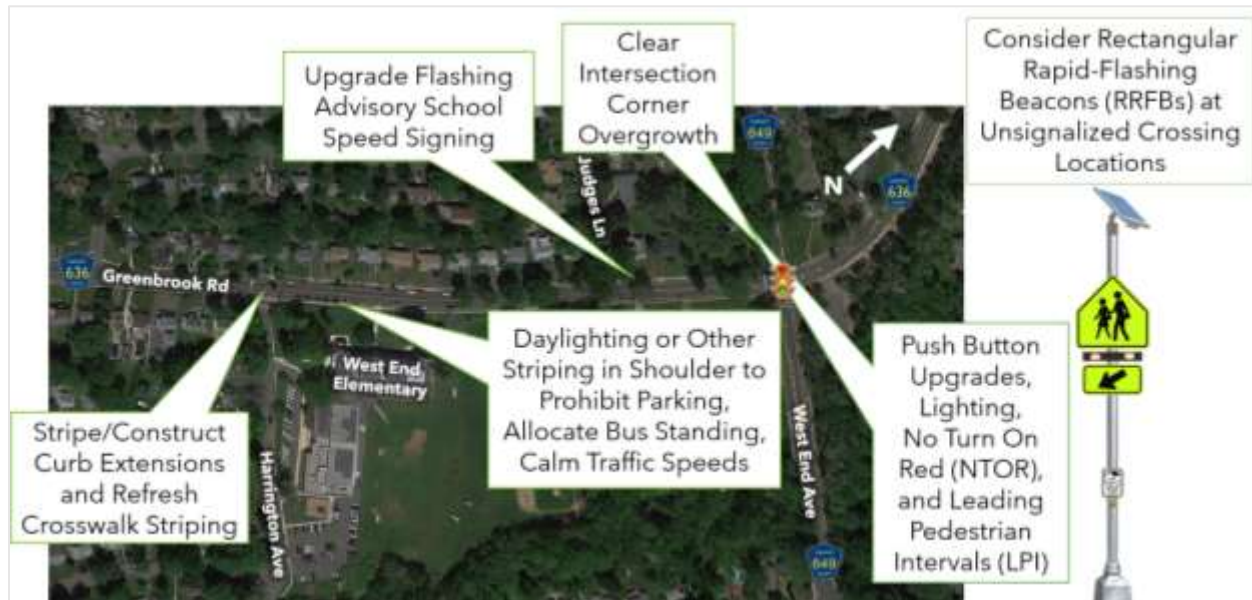
Figure 15 – Sample of Pedestrian Safety Improvements Near West End Elementary

A key recommendation from this RSA is to enhance pedestrian safety through sidewalk upgrades and crosswalks at school locations, such as West End Elementary (**Figure 15**). Due to location of the corridor near parks, schools, or other land uses that tend to have a relatively high share of active mode trip generation, it was discussed to stripe or construct curb extensions and refresh crosswalk striping and consider the installation of Rectangular Rapid-Flashing Beacons (RRFBs) at unsignalized crossing locations.

Daylighting or other striping in shoulder would aid to prohibit parking, allocate bus standing, and calm traffic speeds. At nearby signalized intersections, push button upgrades, lighting, No Turn on Red (NTOR) restrictions, and Leading Pedestrian Intervals (LPIs) are recommended.

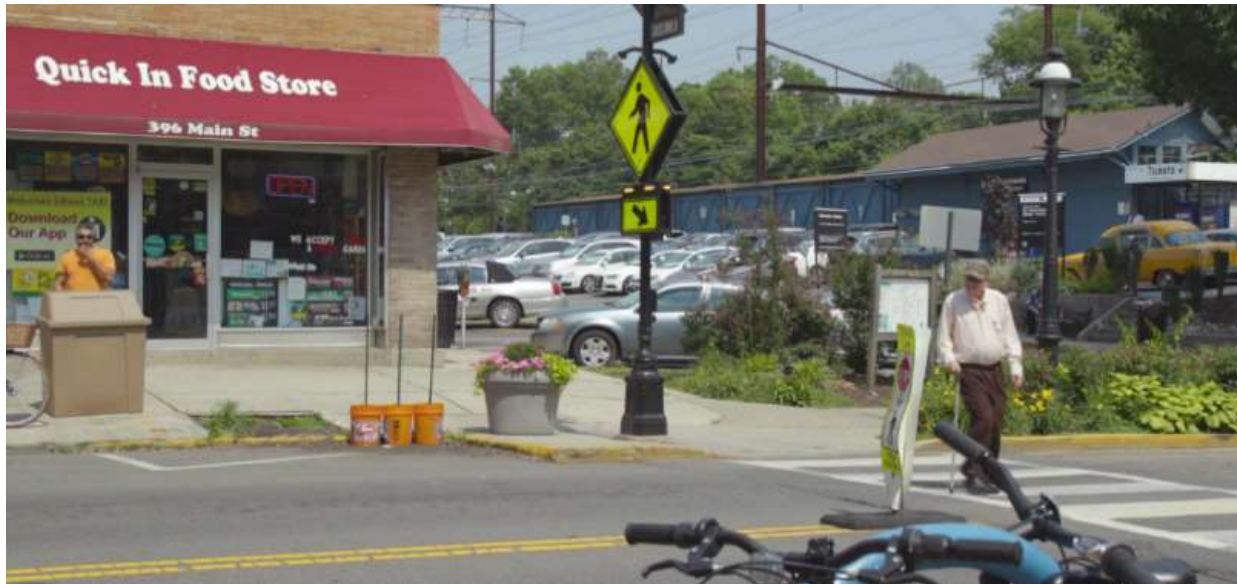
At locations where new midblock crosswalks are proposed in this RSA report, such as those near West End Elementary School and Fromm Field, pedestrian-actuated RRFBs could further increase the visibility of students and other pedestrians crossing at these locations. Installing RRFBs at crossing locations could reduce the risk of vehicle-pedestrian crashes to as little as 10% (average crash reduction seen is 47.4%²⁶).
