FINAL REPORT

Somerset County Roadway Safety Study

December 2021

Executive Summary

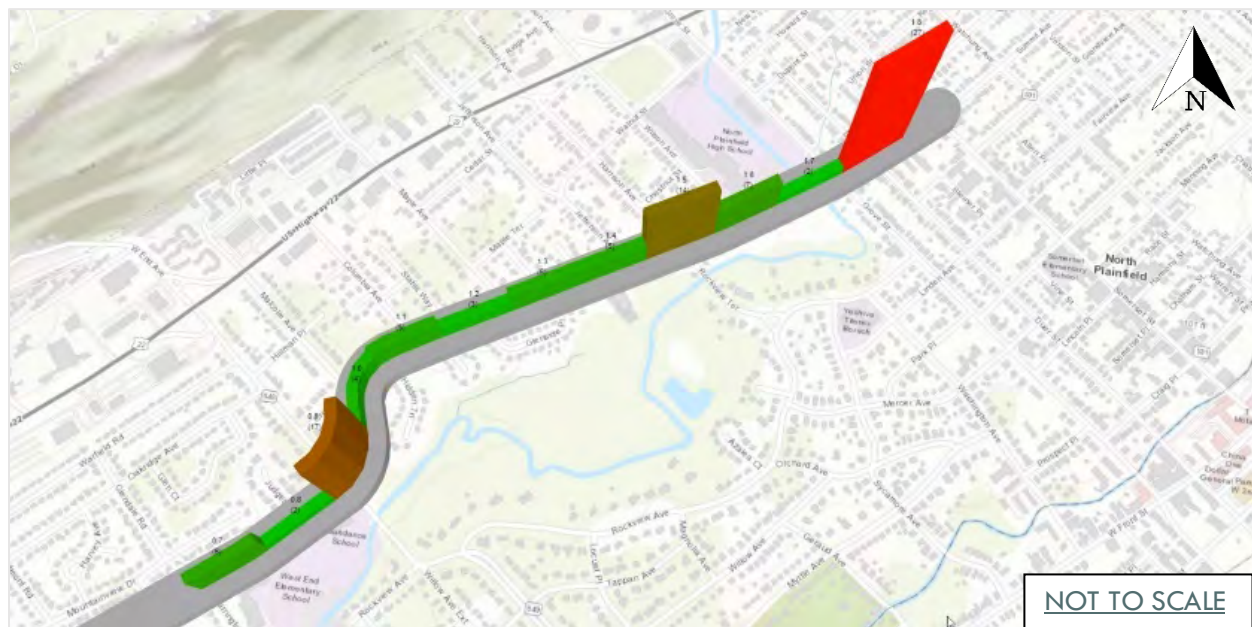
Figure 5 - NJDOT Safety Voyager - Sample Crash Data (Greenbrook Road, North Plainfield Borough)

This analysis evaluated crash attributes such as crash type and severity as a percentage of the total crashes to achieve a more robust understanding of the locations compared to the crash activity on the County roadway system. The project team then mapped all crashes along the segments onto collision diagrams, which can be found in Appendix D, providing a quick spatial overview of crash clustering patterns.

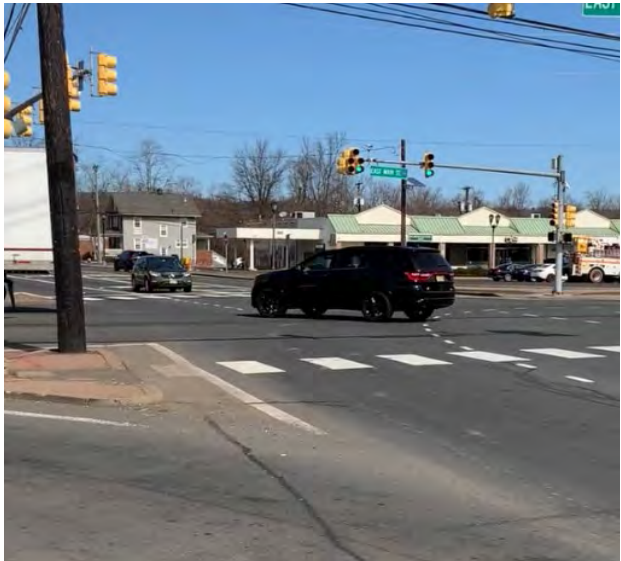
Figure 16 - Field Observations and Identified Needs, Main Street/Finderne Avenue

Close calls between northbound permissive left and southbound through traffic at Finderne Avenue & Main Street intersection

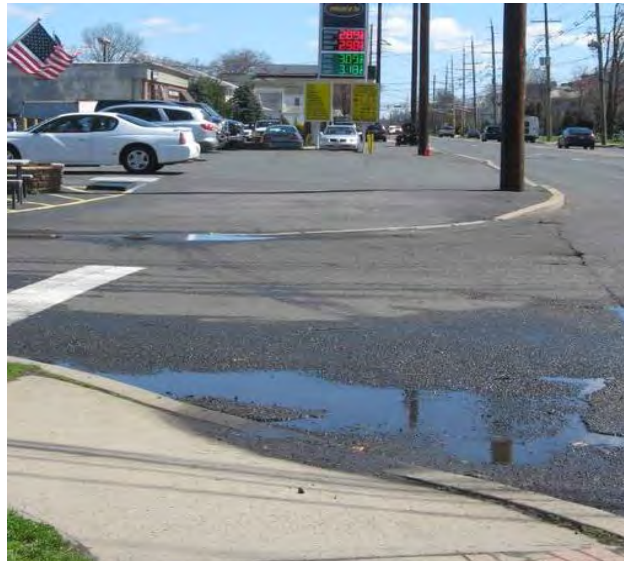
Sidewalk on north side of Main Street often interrupted by wide asphalt curb cuts and parked/standing vehicles

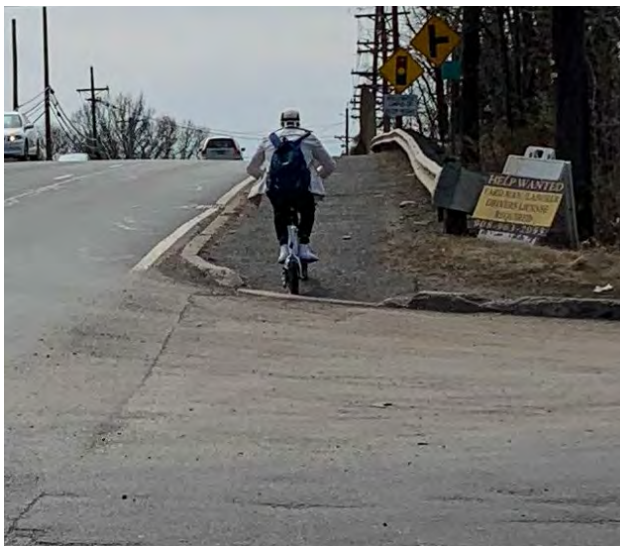
Cycling on Finderne Avenue restricted to narrow multiuse path over bridge with minimal delineation from travel lanes

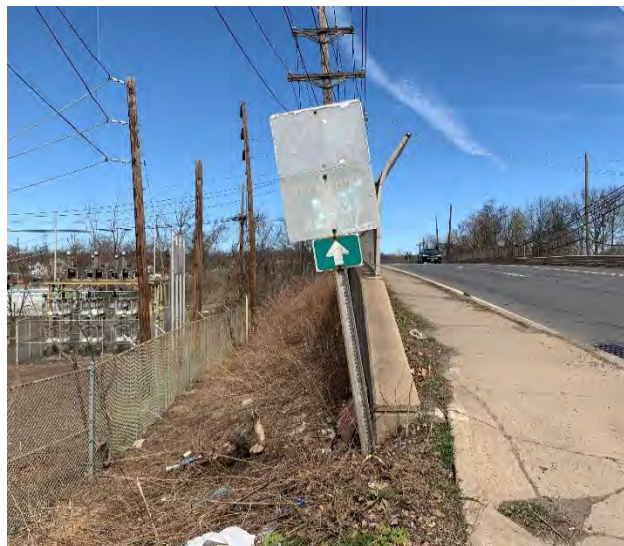
Heavily used cycling route lacking updated wayfinding to connect local communities

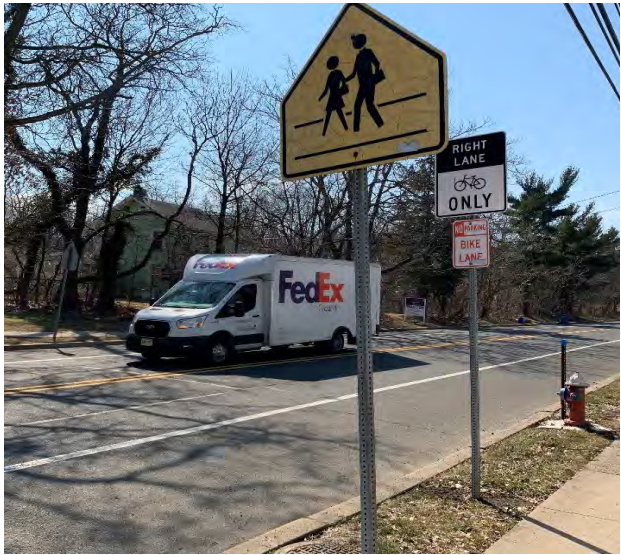
Figure 18 - Field Observations and Identified Needs, Franklin Boulevard

School signage to be upgraded; bike lane not adequately striped

School signing and striping on Franklin Boulevard on approach to Hillcrest Elementary School, and on the school grounds itself needs upgrade to MUTCD standards (sign mounting height, fluorescent yellow-green signing, etc.) and state signing practices. While the overhead flashing beacon provided for both directions of travel helps alert roadway users on Franklin Boulevard of crosswalk traffic during school arrival and dismissal periods, more clear and consistent messaging is needed at street-level. Although not current typical County practice, optional messages striped on the pavement, like “SCHOOL” and “SLOW,” could be considered to better catch the cone of vision for drivers passing the school. Wider crosswalk bars also better alert drivers to potential crossing pedestrian traffic. For the re-signing and re-striping of school advisory messages on Franklin Boulevard, the designer should refer to NJDOT’s *New Jersey School Zone Design Guide* (2014, key figure shown on **Figure 20**) and the MUTCD for best practices.

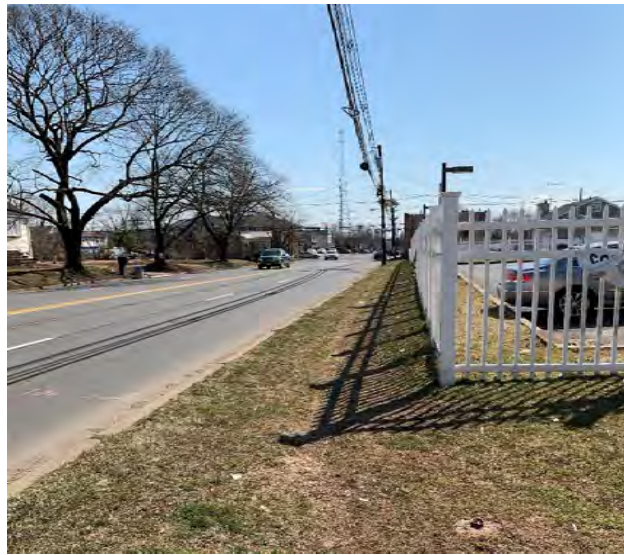
Gap in sidewalk connectivity between Fuller Street and Somerset Street

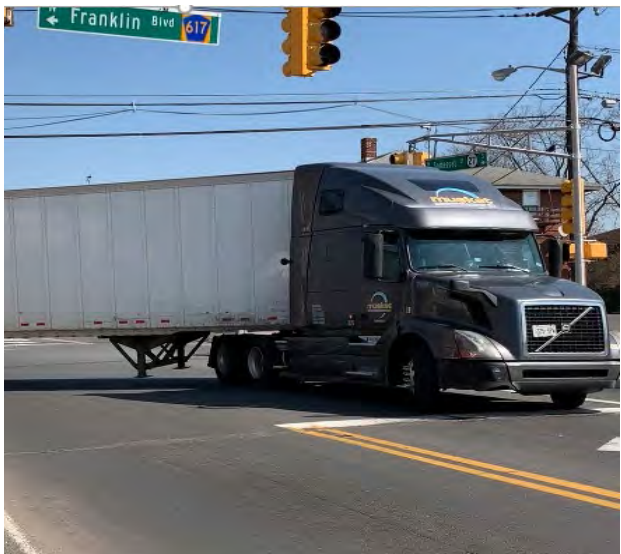
Heavy vehicles encroaching onto Somerset Street left turn lane onto Franklin Boulevard

Conceptual design of improvements at Franklin Boulevard intersections with Route 27 and Hamilton Street are underway with NJDOT redesigning the Route 27 (Somerset Street) corridor for a road diet and the County redesigning Hamilton Street, incorporating various safety improvements. In addition to these improvement projects, due to the heavy truck turning movements at these intersections and numerous curb overruns (especially in the northwest corner of both intersections), it is recommended that concrete mountable curbs (Figure 21) be considered for the redesigns of both intersections to accommodate the large sweeping truck turning movements at these heavily traveled intersections, mitigating the instances of pedestrian space encroachment and encroachment into the opposing lane of travel. These curbs also allow the designer to tighten turning radii for general passenger car traffic, slowing turning speeds and mitigating the risk of pedestrian-vehicle conflicts and collisions. Should a road diet be achieved at the intersection with Route 27, the additional lateral space provided between the curb and southbound travel lane via the bike lane would mitigate the occurrence of pedestrian space and opposing traffic encroachments for the truck turning movements from Franklin Boulevard southbound onto Route 27 southbound.

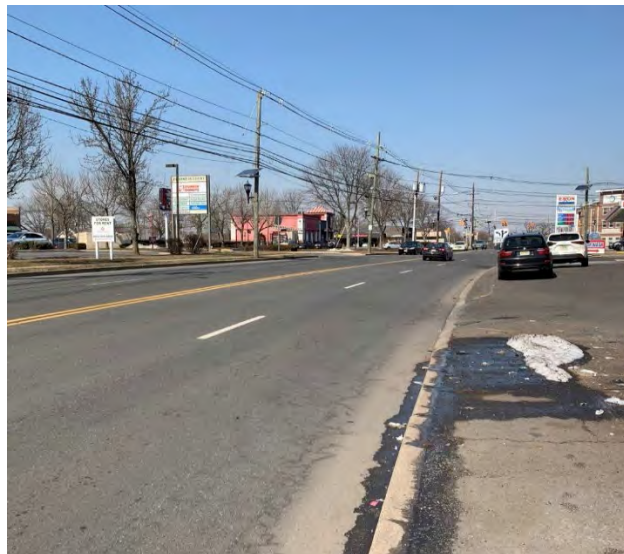
Sidewalk interrupted by wide curb cuts and vehicles encroaching on pedestrian paths

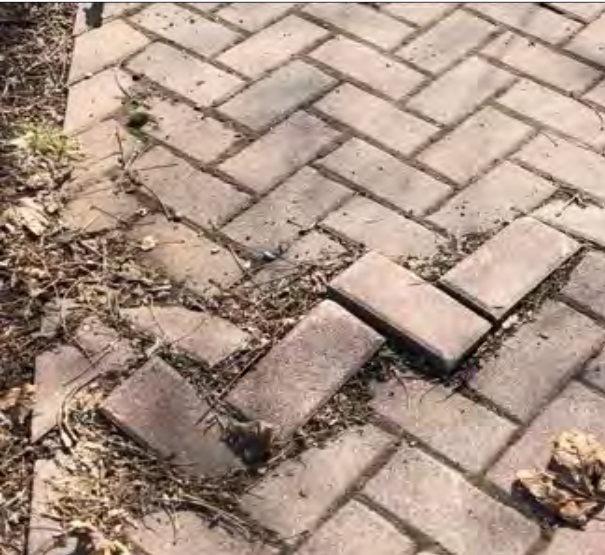
Figure 20 - Field Observations and Identified Needs, Millstone Borough

Brick paver sidewalks need to be reset and repaired along corridor

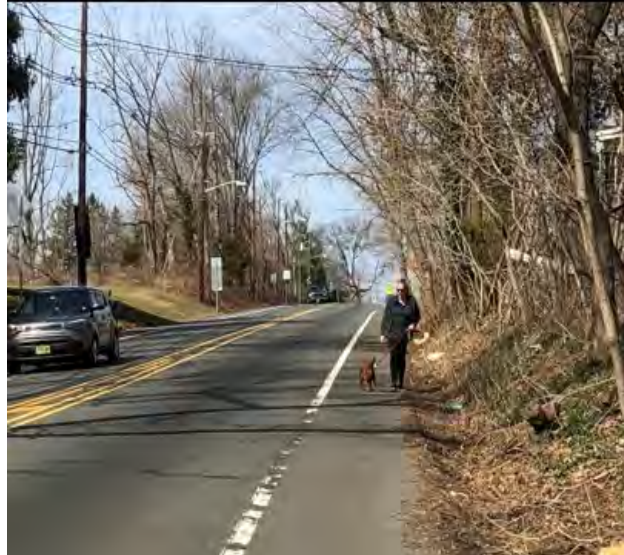
Gaps in pedestrian connectivity and pavement drop-offs on side of road

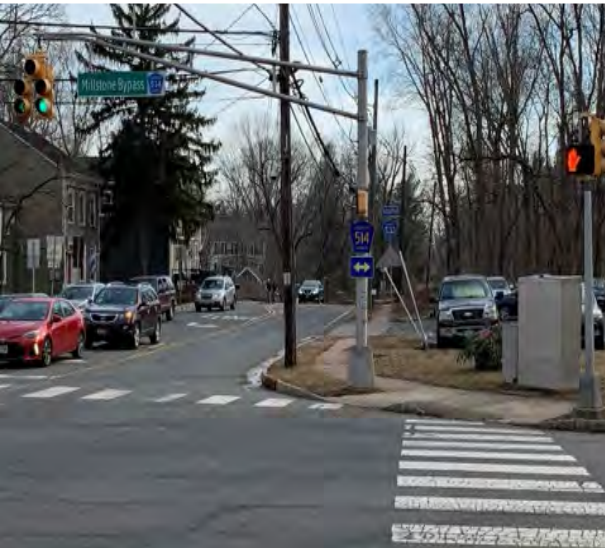
Signal at Amwell Road & Main Street lacks pedestrian countdown signal heads

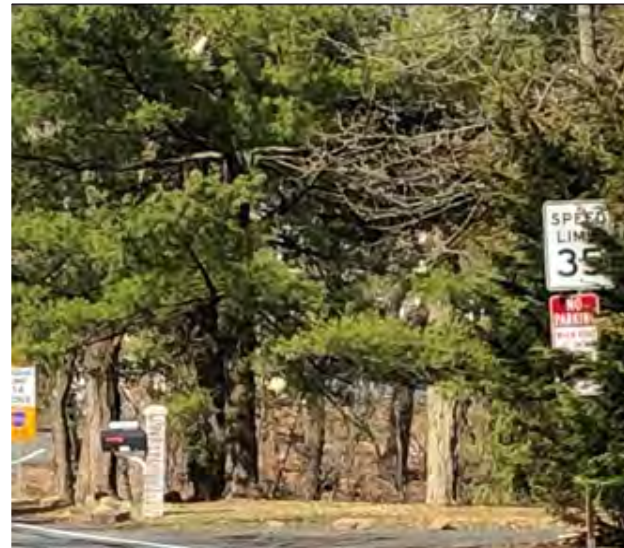
Branches obstructing signage along Main Street

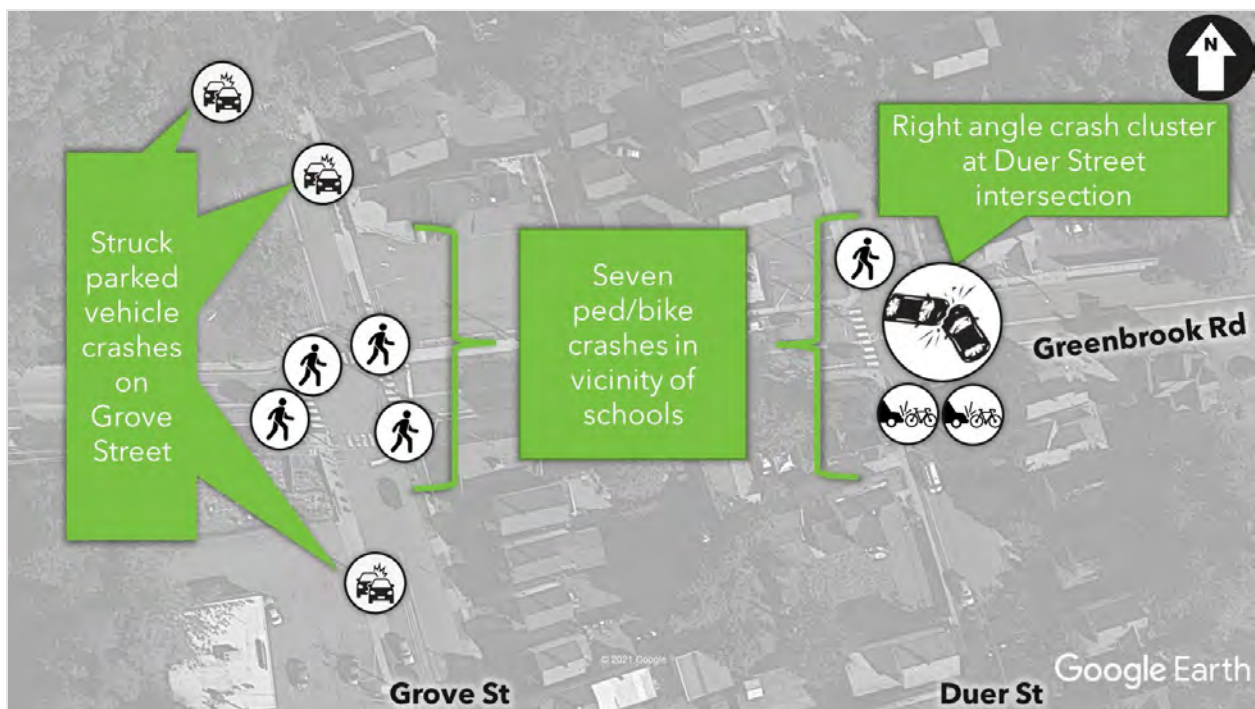
Figure 21 - Collision Highlights, Greenbrook Road

- Bicycle and pedestrian crashes have been reported at this location
- Crashes between parked vehicles and westbound traffic have occurred from Stone Street and Grove Street

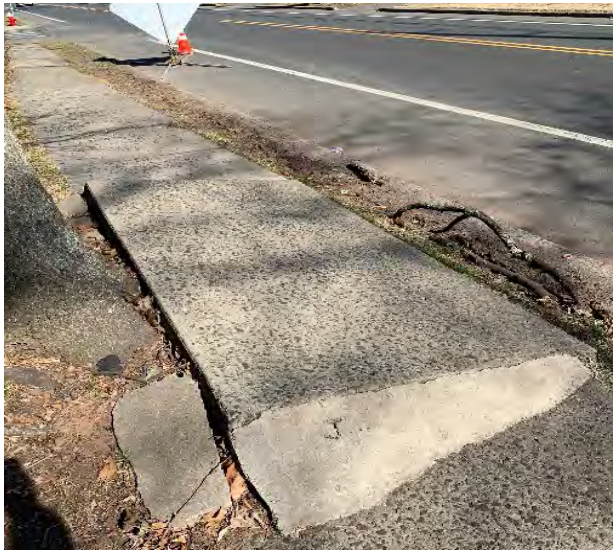
Figure 22 - Field Observations and Identified Needs, Greenbrook Road

Severe sidewalk heaving at locations with mature trees

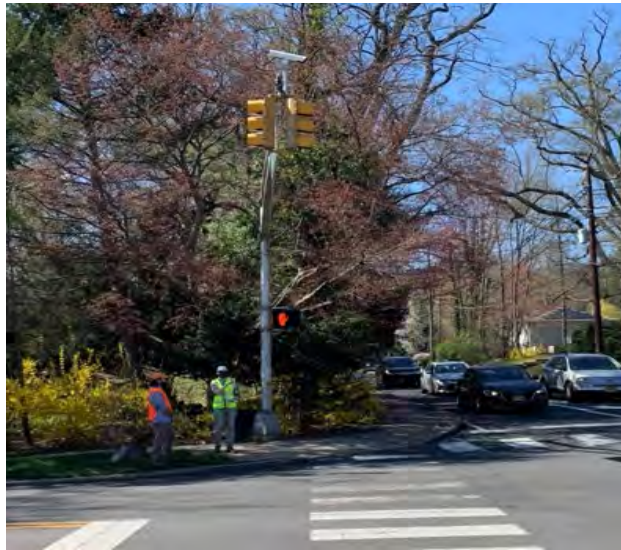
Branches and foliage at the northwest corner of West End Avenue intersection impairing motorists sight distance should be trimmed back

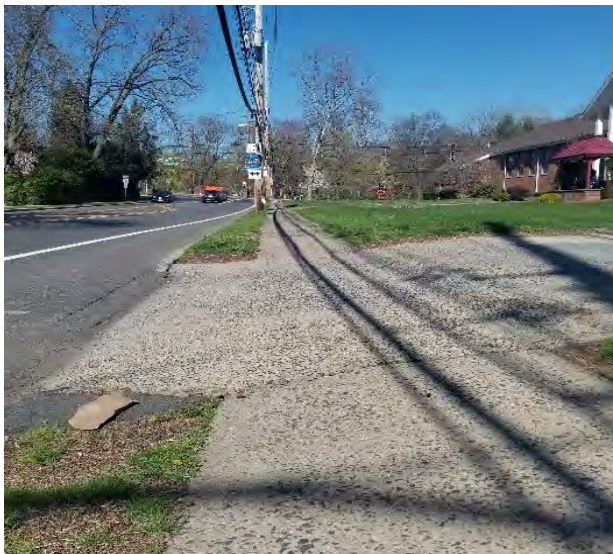
Steep driveway pitch that slopes toward street near Judges Lane

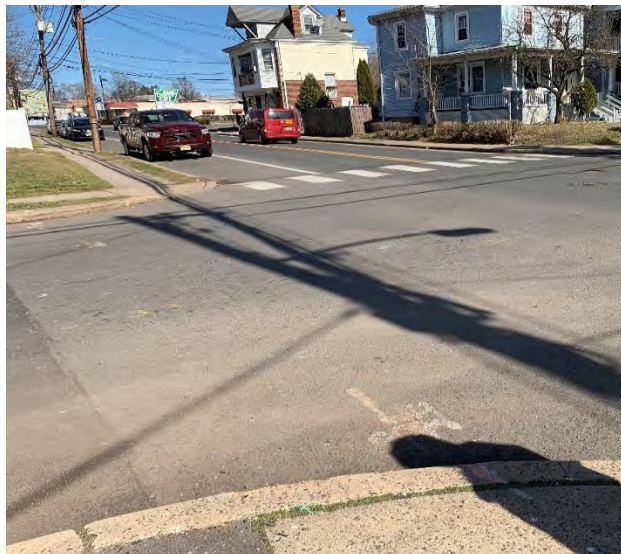
Parked vehicles block motorists' sight line to pedestrians at Duer Street

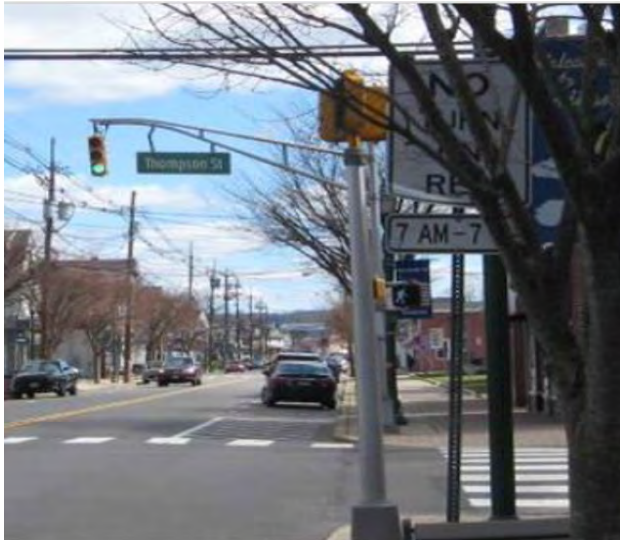
Figure 24 - Field Observations and Identified Needs, Somerset Street

Signs are blocked by roadside tree branches

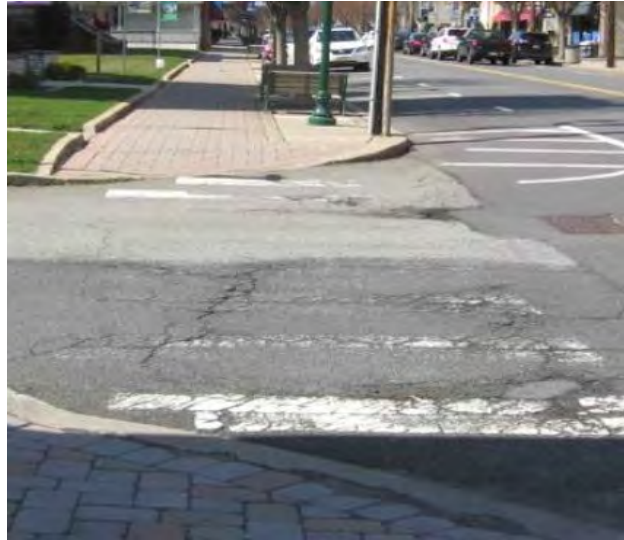
Crosswalk pavement and striping may benefit from updating for better pedestrian/motorist visibility

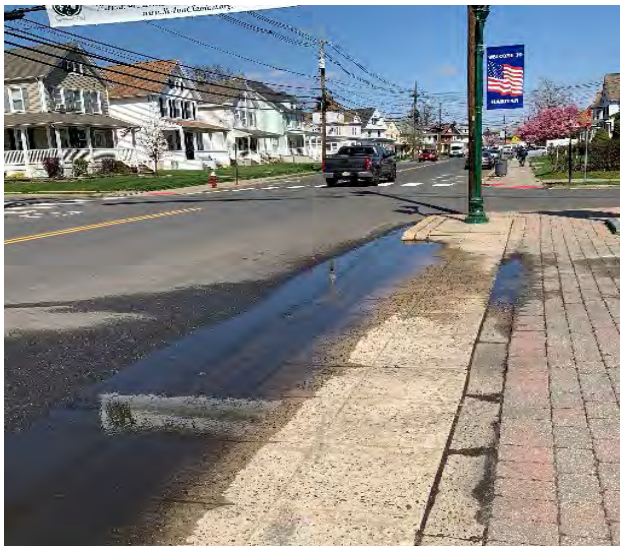
Ponding near crossings indicates drainage problems

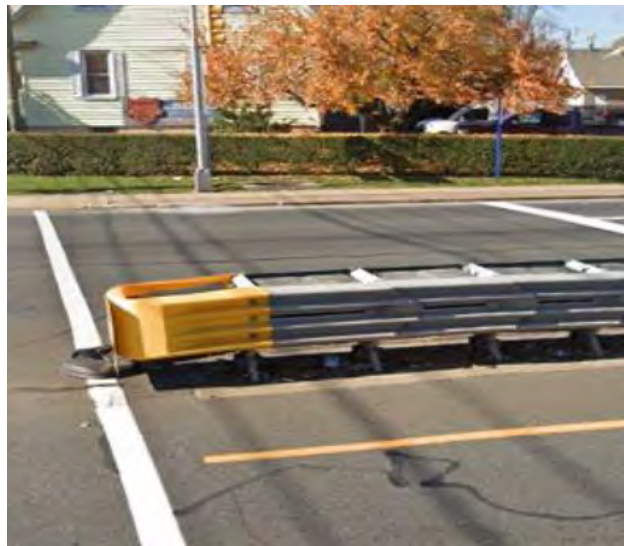
Stop bar on Route 206 South is set too far back

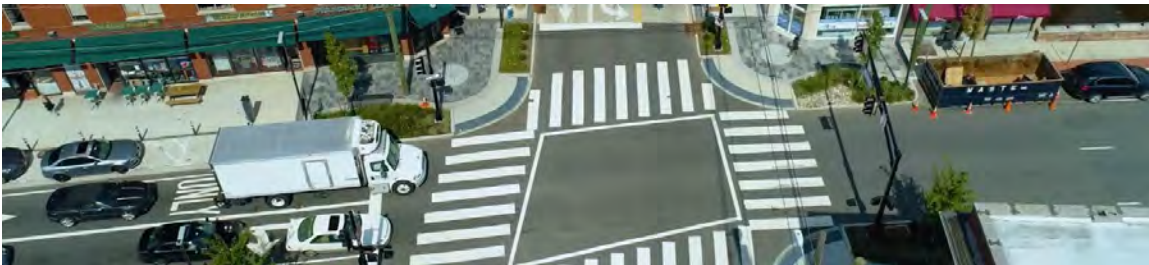
Figure 29 - Aerial Perspective of Daylighting and Curb Extensions, Millburn, NJ

As designs of these improvements on Somerset Street move forward, additional treatments that could be implemented alongside curb extensions should be considered, including ergonomic crosswalks (used to better reflect the more curved paths of pedestrian circulation at an intersection) and infiltration planters (used to act as a receptacle to filter stormwater runoff).

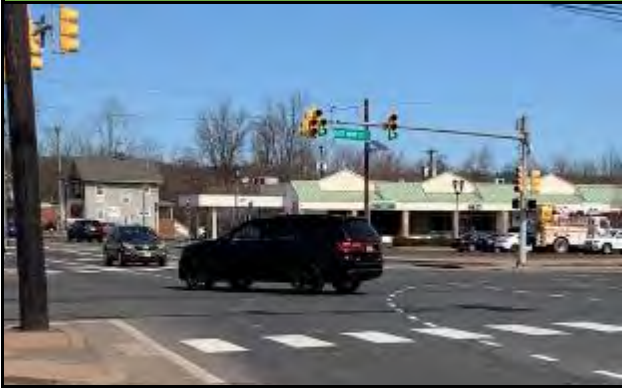
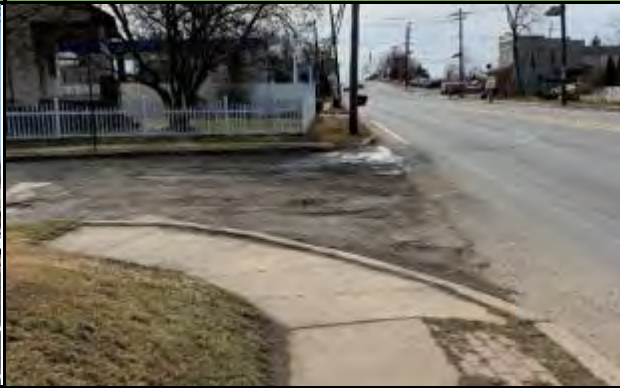
<p>History of pedestrian crashes at Finderne Avenue & Main Street involving vehicles making permissive turns</p>	<p>Heavily-used cycling route lacking updated wayfinding to connect local communities</p>

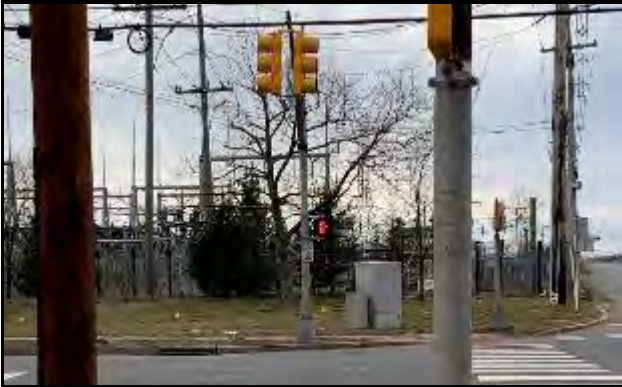
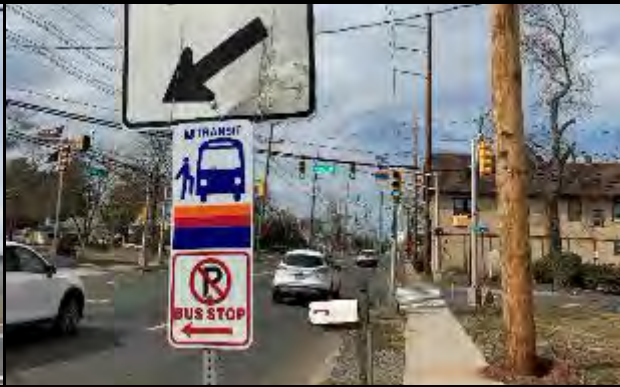
<p>Close calls between NB permissive left and SB through at Finderne Avenue & Main Street intersection</p>	<p>Ponding at side street crossings compromises pedestrian crossing areas, location also lacks curb ramps</p>

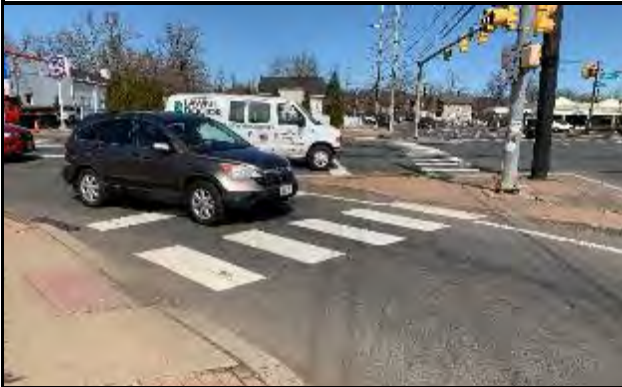
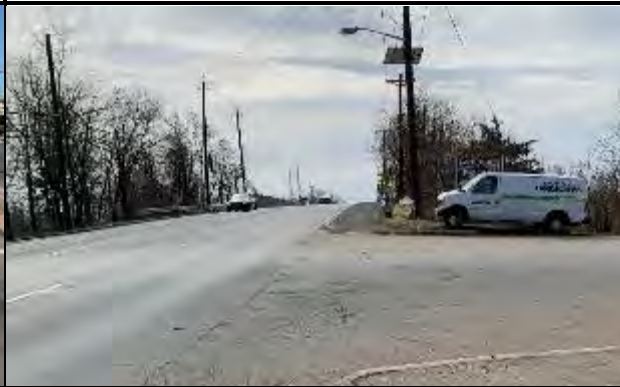
<p>Older signals at Chimney Rock Road and Ramsey Street lacking countdown pedestrian heads and proper clearance times</p>	<p>Transit stops on Main Street lack amenities, dedicated pull off areas, and updated bus route information</p>

<p>Right turn channelized operations at Finderne Avenue & Main Street are signalized, but conflicting crosswalks lack pedestrian heads</p>	<p>Non-compliant curb ramps filled with debris, crosswalk is missing, sight lines hard to establish due to bridge crest</p>

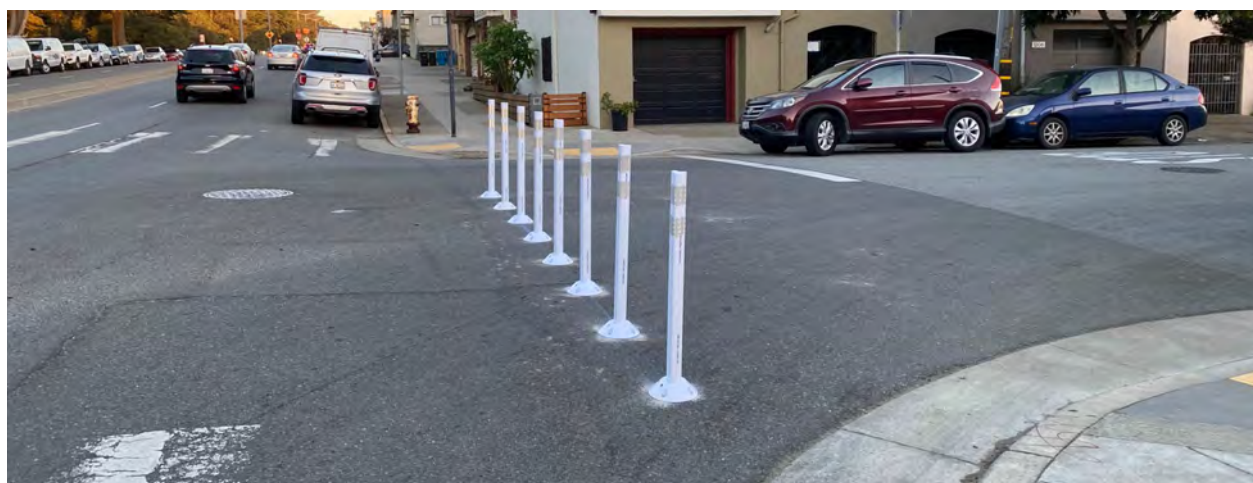
Figure 15 – Temporary Traffic Diverter Allowing Right Turns onto Main Road¹⁶

Figure 16 is a similar improvement implemented by Mercer County. This could be considered as an alternate option to the recommendation within the Implementation Matrix to install an offset signal at Finderne Avenue & Central Avenue/4th Street. With the closure of 4th Street, capacity analysis software should be used to determine if sufficient capacity exists on alternate routes (3rd Street and 2nd Street) to handle the additional demand.

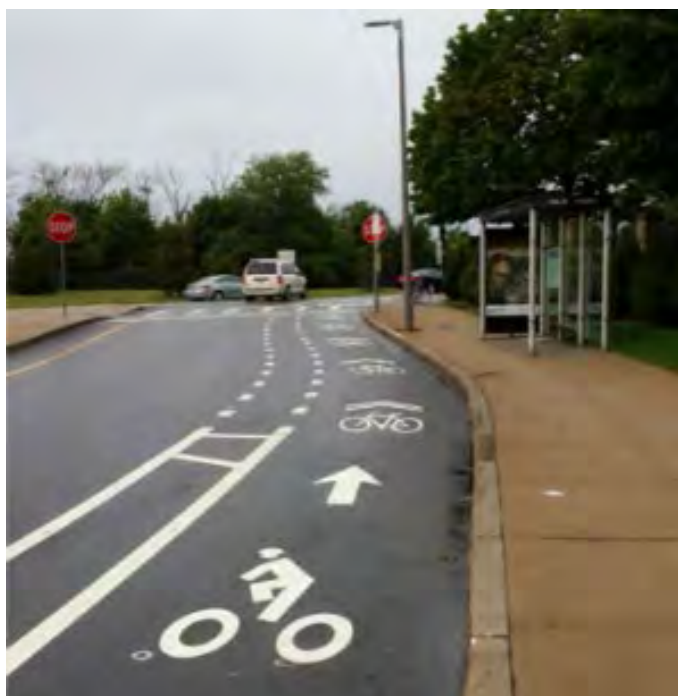
Figure 19 – Transition from Bike Lane to Shared Bus Stop Area in Boston, Massachusetts²⁴

street with a small buffer area. In addition, bus pull-offs could be provided by transitioning the bike lane and buffer area to sharrows at bus stops (**Figure 19**). Ideally, the road diet would be carried to the east towards Bound Brook to connect with more densely populated areas. While the intersection of Finderne Avenue & Main Street may not be able to accommodate cartway width for a bike lane, sharrows on Fulton Avenue and 2nd Street could be utilized by the Township to connect this bicycle route with the existing Township bicycle route west of Finderne Avenue on Bridgewater Avenue. Multiuse crossings with refuge islands at the intersections of Finderne Avenue & Bridgewater Avenue and Main Street & Fulton Avenue, if feasible, would help to further facilitate these connections.

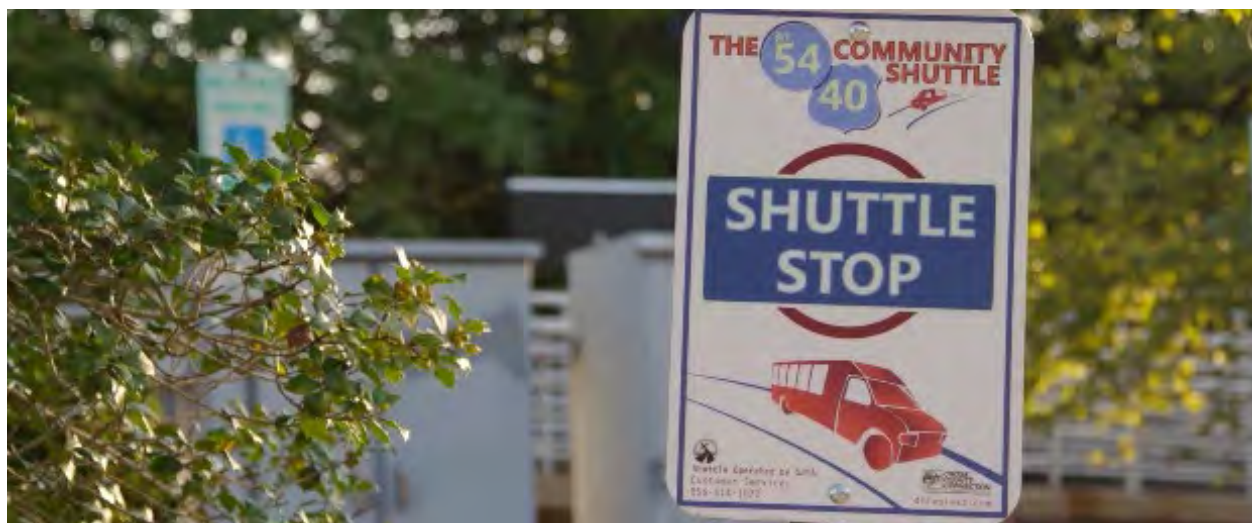
Figure 20 – Sample of Bus Stop Branding²⁵

For the six SCOOT bus routes utilizing Main Street, RSA participants observed the lack of amenities for transit service with no bus shelters, sitting areas, etc. Furthermore, as shown in the **Identified Issues & Observations** section of this report, these stops are incorrectly signed as having NJ TRANSIT service. While the installation of amenities, such as bus shelters, on the inbound (eastbound) side of Main Street would certainly help improve the visibility and useability of transit options in the Finderne neighborhood, a low-cost improvement that could be implemented within the corridor is the branding of bus stop signing with SCOOT, CAT, or RideWise TMA (Transportation Management Authority) logos. An example of bus stop branding for the Cross County Connection TMA's bus service in southern New Jersey is shown in **Figure 20**.

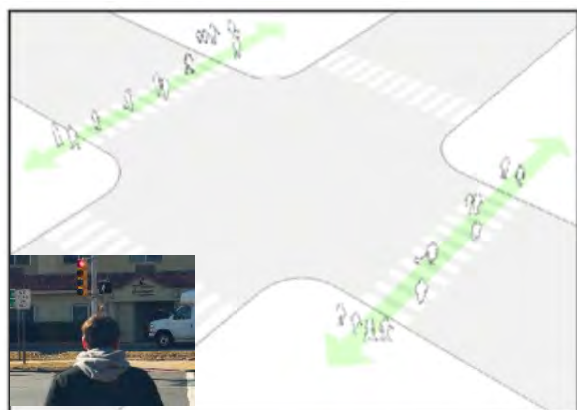
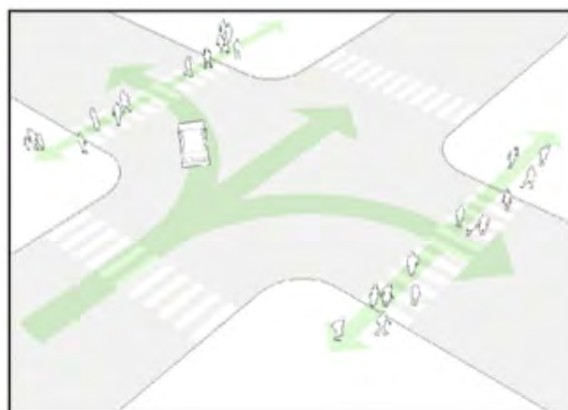
Figure 21 – Leading Pedestrian Interval (from NACTO and Lakewood Township)²⁷

PHASE 1

Pedestrians are given a minimum head start of 3–7 seconds when entering the intersection.

PHASE 2

Through and turning traffic are given the green light. Turning traffic yields to pedestrians already in the crosswalk.

LPIs are a low-cost, effective way to help pedestrians establish their presence at signalized crossing locations before conflicting vehicles have the right-of-way (Figure 21). This is one of FHWA’s Proven Safety Countermeasures, boasting an approximate reduction of 13%²⁶ of pedestrian-vehicle crashes with proper implementation. Signal phasing and vehicular capacity are noted to be barriers to implementation, especially at signalized locations with lead left turn phasing, such as Main Street & Finderne Avenue. The County could take the approach to implement LPIs at every intersection where capacity and phasing allows, which could potentially make Main Street intersections with Ramsey Street/Pearl Street and Chimney Rock Road/Polhemus Lane candidates for implementation.

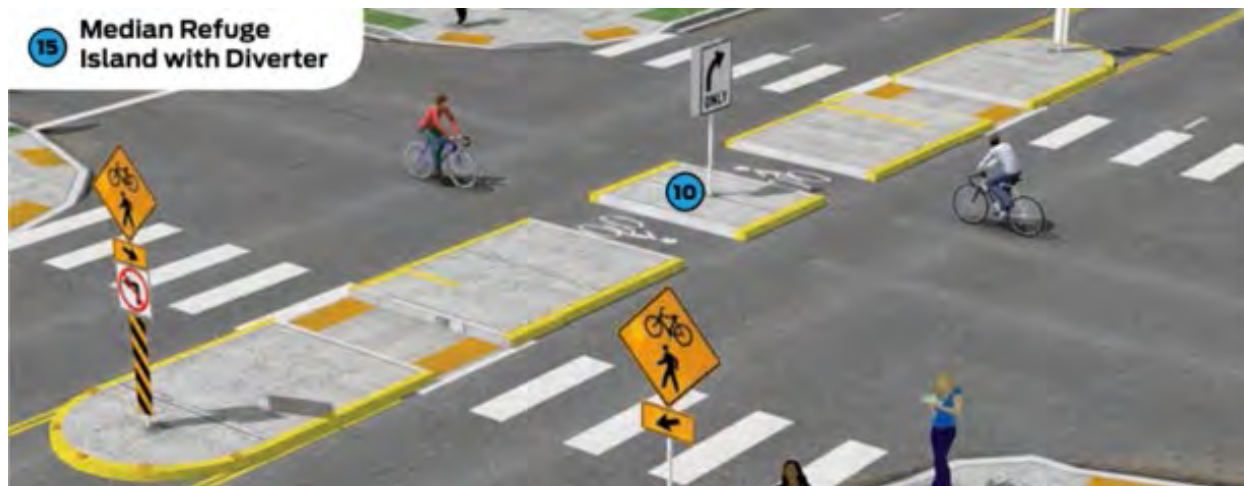
Figure 22 – Diverter Island for Consideration at Fulton Avenue²⁸

Through various outreach efforts (Public Meeting and TAC Meetings), both public and stakeholder participants have indicated occurrence of both cut-through and aggressive driving movements at the Main Street intersection with Fulton Avenue/Shopping Center Driveway. Drivers either drive straight across Main Street, turn left onto Main Street westbound, or turn left onto Main Street eastbound, which results in close calls and collisions at this four-leg unsignalized intersection location. A diverter island could be placed in the cross-hatched median of Main Street to preclude these at-risk turning movements at this intersection such as the crossing of three to four travel lanes, potential conflicting queues, and a wide median.

Furthermore, with the presence of multi-family housing to the south of the intersection and retail and recreational uses to the north of the intersection, such a diverter island (constructed in line with the current cross-hatched median on the westbound Main Street approach to Finderne Avenue) could also accommodate a 20' refuge area width for pedestrians to cross Main Street in two stages (Figure 22). It is recommended that pedestrian-actuated Rectangular Rapid Flashing Beacons (RRFBs, Figure 23Error! Reference source not found.) be implemented in conjunction with the diverter island to improve pedestrian visibility and improve the rate at which vehicles would stop for pedestrians.

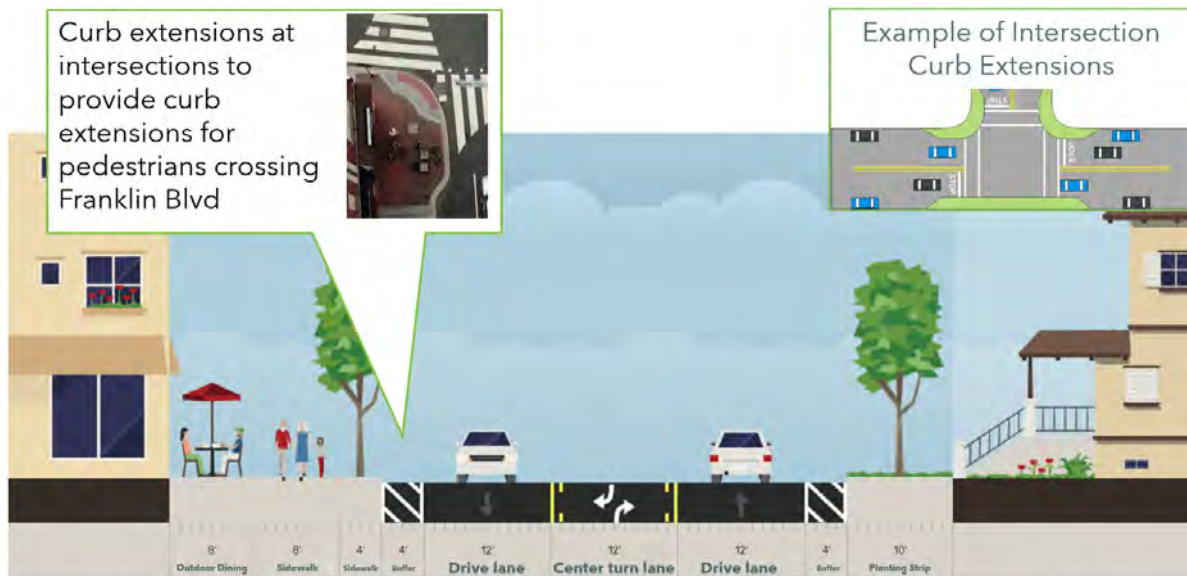
Figure 17 – Alternate Road Diet Option with Shoulders Transitioning to Curb Extensions at Intersections

Alternate Road Diet Option without Bike Lane, Facing North between Frank Street and Fuller Street

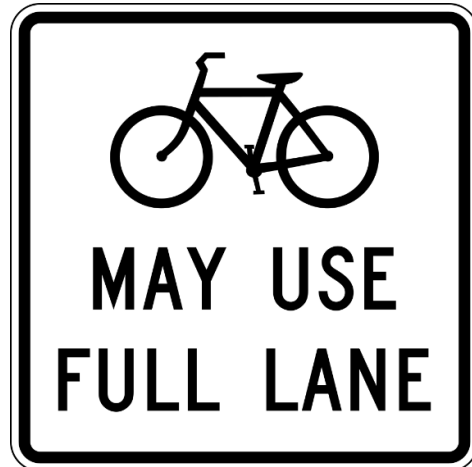
Figure 19 – MUTCD Sign R4-11

). During the RSA, it was also noted that, just past the northern limit of the study corridor at Belmar Street, the bike lanes in each direction dropped off for the roadway to accommodate a two-way left turn lane within the cartway width. To provide continuity of bicycle travel, it is recommended that a “BIKE MAY USE FULL LANE” sign be posted on Franklin Boulevard on segments where the bike lane ends (**Figure 19**).

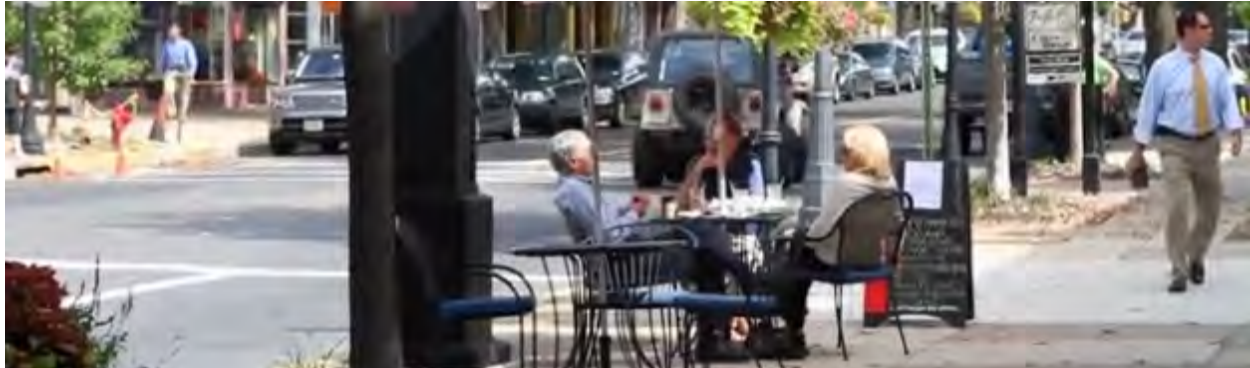
Figure 22 – Street Furniture in Downtown Haddonfield

street traffic. The Township should consider the addition of street furniture (**Figure 22**) in front of this and other new developments to help provide more of a downtown street feel on Franklin Boulevard. Additional striped crossing locations traversing Franklin Boulevard unlocked by a potential road diet would also help achieve this traffic calming effect.

New development projects within this Priority Growth Investment Area (see Phase III study) on the southern end of the corridor, such as 727 Franklin Boulevard between Fuller Street and Frank Street, should specify the design of similar buildings with parking provided behind storefront areas and storefront areas adjacent to the street and sidewalk, which helps drivers to slow vehicle speeds with visual queues of a downtown neighborhood feel. It was noticed, however, that many businesses at 727 Franklin Boulevard were empty and lacked street furniture outside the store front, which made the businesses feel less “engaging” with the

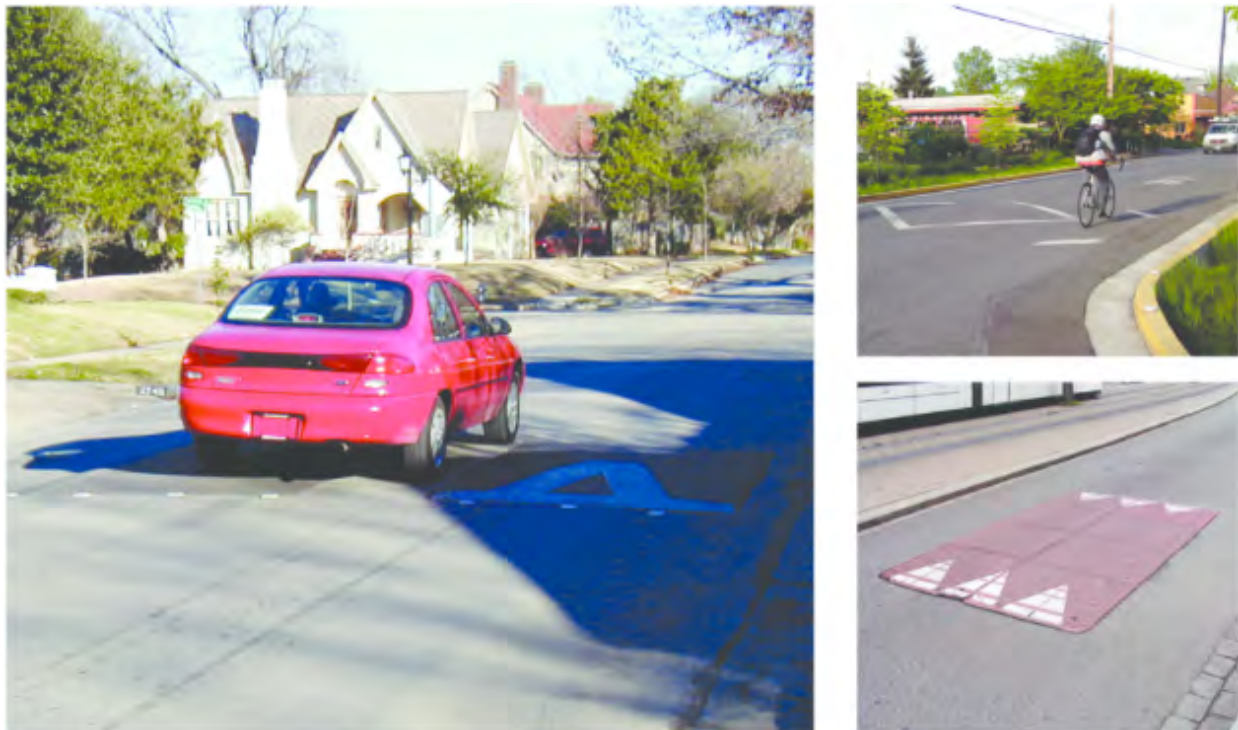
Figure 23 – Sample Speed Humps from NACTO²⁸

Cut-through traffic was observed to occur on Berry Street and Ellen Street, with vehicles bypassing peak hour congestion at the intersection with Hamilton Street to the southwest. Speed humps (**Figure 23**), combined with turning restrictions could help to discourage this cut-through traffic activity. Speed humps can be designed to slow an average vehicle’s wheelbase width yet can also allow for bicyclists and larger emergency vehicles, such as firetrucks, to move along the street unimpeded.

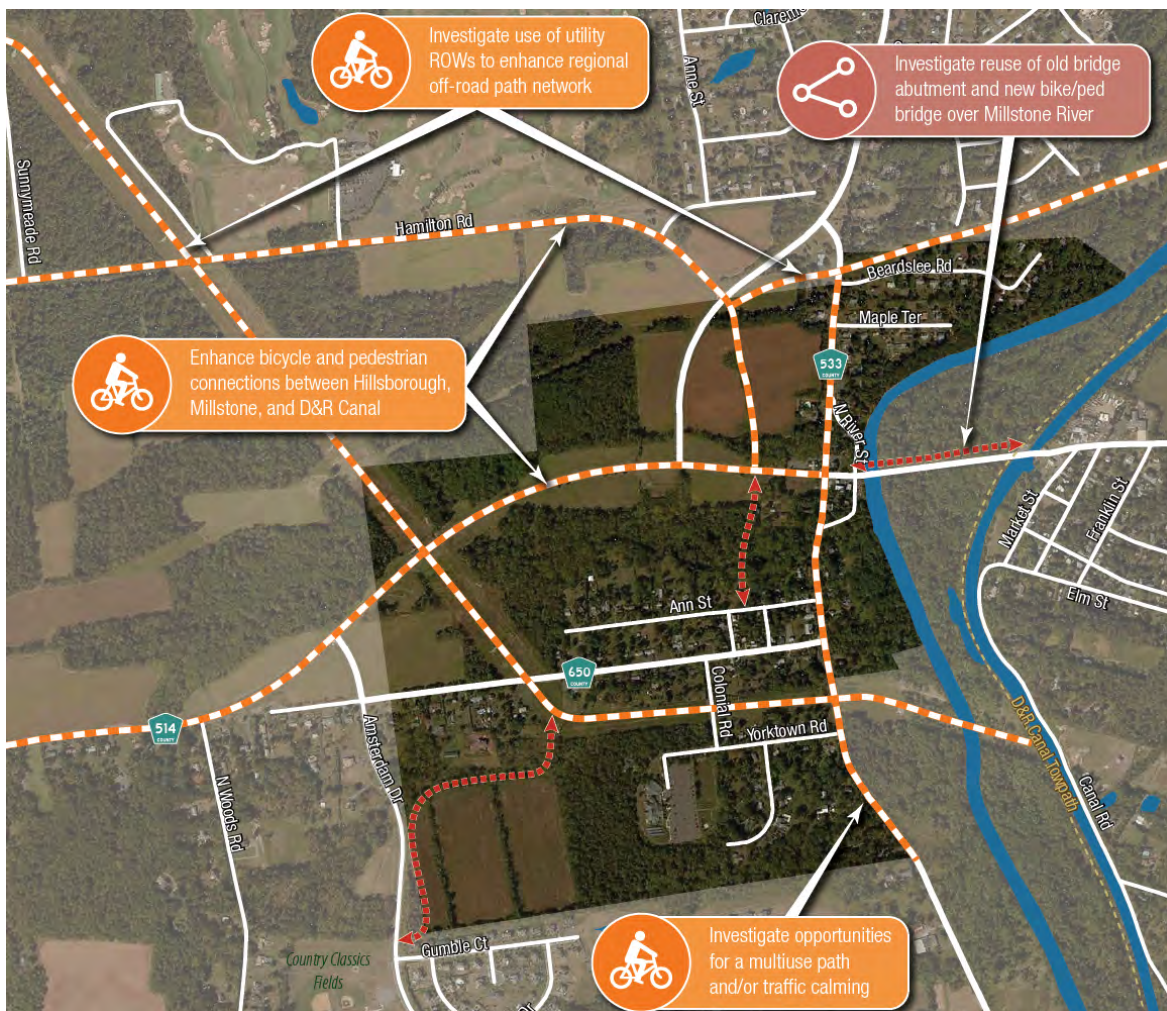
Figure 3 – Multimodal Recommendations from Phase III Study

The area surrounding the corridor segment has been designated as a Local Priority Area (LPA) by the County in its 2017 *Supporting Priority Investment in Somerset County, Phase III* study. The Phase III study noted that this area is a very auto-centric environment and that multimodal mobility improvements can help to support tourism and recreation opportunities in the Borough. An overview of mobility improvements from the Phase III study is shown in **Figure 3**.

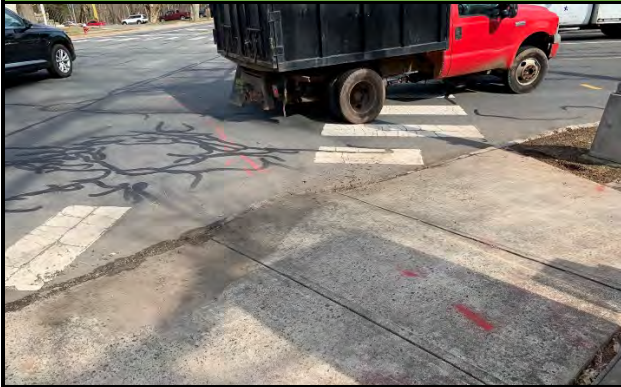
<p>Intersection of Amwell Road and Main Street need ADA-compliance upgrade</p>	<p>Drainage grates should be replaced with bicycle-safe drainage grates</p>

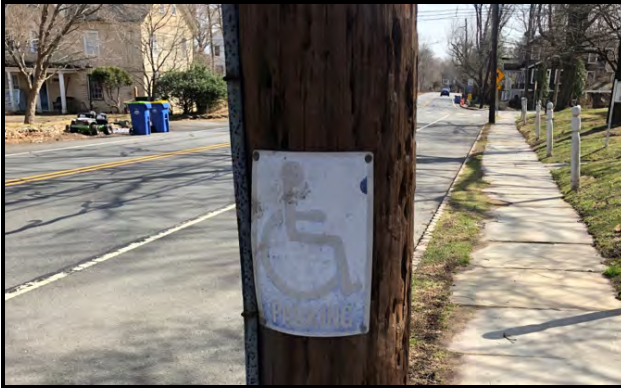
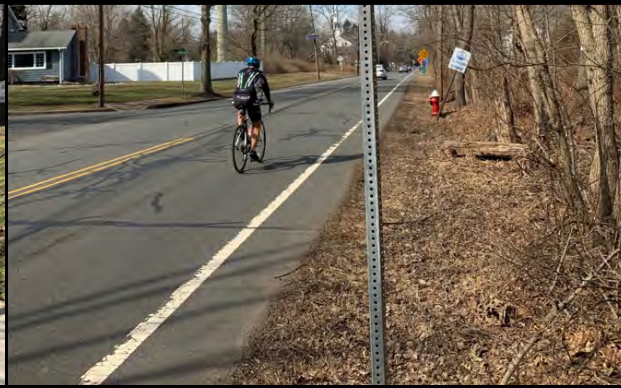
<p>Wheelchair access point is overlooked due to faded signing and striping near Ann Street</p>	<p>Main Street lacks space to accommodate bike lanes. Therefore, cyclists share vehicle roadspace</p>

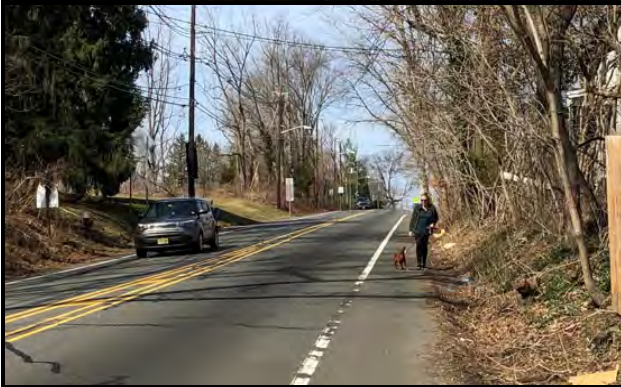
<p>Main Street north of Amwell road lacks sidewalk and safe pedestrian access. Roadway edge also has severe drop-offs</p>	<p>Sidewalk lacks continuity.</p>

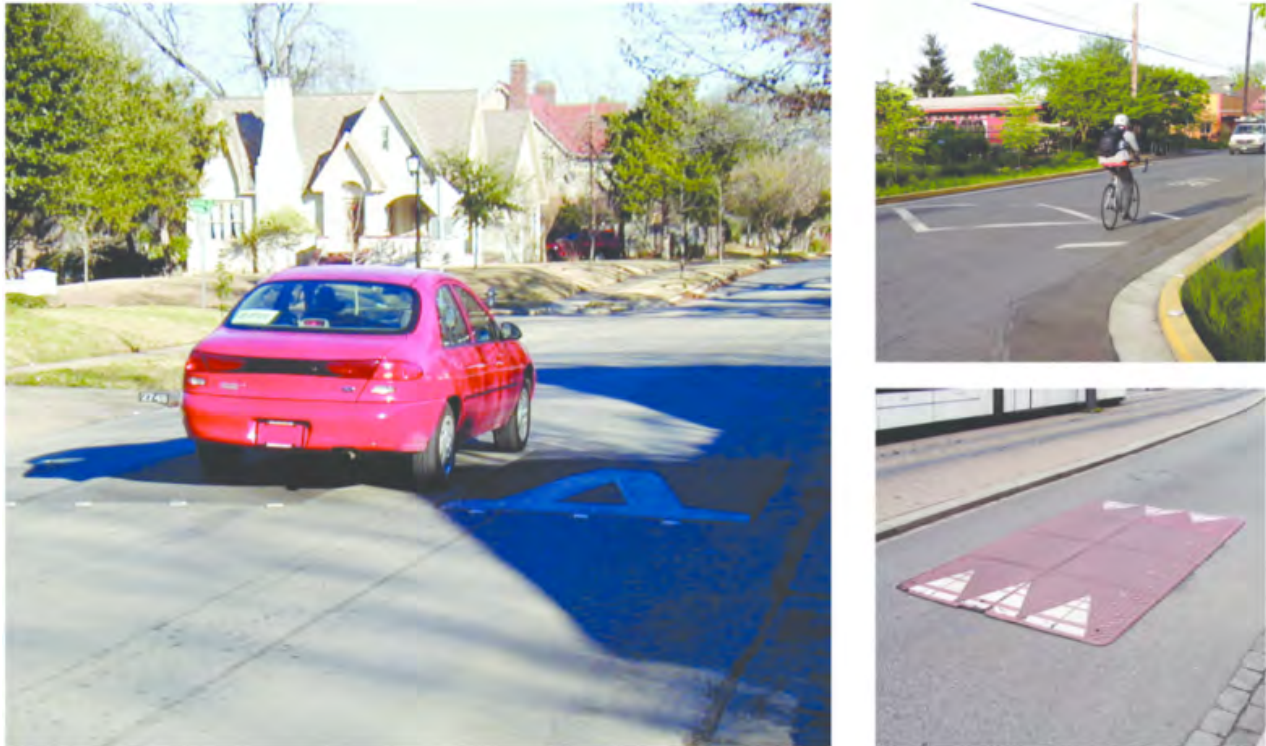
Figure 17 – Sample Speed Humps from NACTO²⁴

At the Township's discretion, either paved or raised speed humps could be installed on North and South River Street to discourage cut-through traffic looking to bypass brief periods of congestion at the Amwell Road (CR 514) intersection. Speed humps can be designed to slow an average vehicle's wheelbase width yet can also allow for bicyclists and larger emergency vehicles, such as firetrucks, to move along the street unimpeded (**Figure 17**).
