FINAL REPORT

Somerset County Roadway Safety Study

December 2021

Executive Summary

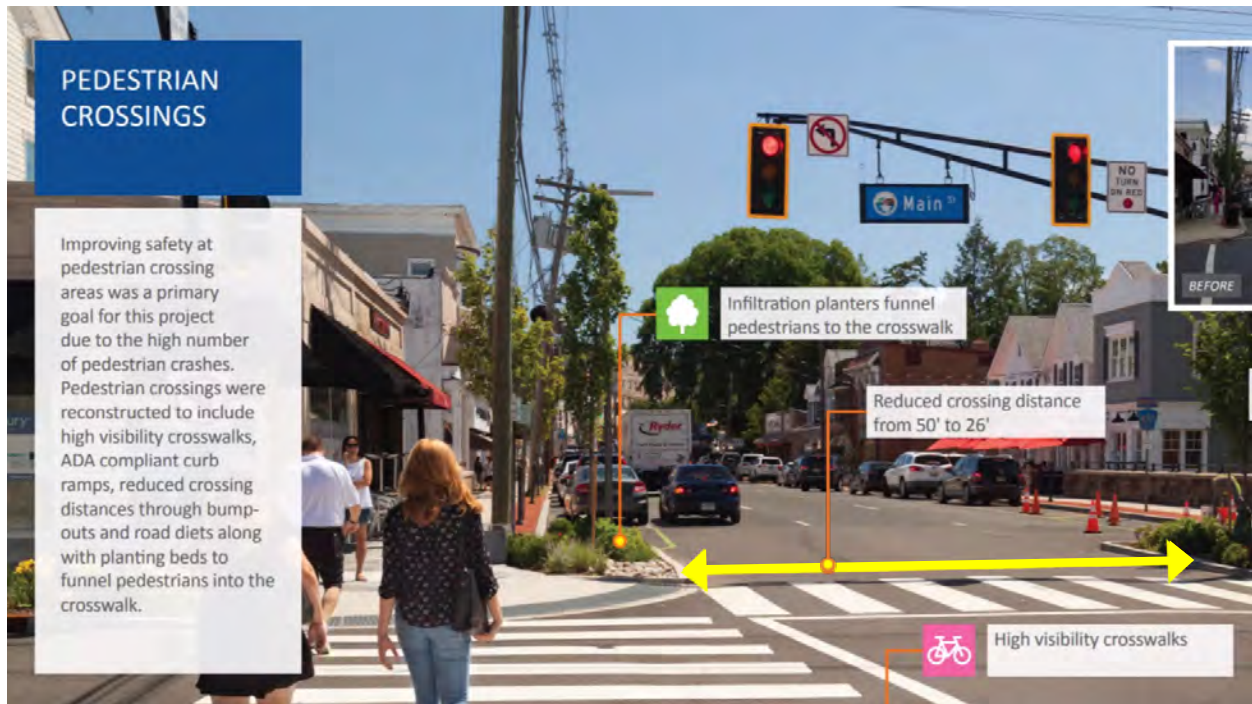
Figure 18 – Millburn Township Curb Extensions with Infiltration Planters, Details Included²⁵

Before construction of the Amwell Road Bypass in the late 90's, CR 650 was the major east-west through route in the Borough serving both passenger car and heavy vehicle traffic. As such, the Amwell Road & Main Street intersection was designed to accommodate heavy vehicle movements. Today, however, this section of Amwell Road has been bypassed and primarily serves vehicles going to/from local residences. This intersection still accommodates large sweeping turning movements, particularly from southbound Main Street to westbound Amwell Road (CR 650) due to large curb radii and shoulders serving as parking areas. Cars can take advantage of these wide sweeping radii for high-speed turning movements. At this location, the County can implement traffic calming on the corners of this intersection, ranging from...

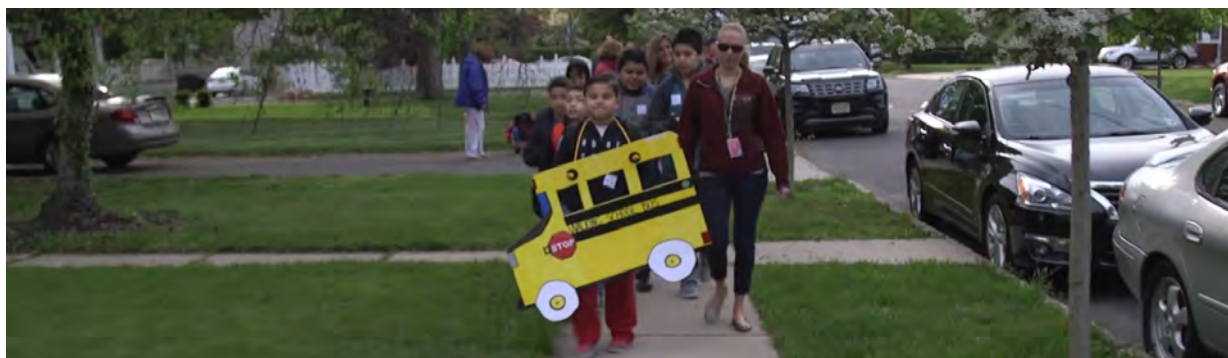
Figure 14 – Walking Bus Demonstration Project in Bound Brook¹⁹

Plainfield School District is encouraged to coordinate with RideWise (the County's TMA) to set up this demonstration project to improve the walkability of the Greenbrook Road corridor.

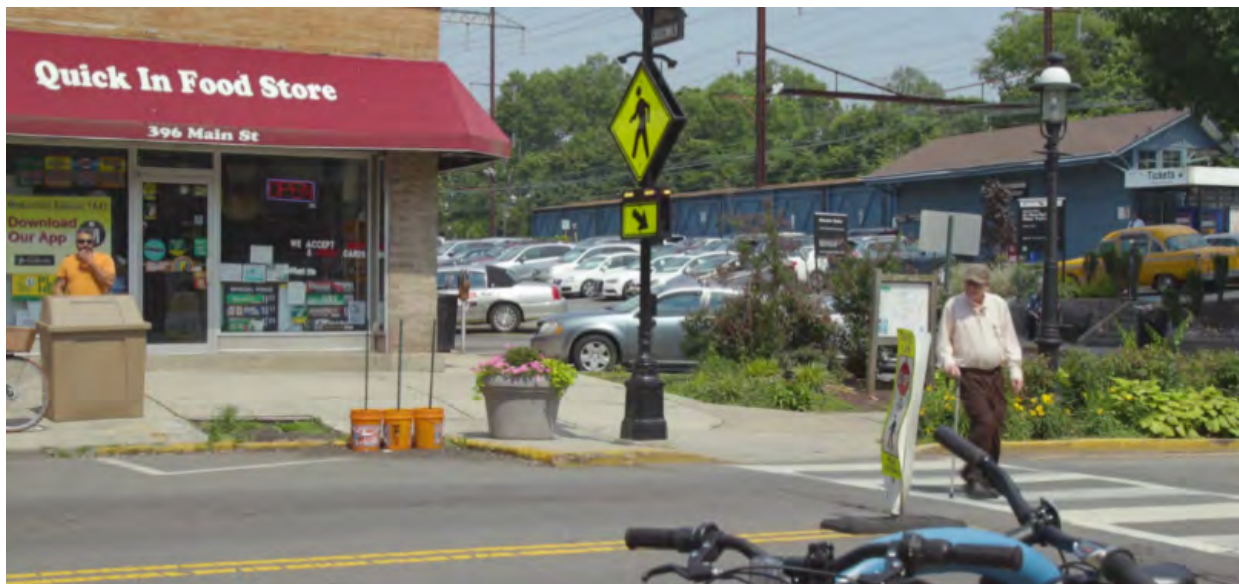
Figure 17 – RRFB Installation in Metuchen Borough by Middlesex County²⁷

At locations where new midblock crosswalks are proposed in this RSA report, such as those near West End Elementary School and Fromm Field, pedestrian-actuated RRFBs could further increase the visibility of students and other pedestrians crossing at these locations. Installing RRFBs at crossing locations could reduce the risk of vehicle-pedestrian crashes to as little as 10% (average crash reduction seen is 47.4%²⁶).

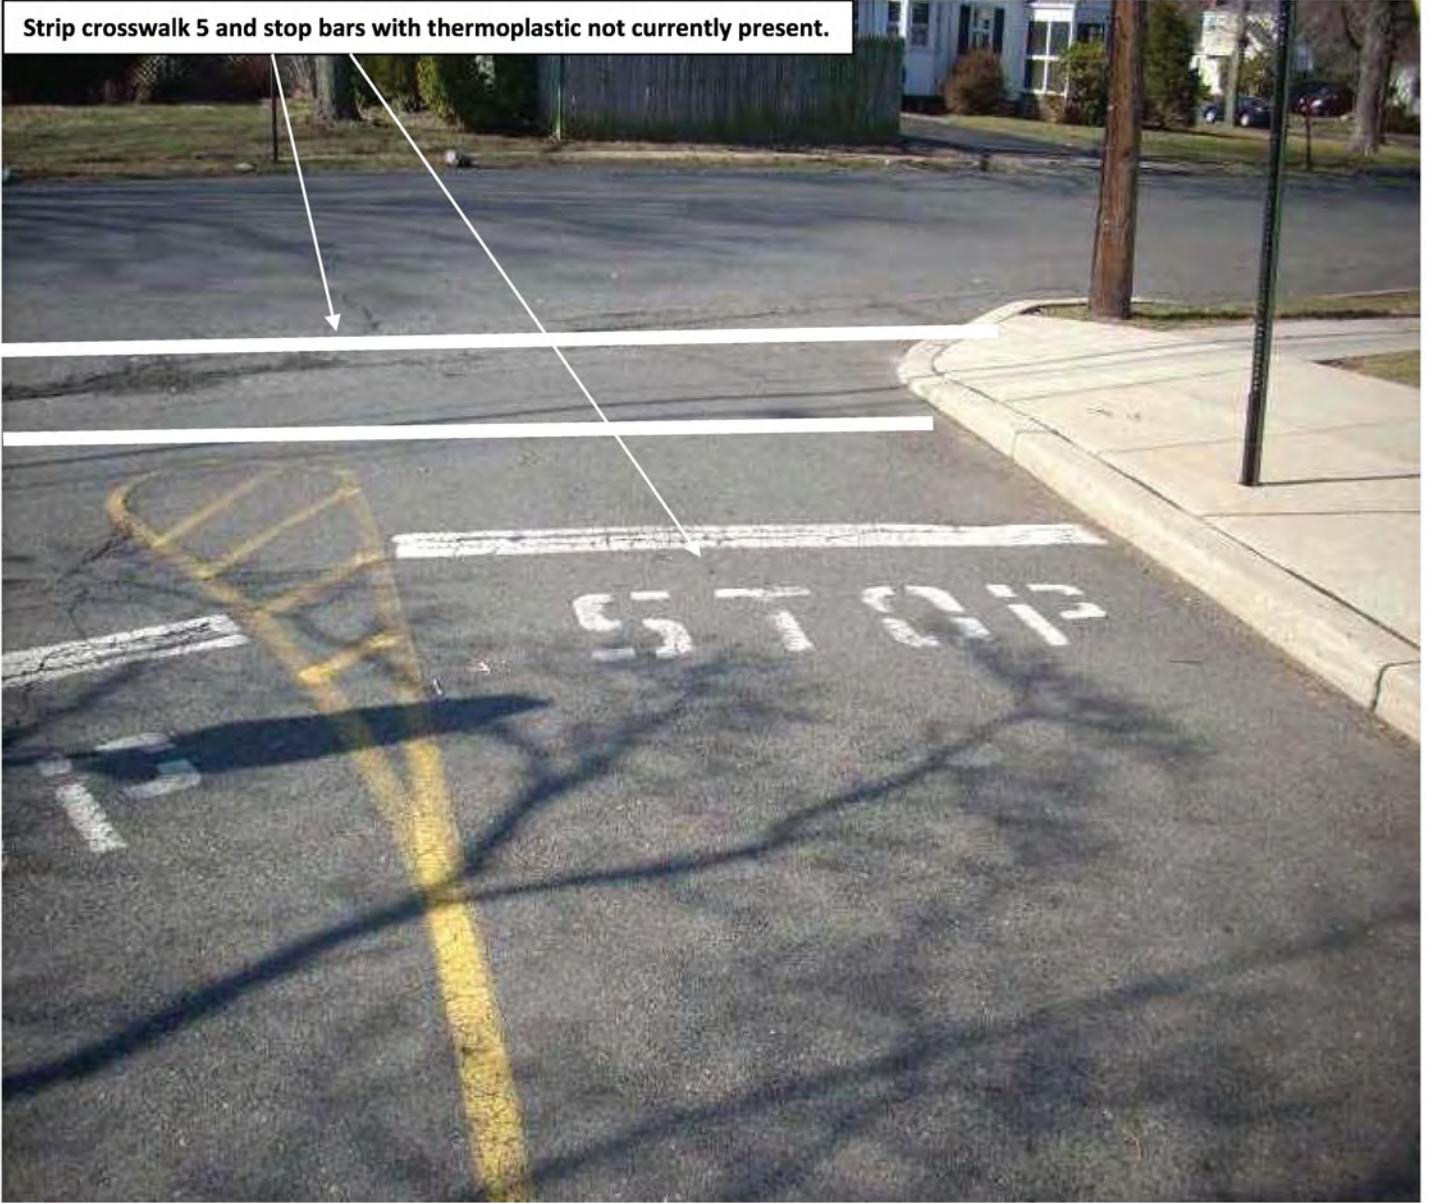
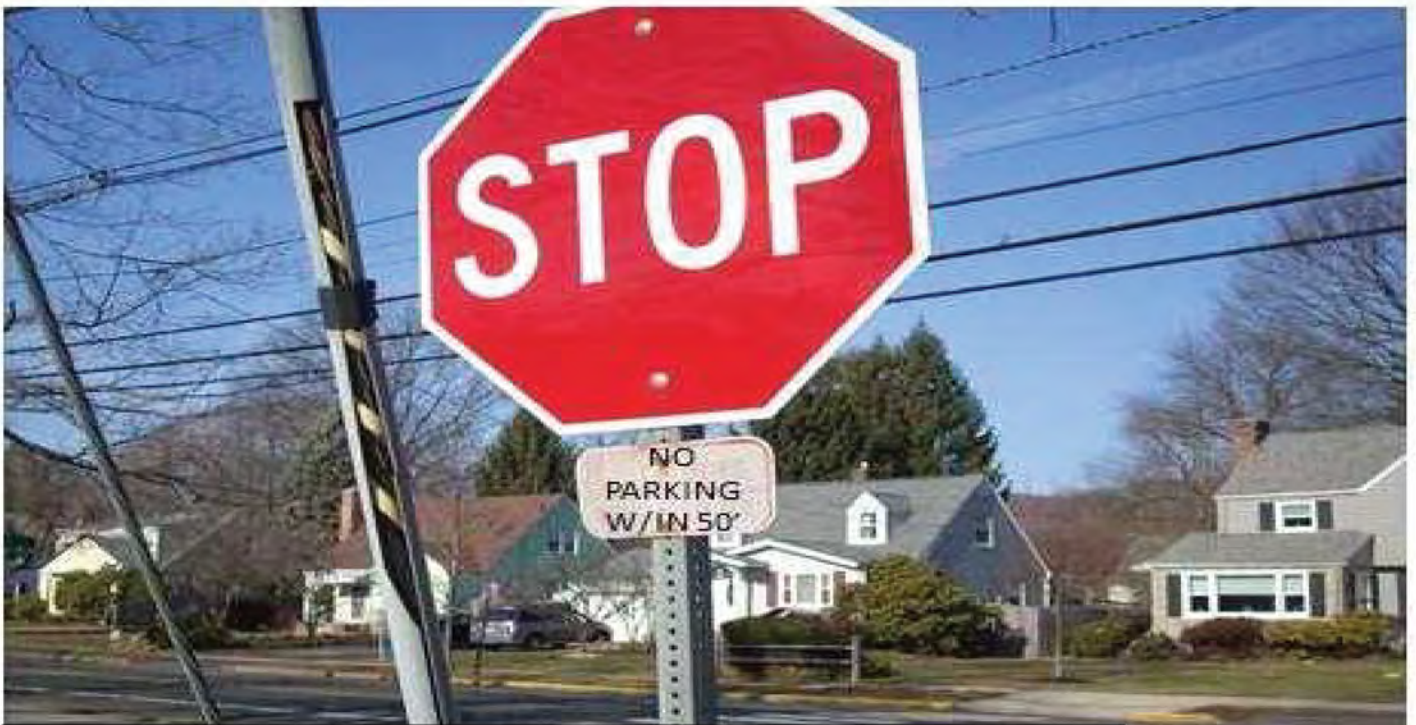
Strip crosswalk 5 and stop bars with thermoplastic not currently present.

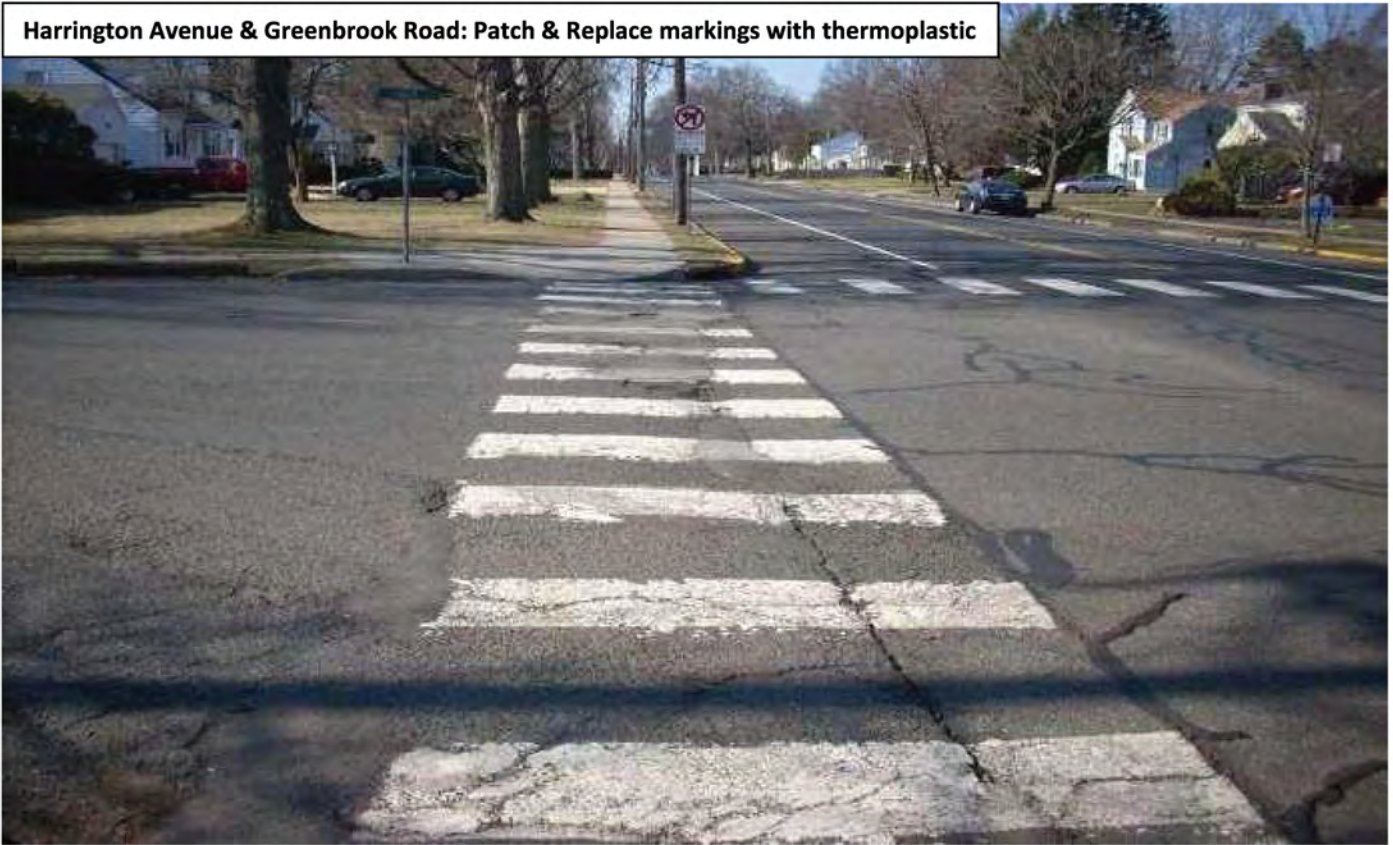
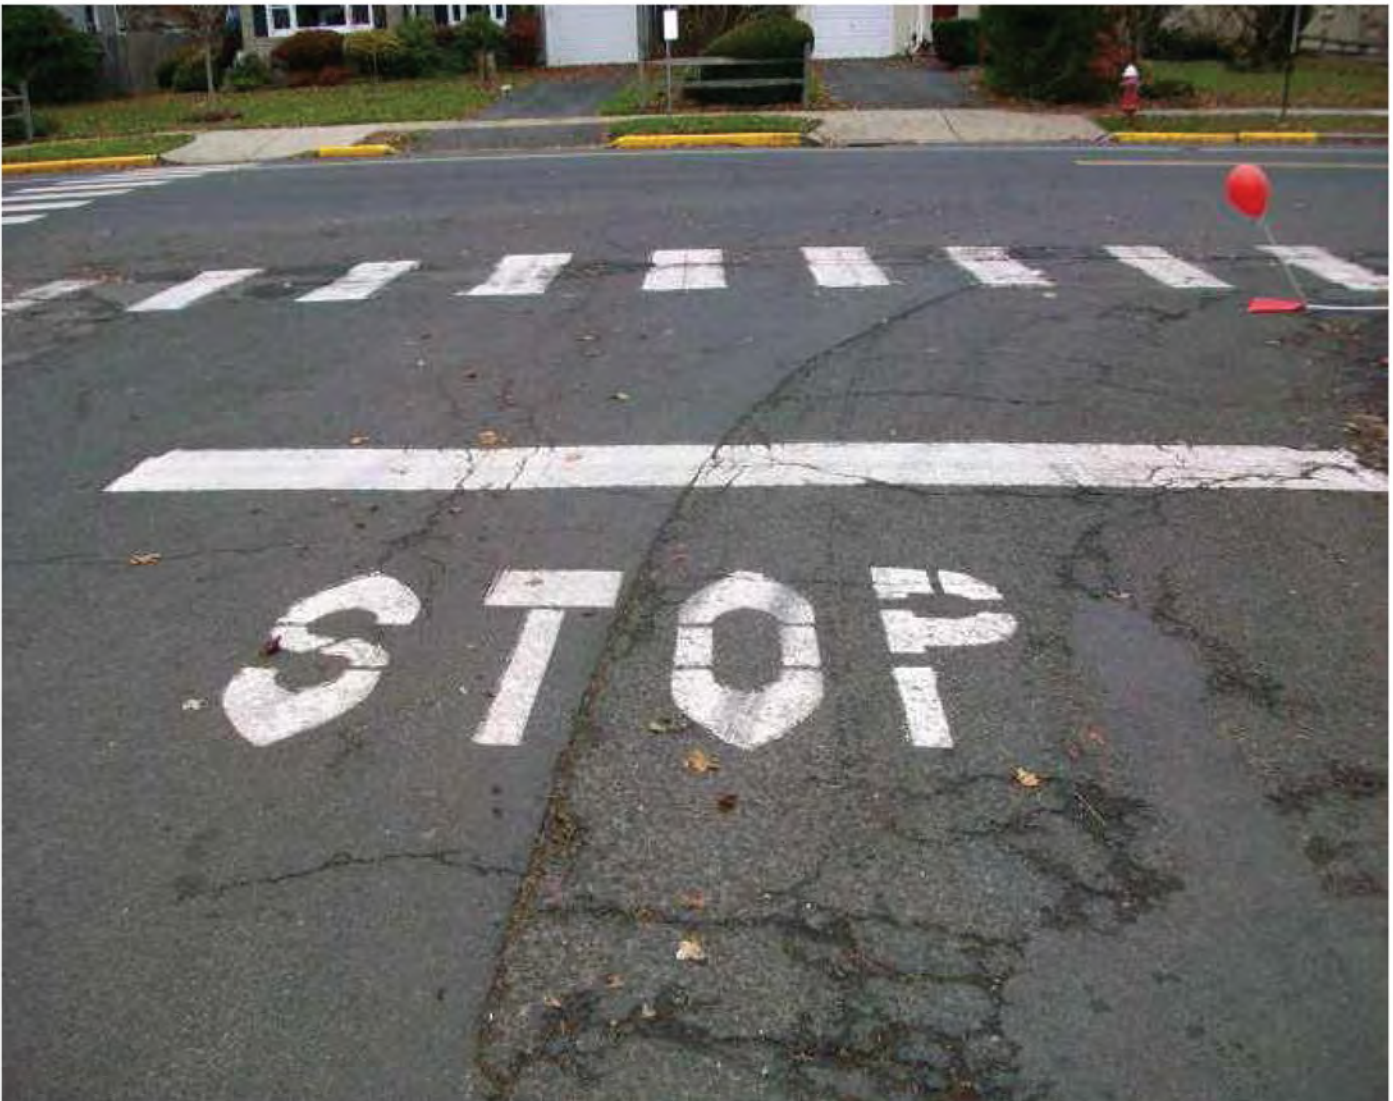
Harrington Avenue & Greenbrook Road: Patch & Replace markings with thermoplastic

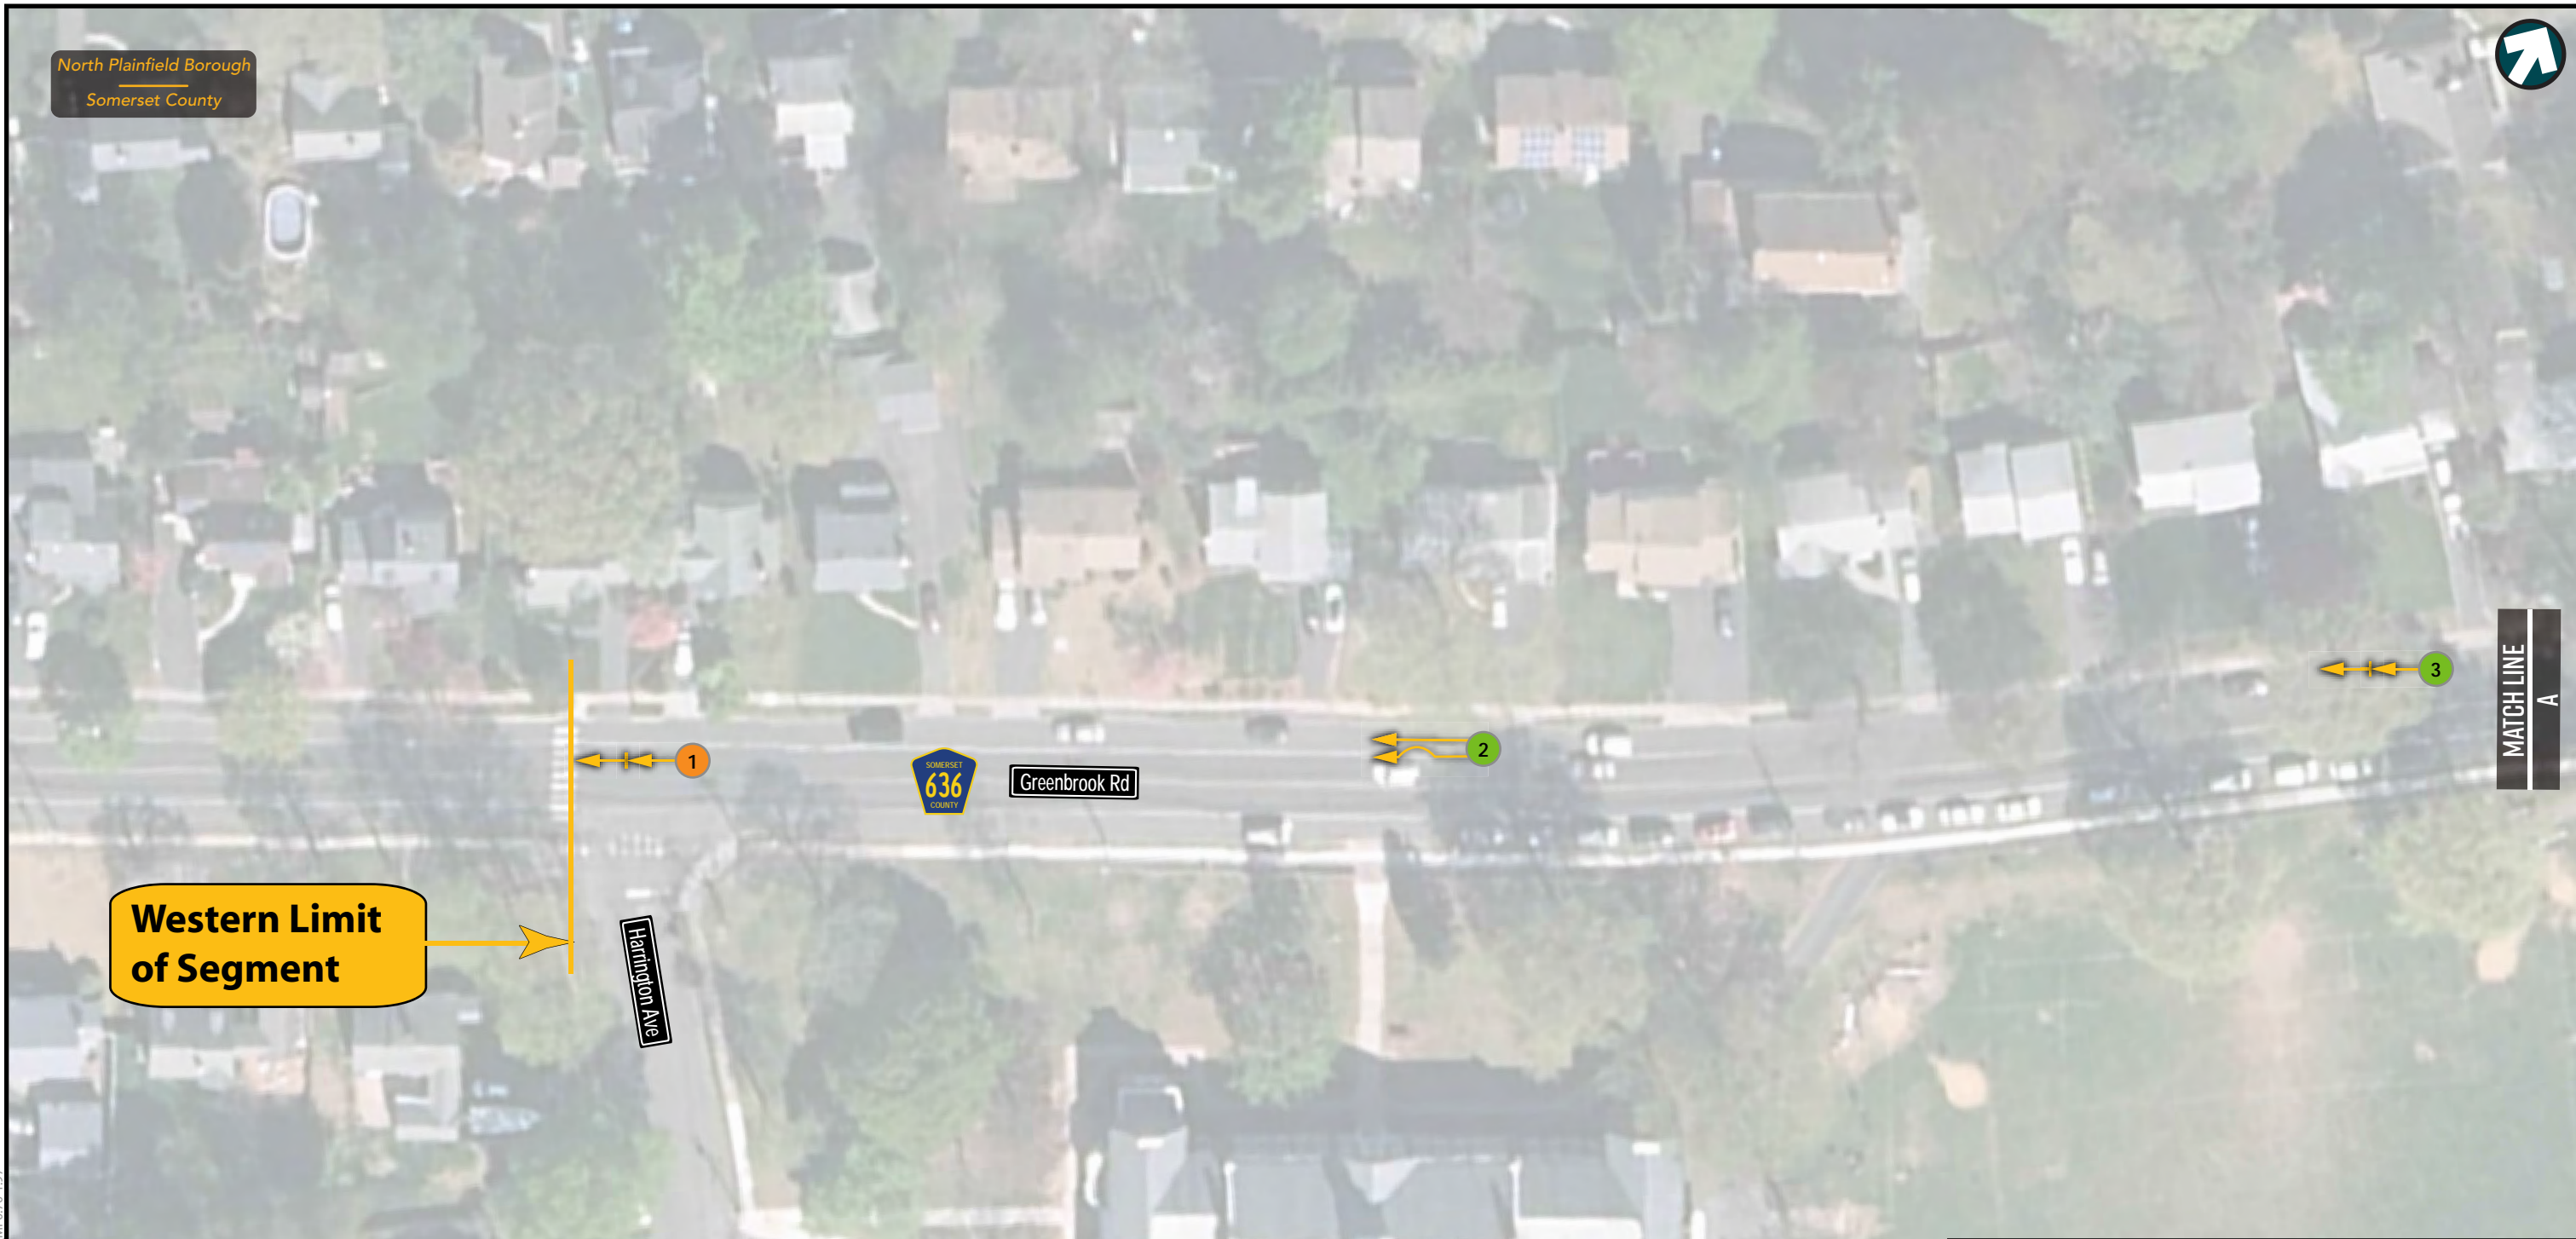
Collision Diagrams

North Plainfield Borough
Somerset County

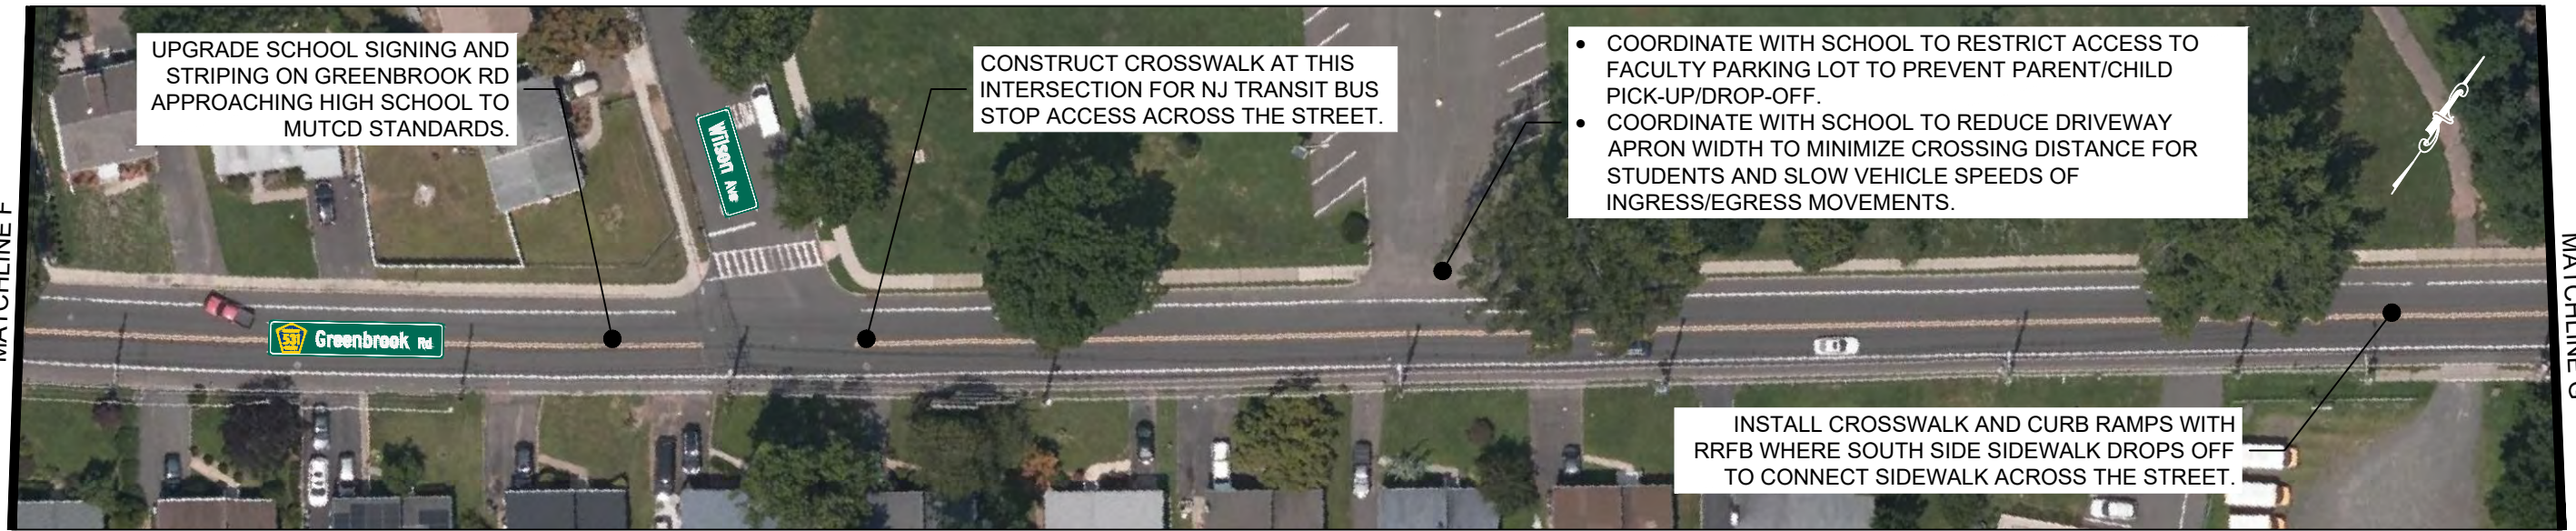
Title
N Plainfield Boro RSA Recommendations
Scale: 1" = 60'

UPGRADE SCHOOL SIGNING AND STRIPING ON GREENBROOK RD APPROACHING HIGH SCHOOL TO MUTCD STANDARDS.

CONSTRUCT CROSSWALK AT THIS INTERSECTION FOR NJ TRANSIT BUS STOP ACCESS ACROSS THE STREET.

- COORDINATE WITH UTILITY COMPANY TO REMOVE GUY WIRE HAZARD.
- CONDUCT A TRAFFIC STUDY TO DETERMINE IF EXISTING VOLUMES WARRANT A DEDICATED SB LEFT TURN LANE.
- UPGRADE PUSH BUTTONS.
- CONSIDER FULL SIGNAL REPLACEMENT AT THIS INTERSECTION AS EXISTING SIGNAL EQUIPMENT HAS REACHED THE END OF ITS USEFUL SERVICE LIFE.

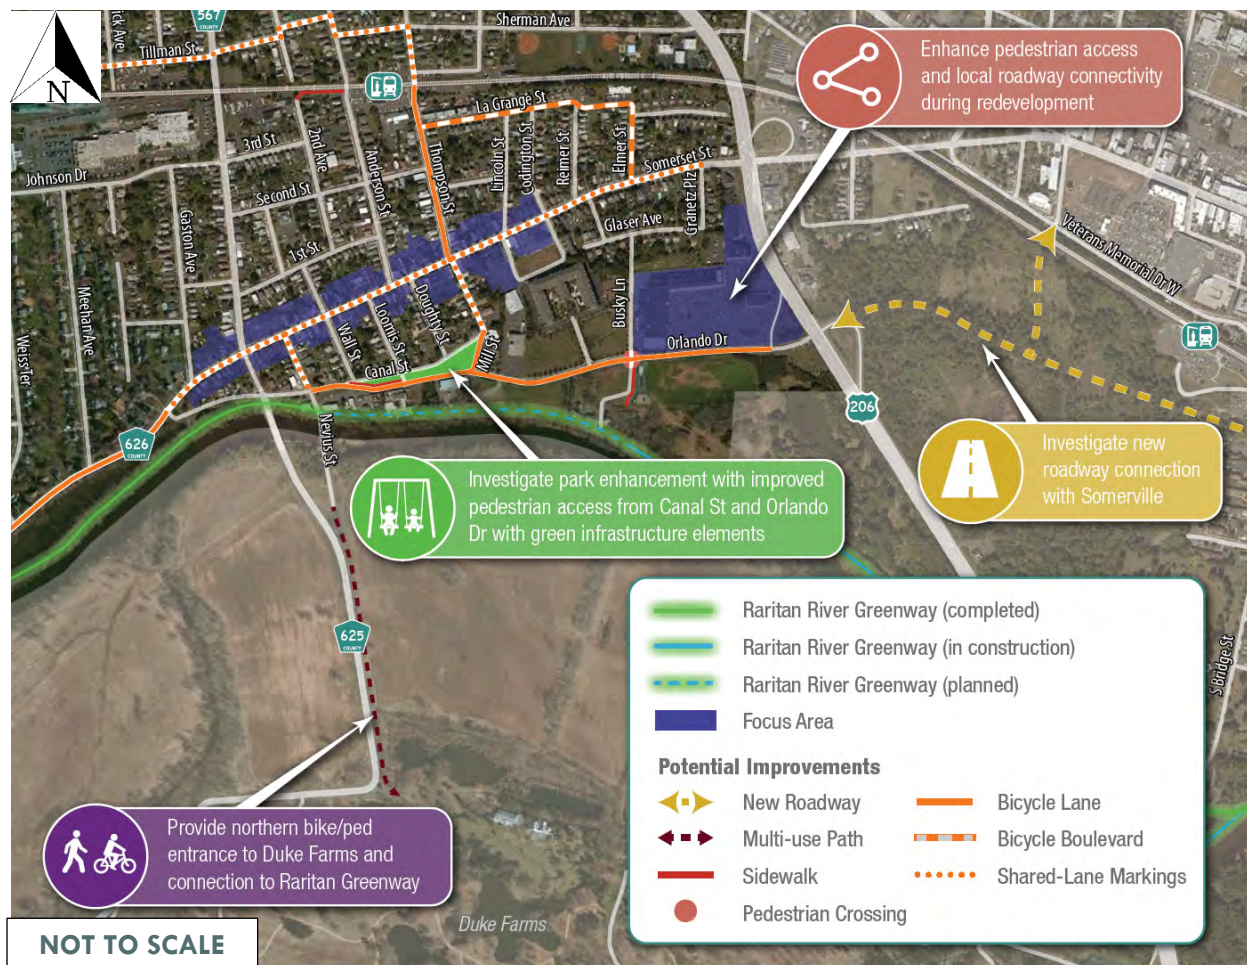
Figure 3 – Transportation Planning Recommendations from Phase III Study

This study also recommended that downtown streetscaping be updated, particularly along Somerset Street, to replace brick pavers with traditional concrete sidewalks or textured pavement for a more ADA-compliant walking surface. Streetscaping towards the western end of Somerset Street was also recommended to be extended eastward as development occurs. Finally, pedestrian access and roadway connectivity improvements were recommended via Somerset Street and Orlando Drive towards Raritan Mall to incentivize economic activity during the redevelopment of this retail space.

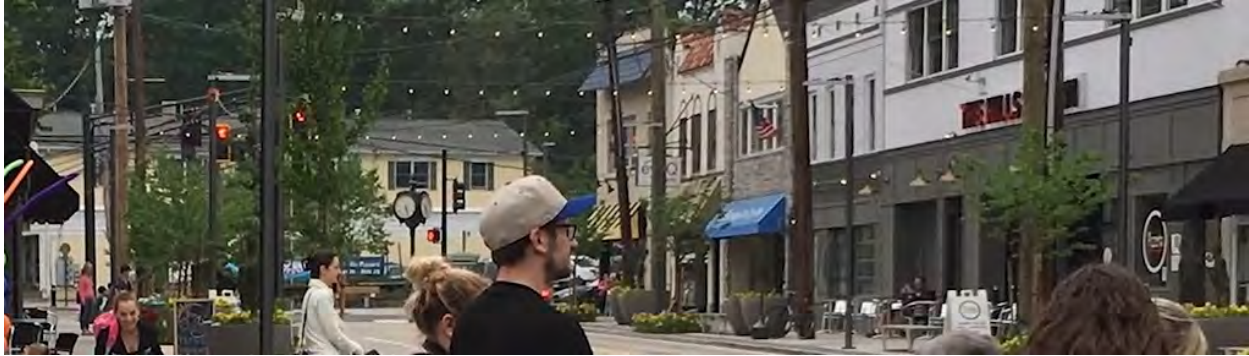
Figure 19 – Example Gateway Treatment with Light Strings in Millburn Township²⁴

RSA participants, particularly from the Borough, highlighted the fact that elevated vehicle speeds can be an issue on entrance to the downtown area, especially during weekend travel periods. Gateway treatments, such as banners strung between utility poles or buildings (as is currently done at the Coddington/Frederick Street intersection), can convey visual queues to drivers of entering a downtown environment with slower speeds. The Borough could also implement a similar gateway treatment for vehicles entering the Borough from the west (Branchburg) and south (Hillsborough) with lights strung overhead at the Nevius Street intersection with Somerset Street, which can also help to add street ambience and incentivize local retail use.

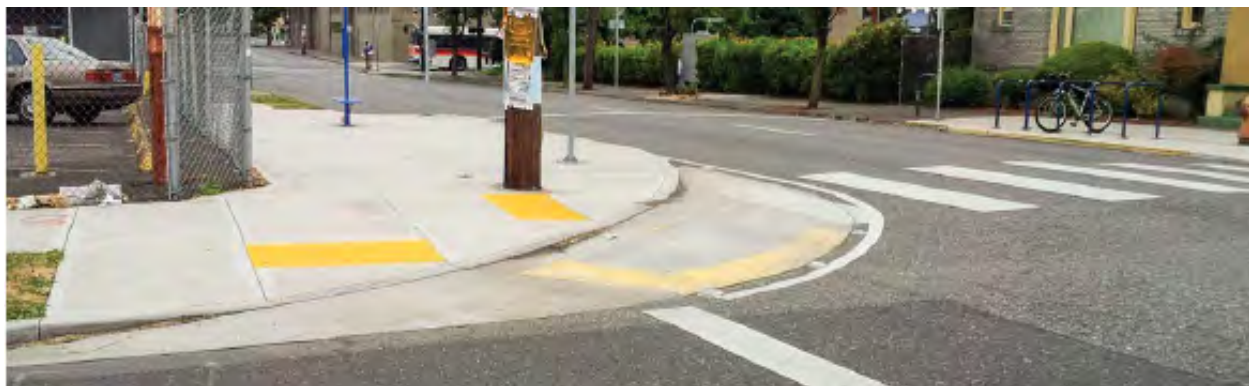
Figure 20 – Mountable Concrete Curbs in Portland Oregon²⁵

The intersection of First Avenue & Somerset Street serves as a conduit of not only vehicular travel, but also pedestrian and cyclist travel to nearby recreational destinations, such as Duke Island Park, Duke Farms, and the Nevius Street Sitting Bridge. However, design of this intersection is vehicular-centric with relatively large turning radii. The County could consider constructing concrete mountable curbs on all corners of the First Avenue intersection to tighten turning radii for general passenger car traffic, slowing turning speeds and mitigating the risk of pedestrian-vehicle conflicts and collisions while accommodating large sweeping truck turning movements. This feature, however, would need to accommodate the pavement loading of the trucks utilizing the feature to preserve the integrity of the mountable curb for crossing pedestrians.

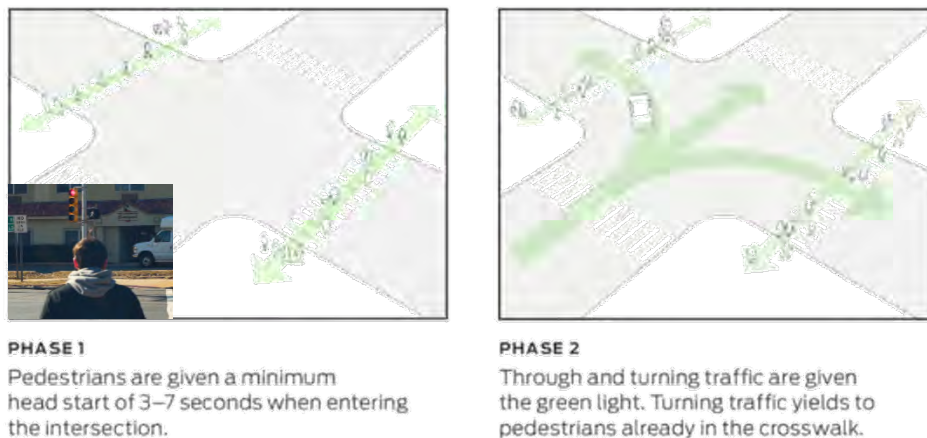
Figure 22 – Leading Pedestrian Interval (from NACTO and Lakewood Township)²⁸

LPIs are a low-cost, effective way to help pedestrians establish their presence at signalized crossing locations before conflicting vehicles have the right-of-way (Figure 22). This is one of FHWA’s Proven Safety Countermeasures, boasting an approximate reduction of 13%²⁷ of pedestrian-vehicle crashes with proper implementation. Vehicular capacity is noted to be a barrier to implementation, which requires intersection capacity analysis before implementation. Thompson Street is a prime candidate for implementation due to relatively low vehicle volumes and two-phase signal timing. Implementation would be difficult at the Route 206 (where NJDOT coordination is needed) and First Avenue (where lead left phasing and congestion may preclude implementation) signals. ADA improvements and phasing adjustment at Route 206 could improve pedestrian safety, by changing the split phasing at the intersection to allow the southern crosswalk phase (which has seen pedestrian collisions, including a fatality) to proceed before the northern crosswalk phase.

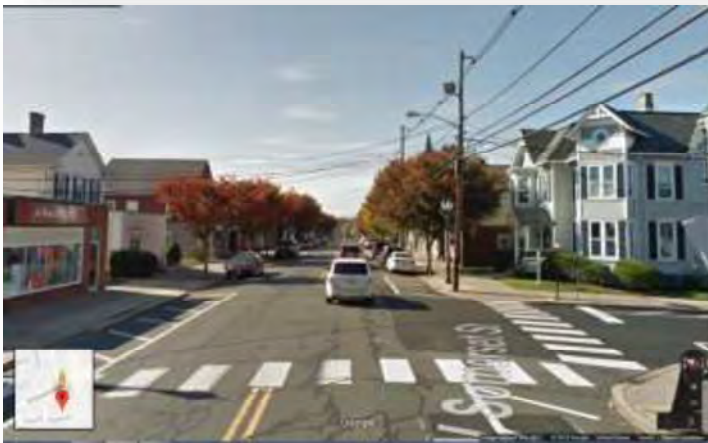
Somerset Street & Loomis Street

- 3-way intersection
- No traffic control devices
- No pedestrian head signals
- Two crosswalks, one on Loomis St. and one across Somerset St.
- 2 lanes

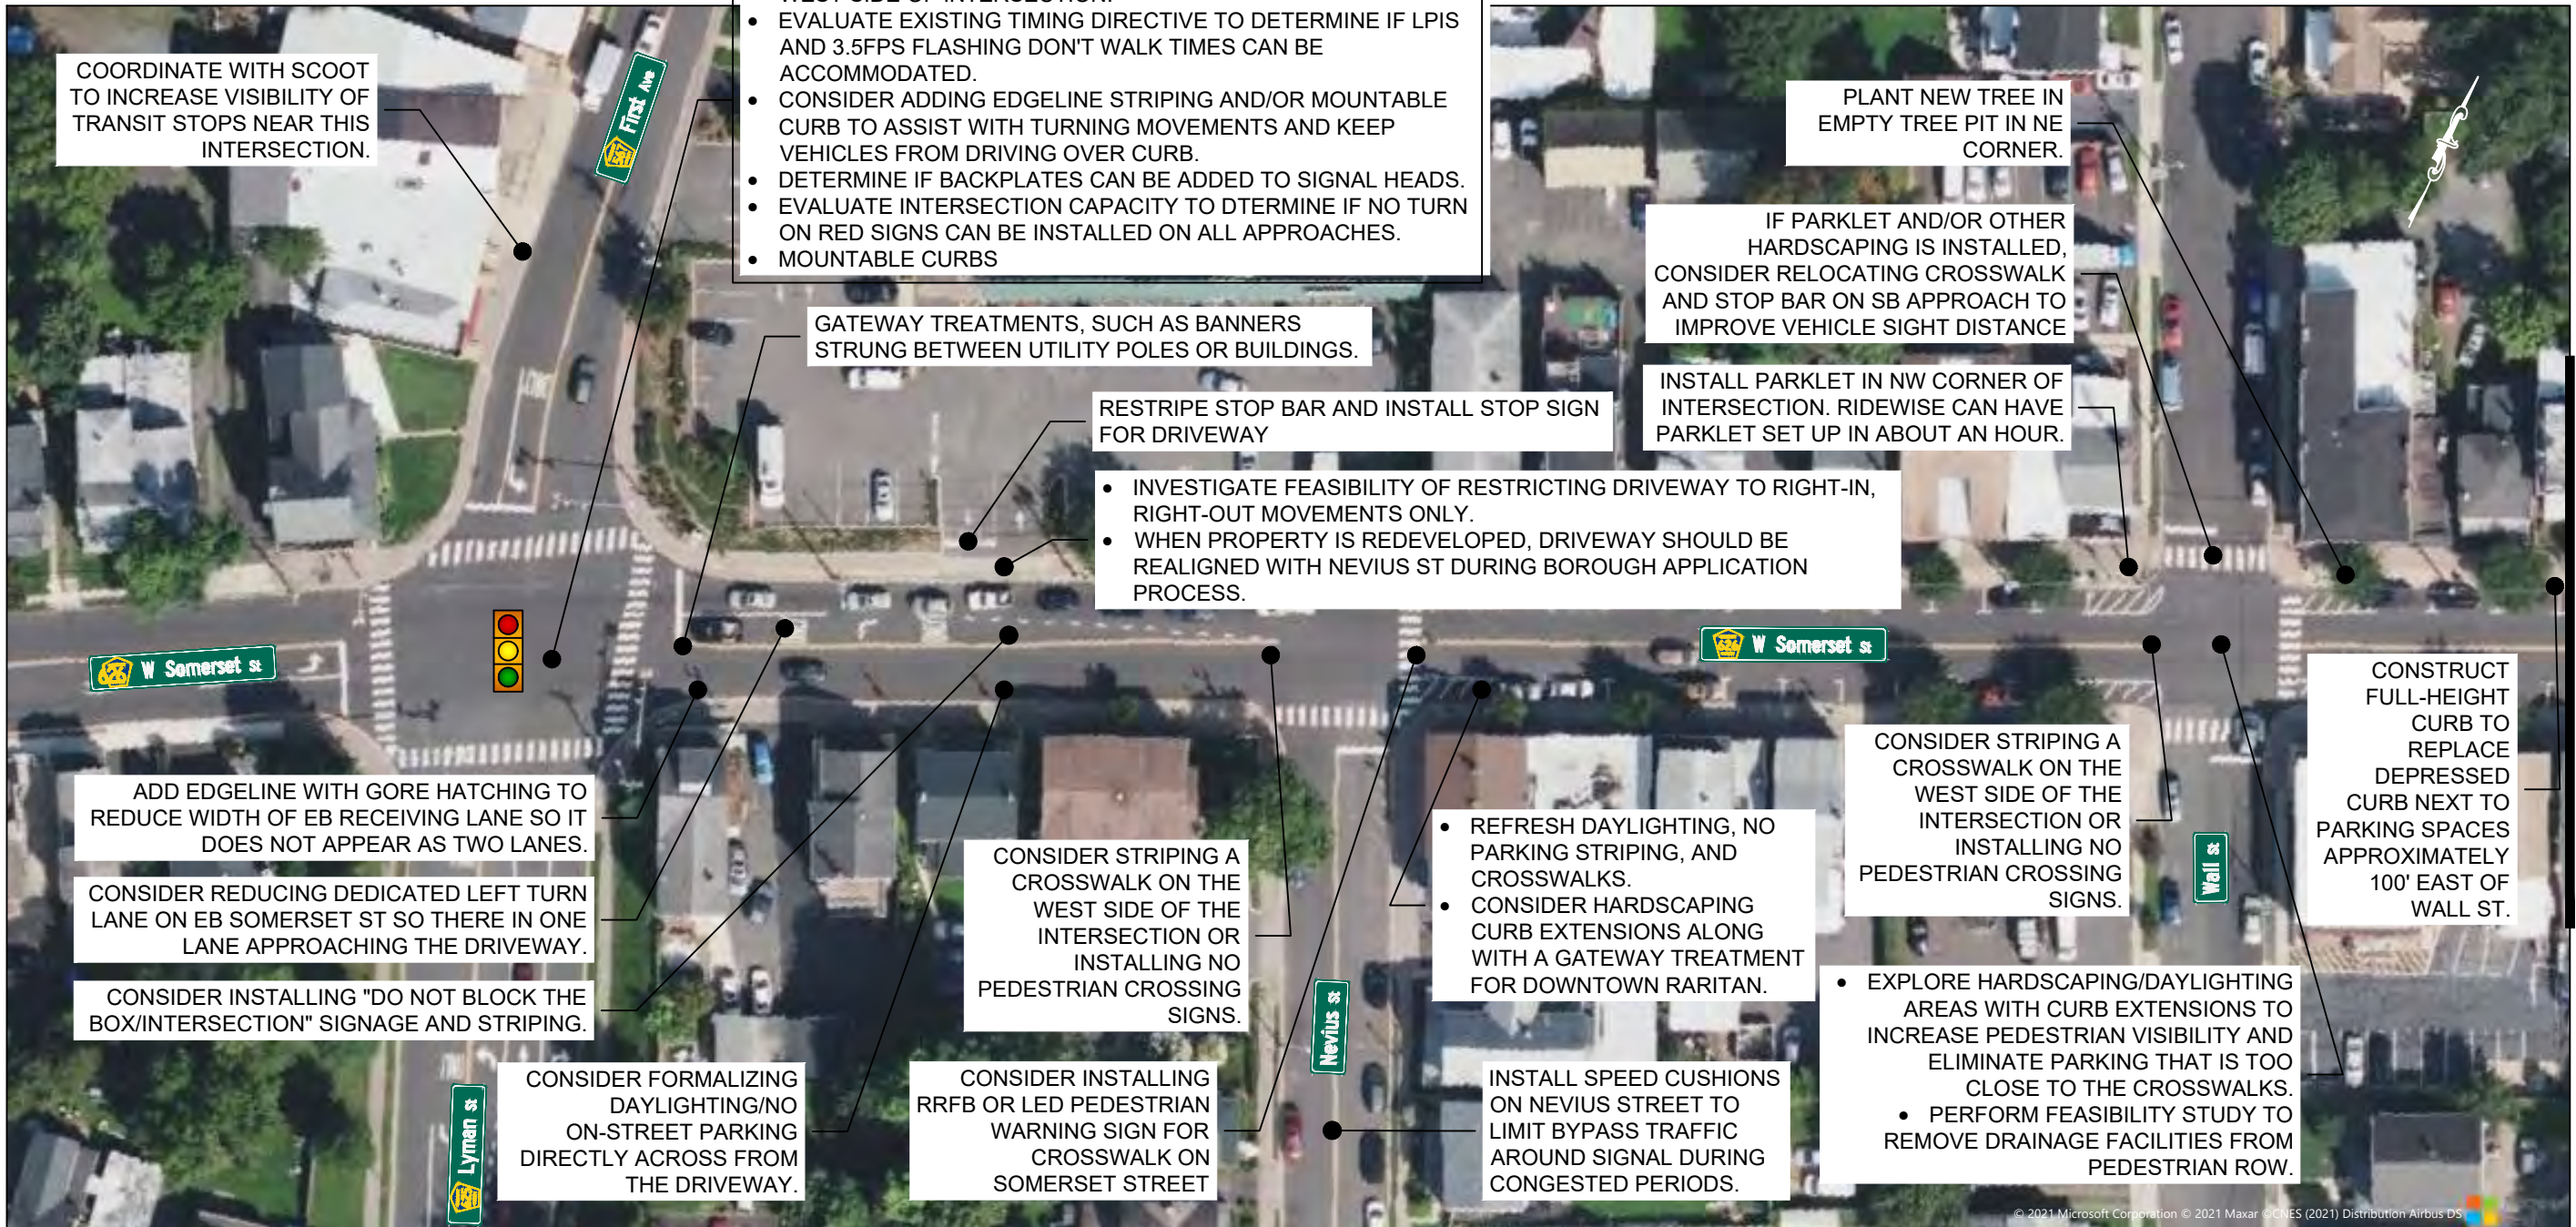
Sheet No.
1 of 4

COORDINATE WITH SCOOT TO INCREASE VISIBILITY OF TRANSIT STOPS NEAR THIS INTERSECTION.

- CONDUCT PHOTOMETRICS ANALYSIS TO DETERMINE IF INTERSECTION LIGHTING MEETS STANDARDS, ESPECIALLY ON WEST SIDE OF INTERSECTION.
- EVALUATE EXISTING TIMING DIRECTIVE TO DETERMINE IF LPIS AND 3.5FPS FLASHING DON'T WALK TIMES CAN BE ACCOMMODATED.
- CONSIDER ADDING EDGELINE STRIPING AND/OR MOUNTABLE CURB TO ASSIST WITH TURNING MOVEMENTS AND KEEP VEHICLES FROM DRIVING OVER CURB.
- DETERMINE IF BACKPLATES CAN BE ADDED TO SIGNAL HEADS.
- EVALUATE INTERSECTION CAPACITY TO DETERMINE IF NO TURN ON RED SIGNS CAN BE INSTALLED ON ALL APPROACHES.
- MOUNTABLE CURBS

CONSTRUCT FULL-HEIGHT CURB TO REPLACE DEPRESSED CURB NEXT TO PARKING SPACES APPROXIMATELY 100' EAST OF WALL ST.
